LeakFREE® Roof Inspection

Report No :
43287

Property Inspected :
10 Summer Street
Los Angeles, CA 90001

Inspected By :
John Smith
NRCIA Certified
Roof Inspector

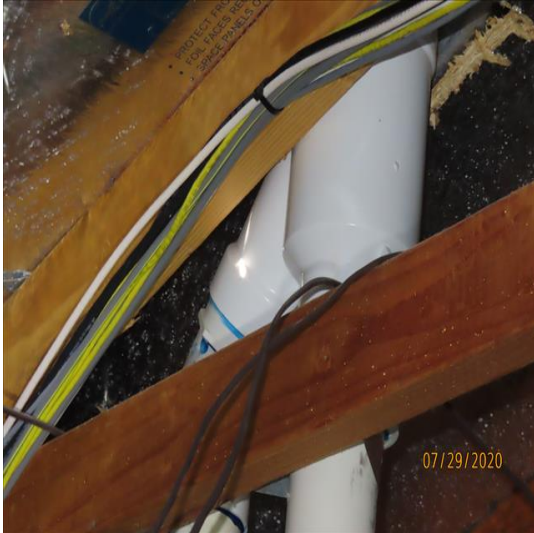
Image Number: 22

Observation: Daylight was observed at the exhaust pipe.

Cause: Upon completion of the inspection, it was determined that this is a result of deficient sealant at the roof penetration.

Remedy: See roof section for further details and determinations.

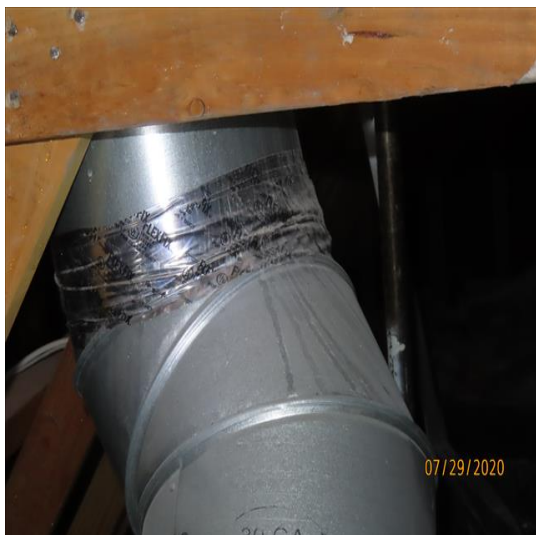
Image Number: 28

Observation: Water stains were observed on the exhaust vent pipe in the attic.

Cause: Upon completion of the inspection, it was determined that this is a result of a damaged roof flashing.

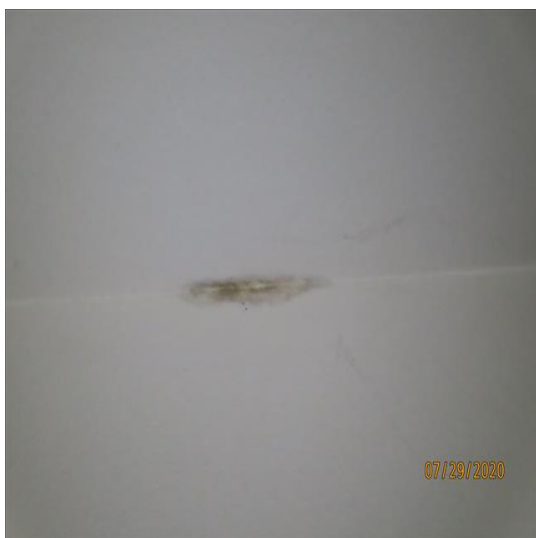
Image Number: 30

Observation: Moisture intrusion was observed on the ceiling of the garage. There is living space directly above this area.

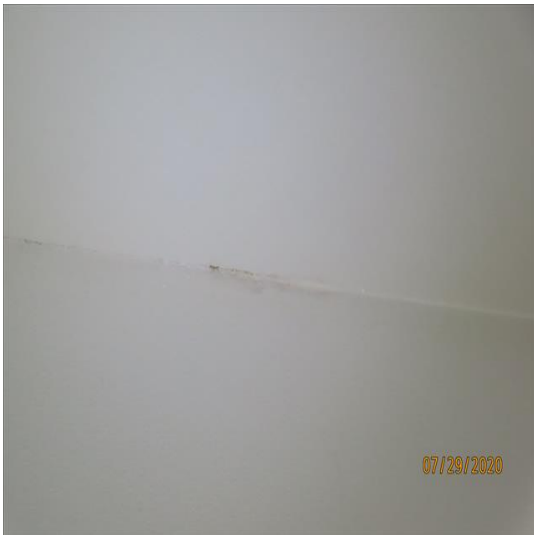
Image Number: 32

Observation: Moisture intrusion was observed on the ceiling of the garage. There is living space directly above this area.

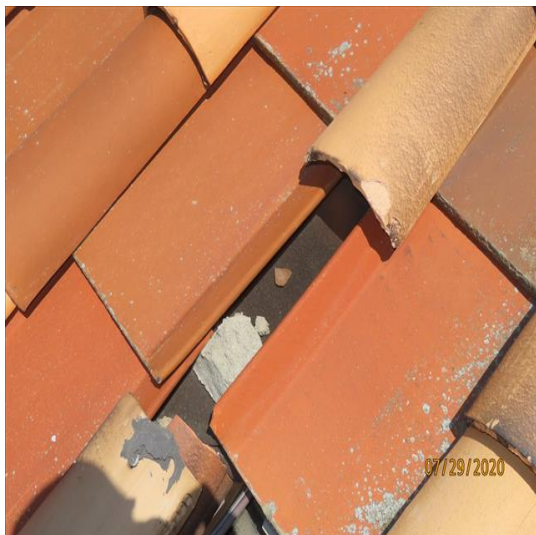
Image Number: 35

Observation: Broken/damaged tiles were observed in various locations throughout the roof system.

Determination: Roof Repair required for LeakFREE Roof Certification

Remedy: Remove and replace all necessary damaged tiles.

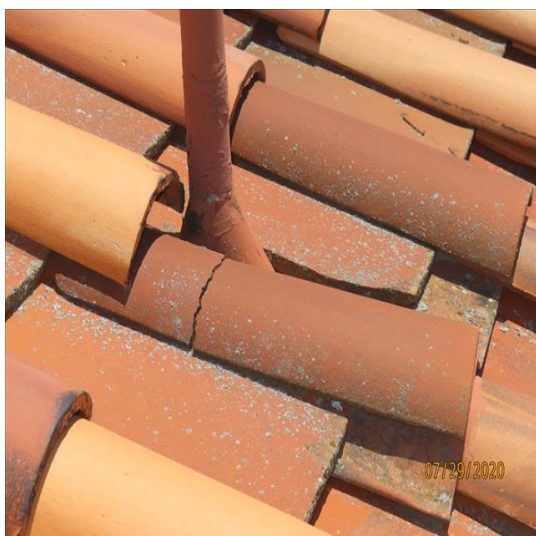
Image Number: 36

Observation: The sealant is cracked and deteriorated at various penetrations throughout the roof system. The roof penetrations need to be cleaned and re-sealed approximately every 5 years.

Determination: Roof Repair required for LeakFREE Roof Certification

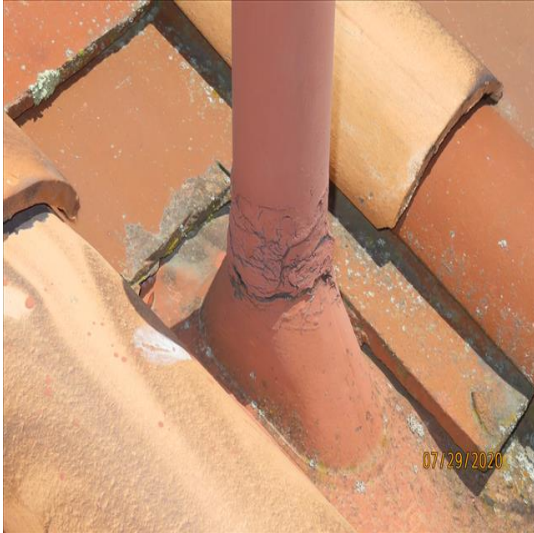
Image Number: 37

Observation: The sealant is cracked and deteriorated at various penetrations throughout the roof system. The roof penetrations need to be cleaned and re-sealed approximately every 5 years.

Determination: Roof Repair required for LeakFREE Roof Certification

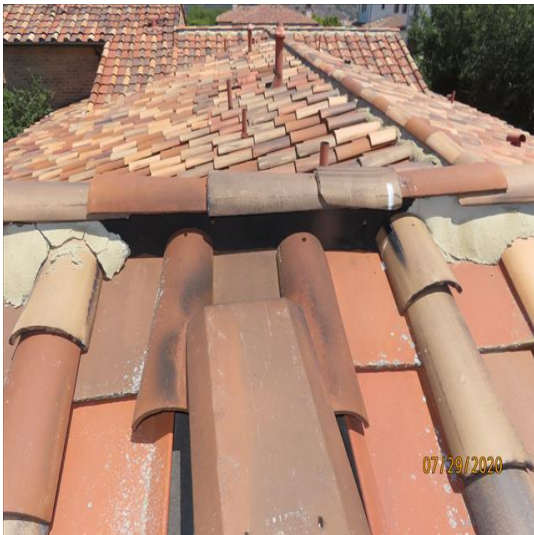
Image Number: 38

Observation: Missing mortar was observed at the ridge.

Determination: Roof Repair required for LeakFREE Roof Certification

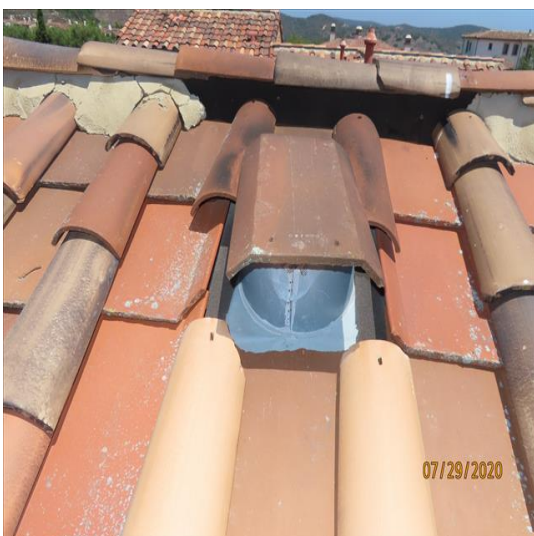
Image Number: 39

Observation: Damaged roof flashing (2) was observed. The metal cap is missing which has exposed a 10" hole in the roof system.

Determination: Roof Repair required for LeakFREE Roof Certification

Remedy: Damaged flashing (2): Remove the tiles surrounding the flashing, remove and disposed the damaged flashing, install an new 10" t-top flashing, install new underlayment where necessary, re-install the tiles, paint the flashing to match.

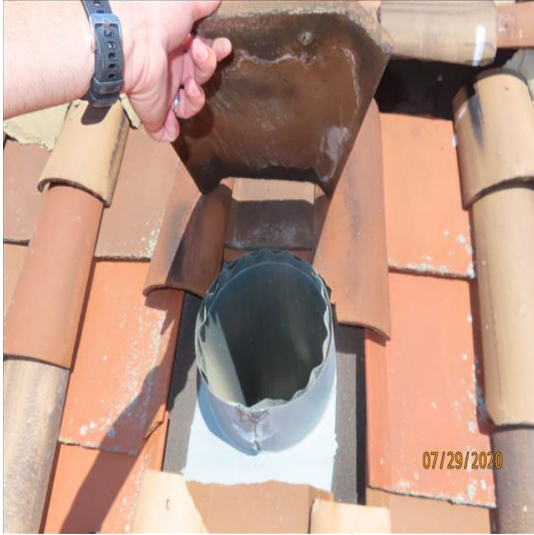
Image Number: 40

Observation: Damaged roof flashing (2) was observed. The metal cap is missing which has exposed a 10" hole in the roof system.

Determination: Roof Repair required for LeakFREE Roof Certification

Remedy: Damaged flashing (2): Remove the tiles surrounding the flashing, remove and disposed the damaged flashing, install an new 10" t-top flashing, install new underlayment where necessary, re-install the tiles, paint the flashing to match.

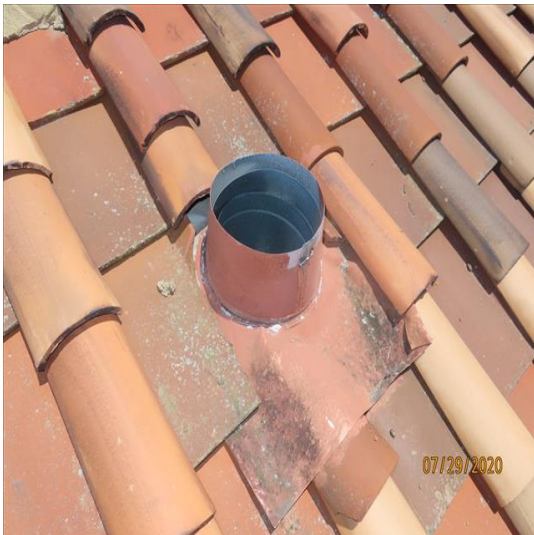
Image Number: 41

Observation: Damaged roof flashing (2) was observed. The metal cap is missing which has exposed a 10" hole in the roof system.

Determination: Roof Repair required for LeakFREE Roof Certification

Remedy: Damaged flashing (2): Remove the tiles surrounding the flashing, remove and disposed the damaged flashing, install an new 10" t-top flashing, install new underlayment where necessary, re-install the tiles, paint the flashing to match.

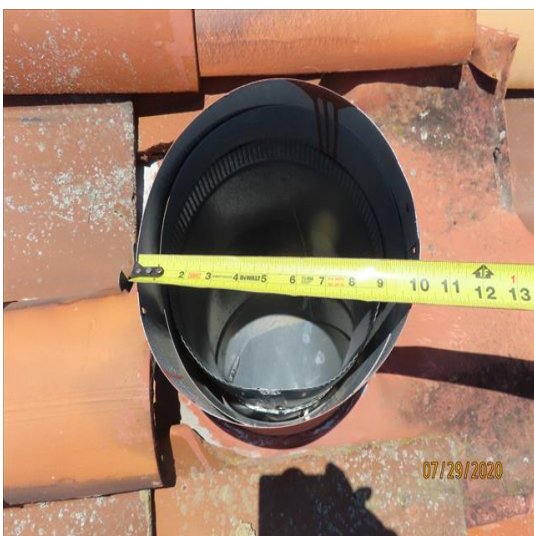
Image Number: 42

Observation: Damaged roof flashing (2) was observed. The metal cap is missing which has exposed a 10" hole in the roof system.

Determination: Roof Repair required for LeakFREE Roof Certification

Remedy: Damaged flashing (2): Remove the tiles surrounding the flashing, remove and disposed the damaged flashing, install an new 10" t-top flashing, install new underlayment where necessary, re-install the tiles, paint the flashing to match.

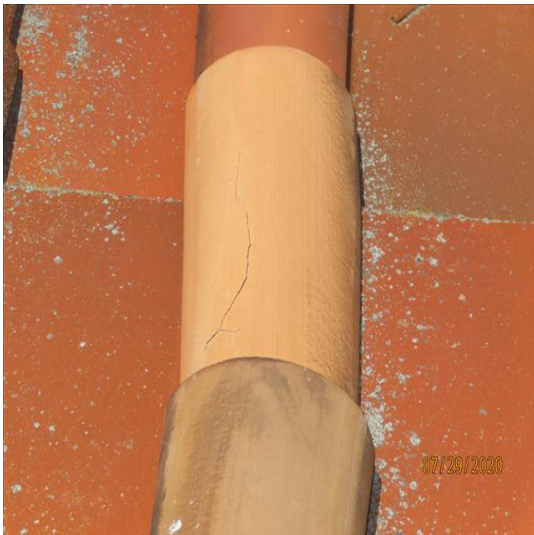
Image Number: 44

Observation: Broken/damaged tiles were observed in various locations throughout the roof system.

Determination: Roof Repair required for LeakFREE Roof Certification

Remedy: Remove and replace all necessary damaged tiles.

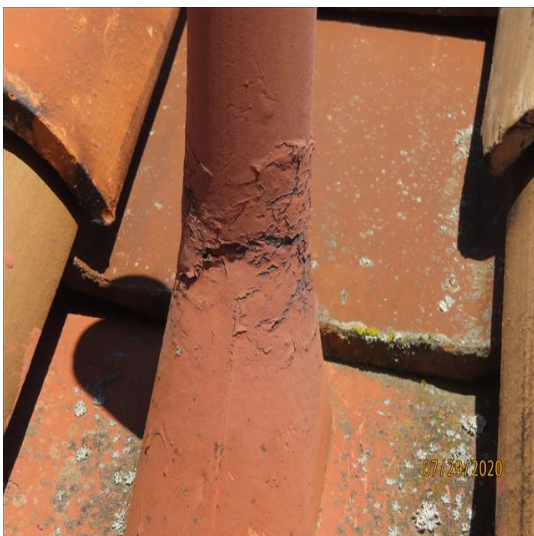
Image Number: 45

Observation: The sealant is cracked and deteriorated at various penetrations throughout the roof system. The roof penetrations need to be cleaned and re-sealed approximately every 5 years.

Determination: Roof Repair required for LeakFREE Roof Certification

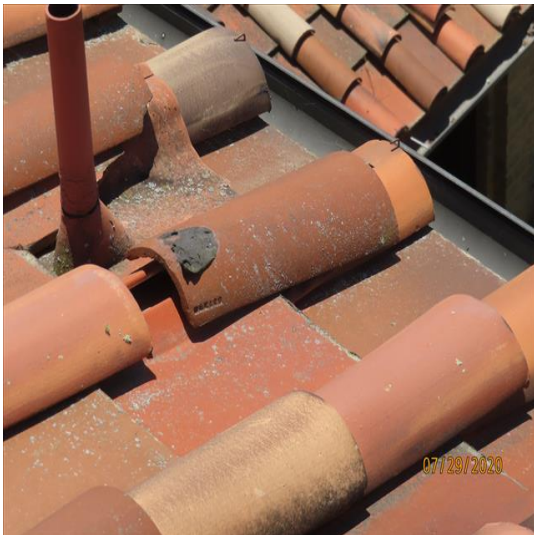
Image Number: 47

Observation: Loose/displaced tiles were observed in various locations throughout the roof system.

Determination: Roof Repair required for LeakFREE Roof Certification

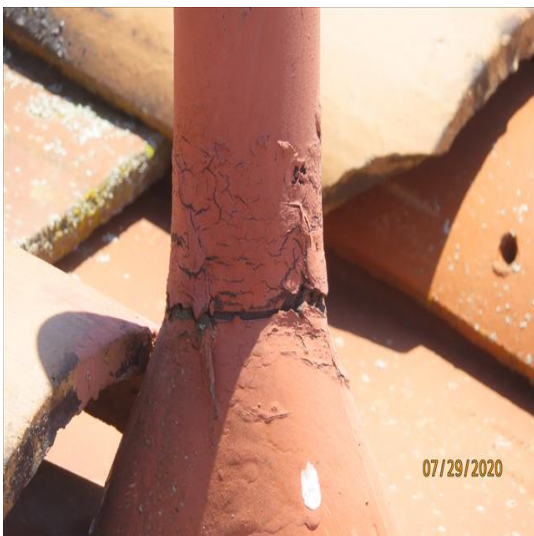
Image Number: 48

Observation: The sealant is cracked and deteriorated at various penetrations throughout the roof system. The roof penetrations need to be cleaned and re-sealed approximately every 5 years.

Determination: Roof Repair required for LeakFREE Roof Certification

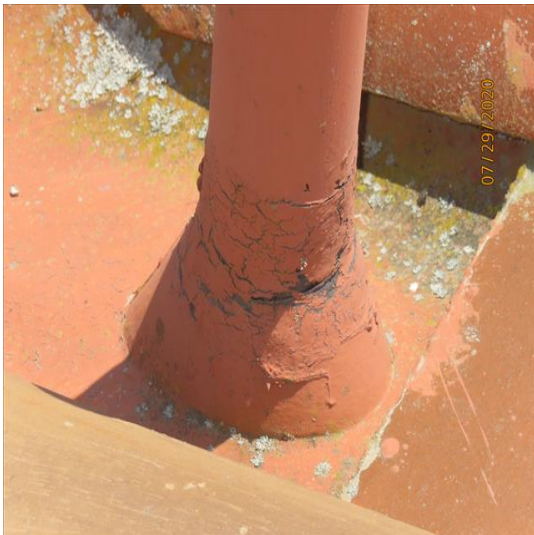
Image Number: 53

Observation: The sealant is cracked and deteriorated at various penetrations throughout the roof system. The roof penetrations need to be cleaned and re-sealed approximately every 5 years.

Determination: Roof Repair required for LeakFREE Roof Certification

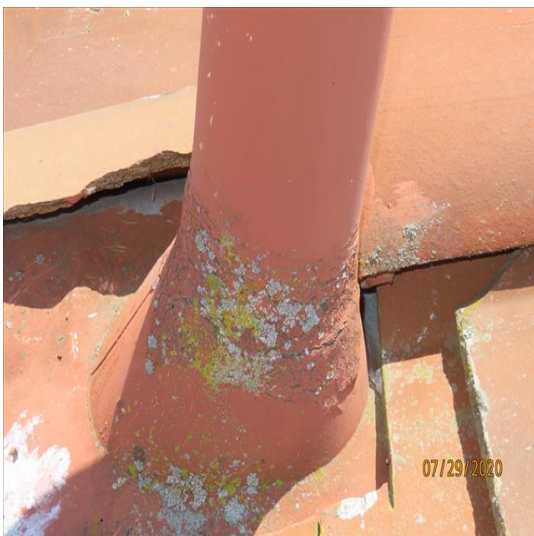
Image Number: 54

Observation: The sealant is cracked and deteriorated at various penetrations throughout the roof system. The roof penetrations need to be cleaned and re-sealed approximately every 5 years.

Determination: Roof Repair required for LeakFREE Roof Certification

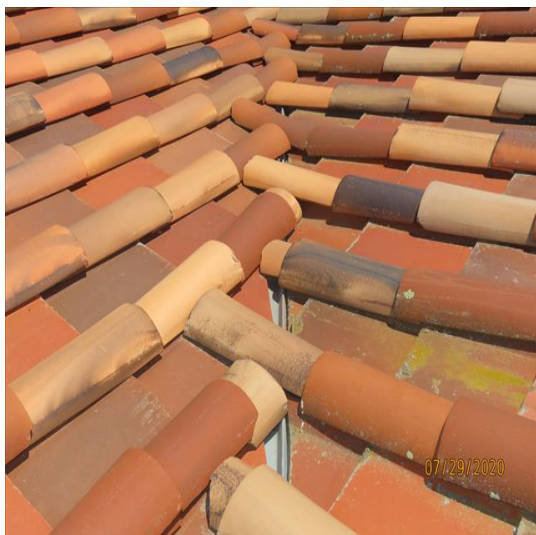
Image Number: 55

Observation: The tiles in the valley were woven together rather than properly cut back. The close cut tiles will impede proper drainage of water and debris. When water can't flow down the valley, it will be pushed laterally under the tiles causing interior moisture intrusion. This is the predominant cause of leaks on a tile roof system.

Determination: Roof Repair required for LeakFREE Roof Certification

Remedy: Valley repair: Cut the tiles at the valley locations to expose approximately 3" of the valley metal.

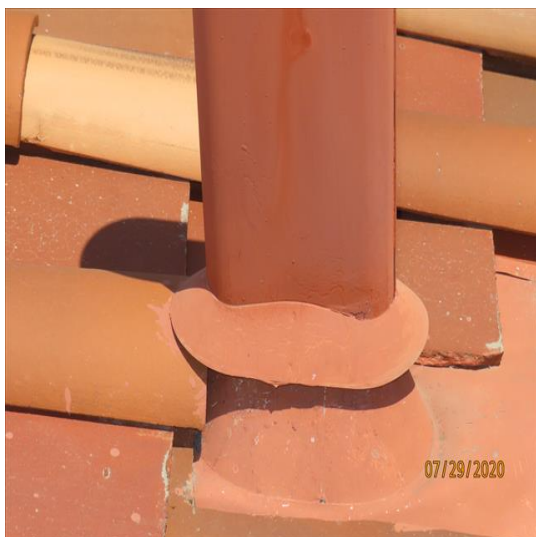
Image Number: 56

Observation: The sealant is cracked and deteriorated at various penetrations throughout the roof system. The roof penetrations need to be cleaned and re-sealed approximately every 5 years.

Determination: Roof Repair required for LeakFREE Roof Certification

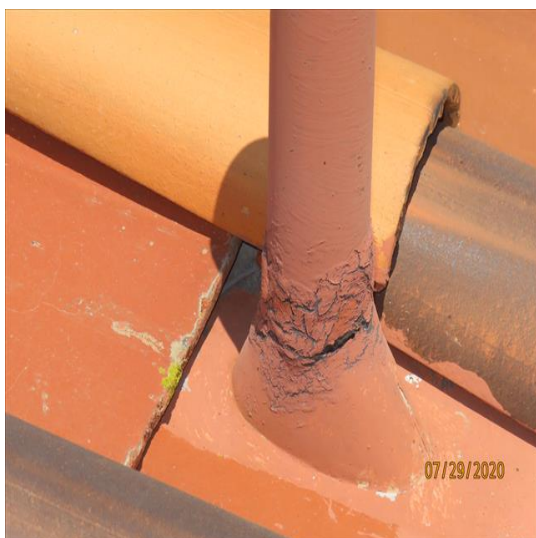
Image Number: 57

Observation: The sealant is cracked and deteriorated at various penetrations throughout the roof system. The roof penetrations need to be cleaned and re-sealed approximately every 5 years.

Determination: Roof Repair required for LeakFREE Roof Certification

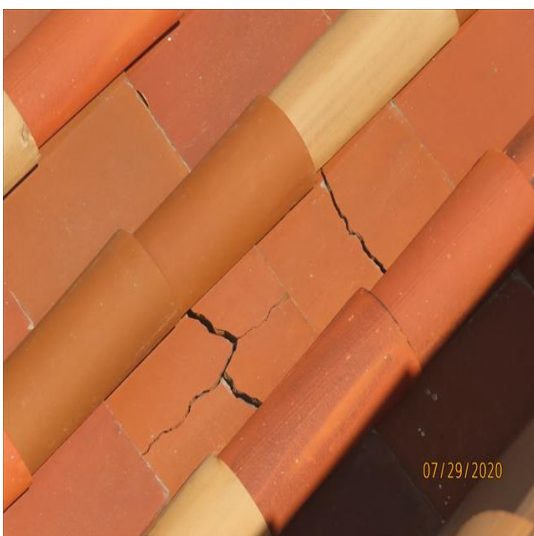
Image Number: 60

Observation: Broken/damaged tiles were observed in various locations throughout the roof system.

Determination: Roof Repair required for LeakFREE Roof Certification

Remedy: Remove and replace all necessary damaged tiles.

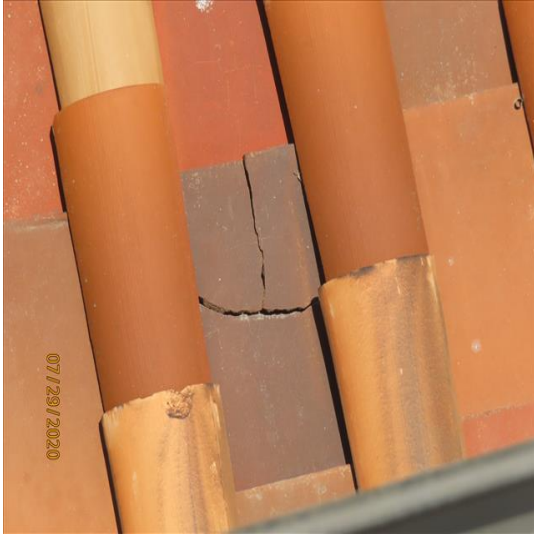
Image Number: 61

Observation: Broken/damaged tiles were observed in various locations throughout the roof system.

Determination: Roof Repair required for LeakFREE Roof Certification

Remedy: Remove and replace all necessary damaged tiles.

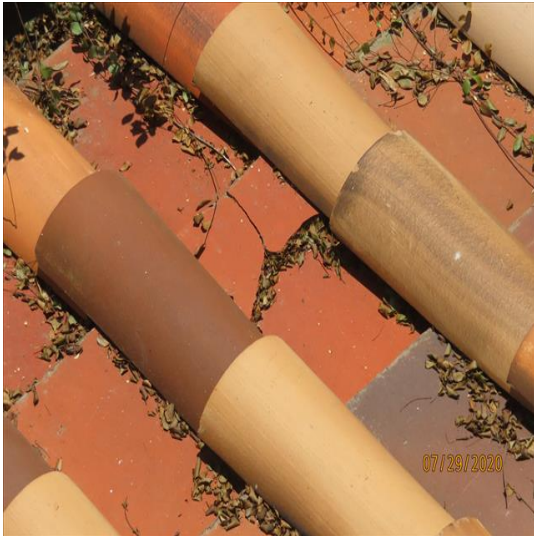
Image Number: 62

Observation: Broken/damaged tiles were observed in various locations throughout the roof system.

Determination: Roof Repair required for LeakFREE Roof Certification

Remedy: Remove and replace all necessary damaged tiles.

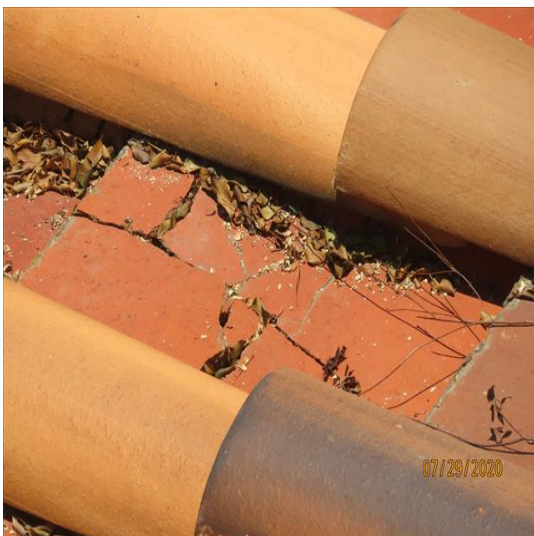
Image Number: 63

Observation: Broken/damaged tiles were observed in various locations throughout the roof system.

Determination: Roof Repair required for LeakFREE Roof Certification

Remedy: Remove and replace all necessary damaged tiles.

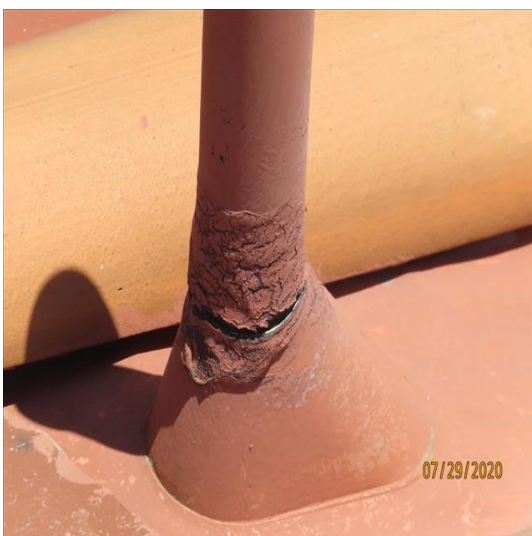
Image Number: 66

Observation: The sealant is cracked and deteriorated at various penetrations throughout the roof system. The roof penetrations need to be cleaned and re-sealed approximately every 5 years.

Determination: Roof Repair required for LeakFREE Roof Certification

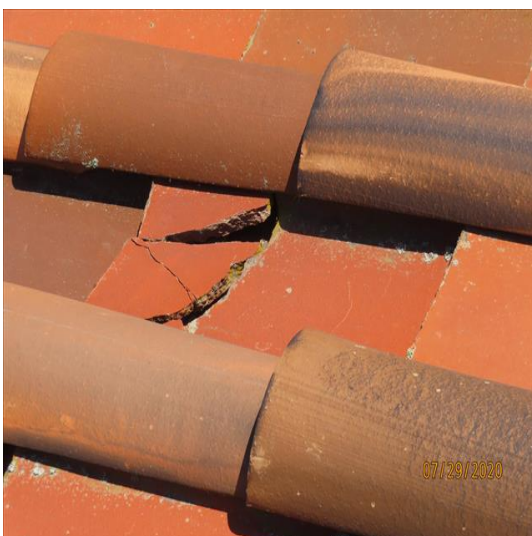
Image Number: 69

Observation: Broken/damaged tiles were observed in various locations throughout the roof system.

Determination: Roof Repair required for LeakFREE Roof Certification

Remedy: Remove and replace all necessary damaged tiles.

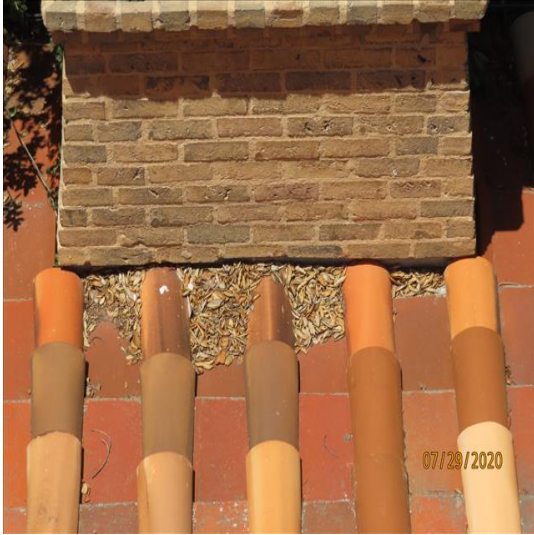
Image Number: 73

Observation: A build up of debris was observed in various locations throughout the roof system. This will impede proper drainage of rain water.

Determination: Roof Repair required for LeakFREE Roof Certification

Remedy: Upon completion of the roof repairs, clean all possible debris off the roof. This is recommended at least once a year prior to the rainy season.

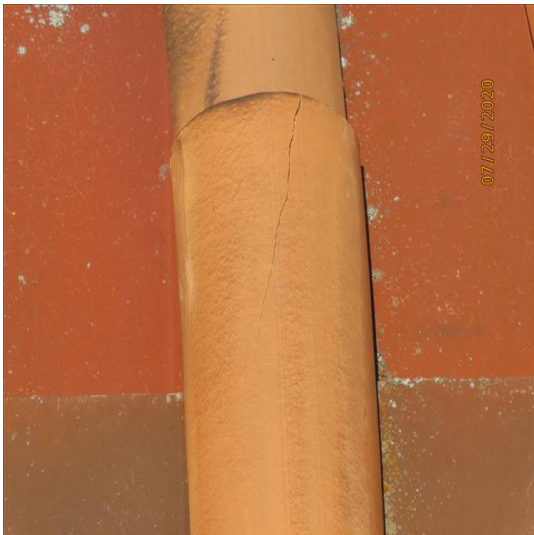
Image Number: 77

Observation: Broken/damaged tiles were observed in various locations throughout the roof system.

Determination: Roof Repair required for LeakFREE Roof Certification

Remedy: Remove and replace all necessary damaged tiles.

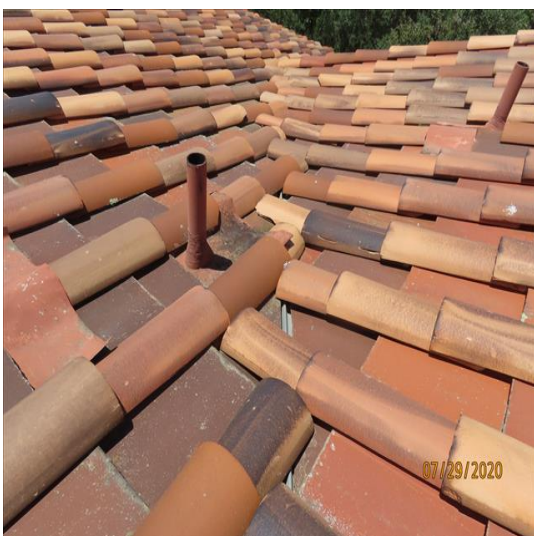
Image Number: 78

Observation: The tiles in the valley were woven together rather than properly cut back. The close cut tiles will impede proper drainage of water and debris. When water can't flow down the valley, it will be pushed laterally under the tiles causing interior moisture intrusion. This is the predominant cause of leaks on a tile roof system.

Determination: Roof Repair required for LeakFREE Roof Certification

Remedy: Valley repair: Cut the tiles at the valley locations to expose approximately 3" of the valley metal.

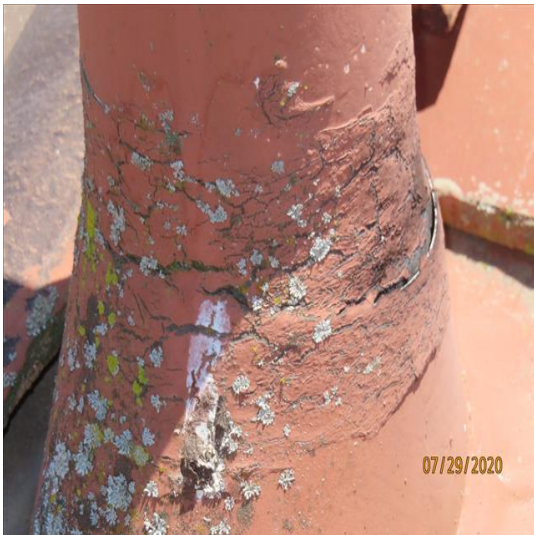
Image Number: 83

Observation: The sealant is cracked and deteriorated at various penetrations throughout the roof system. The roof penetrations need to be cleaned and re-sealed approximately every 5 years.

Determination: Roof Repair required for LeakFREE Roof Certification

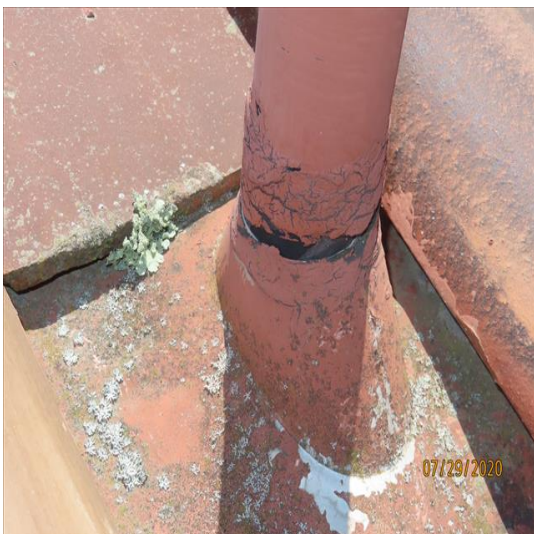
Image Number: 84

Observation: The sealant is cracked and deteriorated at various penetrations throughout the roof system. The roof penetrations need to be cleaned and re-sealed approximately every 5 years.

Determination: Roof Repair required for LeakFREE Roof Certification

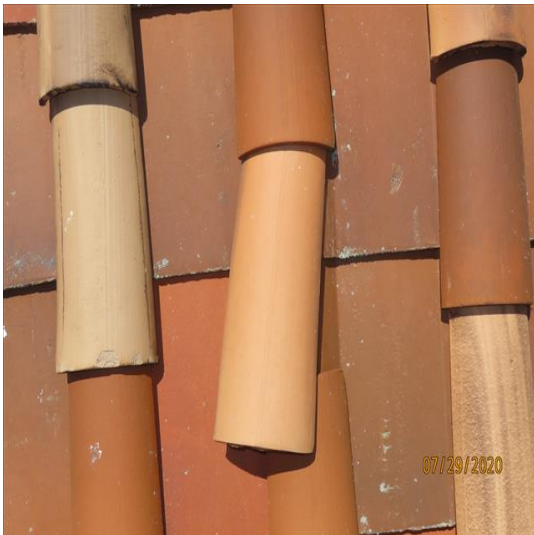
Image Number: 86

Observation: Loose/displaced tiles were observed in various locations throughout the roof system.

Determination: Roof Repair required for LeakFREE Roof Certification

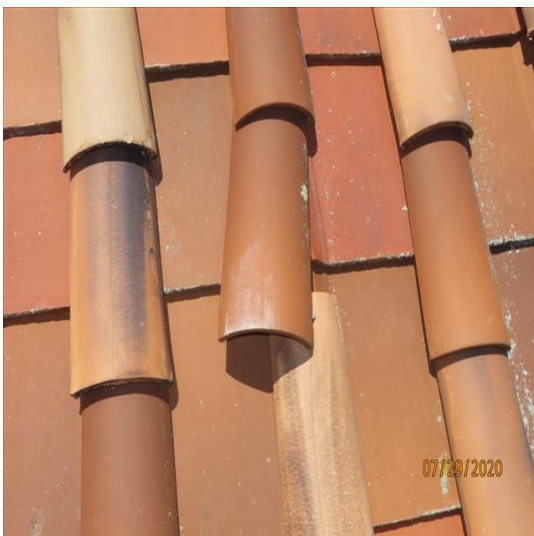
Image Number: 87

Observation: Loose/displaced tiles were observed in various locations throughout the roof system.

Determination: Roof Repair required for LeakFREE Roof Certification

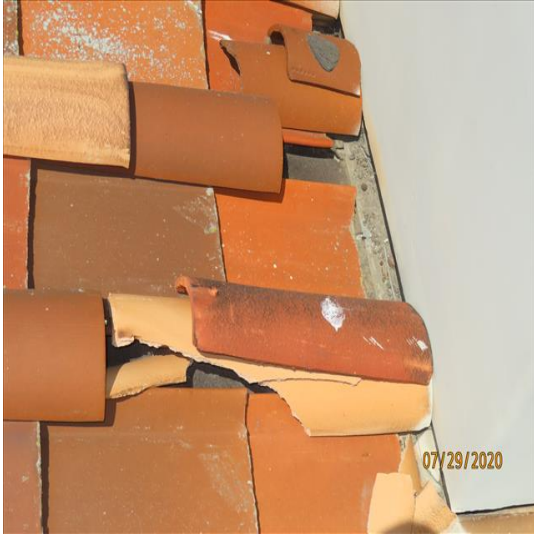
Image Number: 88

Observation: Broken/damaged tiles were observed in various locations throughout the roof system.

Determination: Roof Repair required for LeakFREE Roof Certification

Remedy: Remove and replace all necessary damaged tiles.

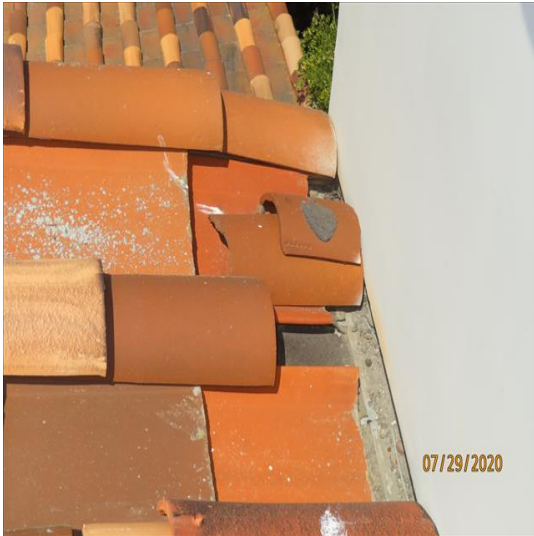
Image Number: 89

Observation: Broken/damaged tiles were observed in various locations throughout the roof system.

Determination: Roof Repair required for LeakFREE Roof Certification

Remedy: Remove and replace all necessary damaged tiles.

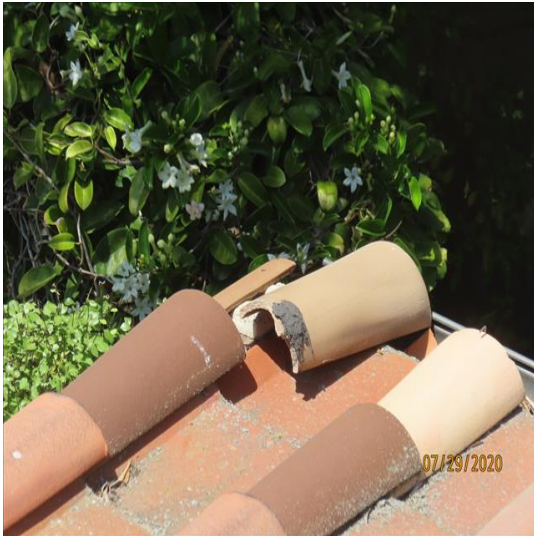
Image Number: 92

Determination: Roof Repair required for LeakFREE Roof Certification

Remedy: Remove and replace all necessary damaged tiles.
