# LeakFREE® Roof Inspection

**Report No:**  
135207

**Inspection Date:**  
05/04/2026

**Property Inspected:**  
303 N Granite Ct  
Brian Head, UT, 84719

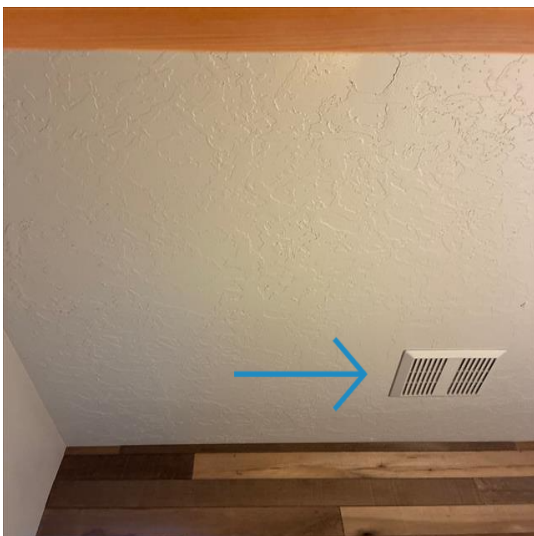
**Image Number: 6**

**Observation:** Overview: Bathroom Exhaust Termination: The master bathroom exhaust fan was observed to terminate into the open attic space which is a **red flag**. Bathroom exhaust fans are required to vent to the building exterior. Discharging warm, moist air into the attic introduces humidity that can condense on cold roof sheathing, saturate insulation, contribute to ice dam formation, and accelerate deterioration of roof structural components.

**Cause:** Improper bathroom exhaust installation — duct not extended to a code-compliant exterior termination.

**Remedy:** Recommend extending the bathroom exhaust duct to terminate at a code-compliant exterior location by a qualified mechanical or general contractor.

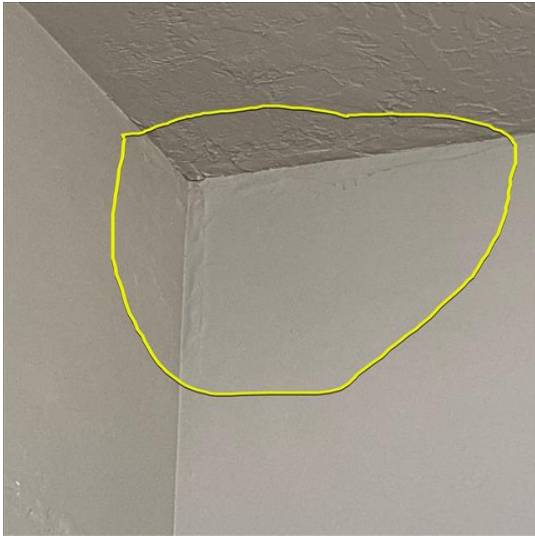
**Image Number:** 7  
**Observation:** **Observation:** Bubbling paint and moisture staining were observed, indicating active or prior moisture intrusion from above.

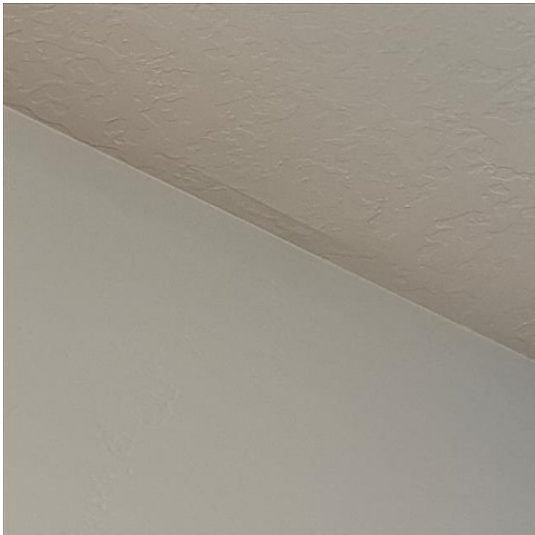
**Image Number:** 9  
**Observation:** **Observation:** Cracking in the drywall sealing was observed.

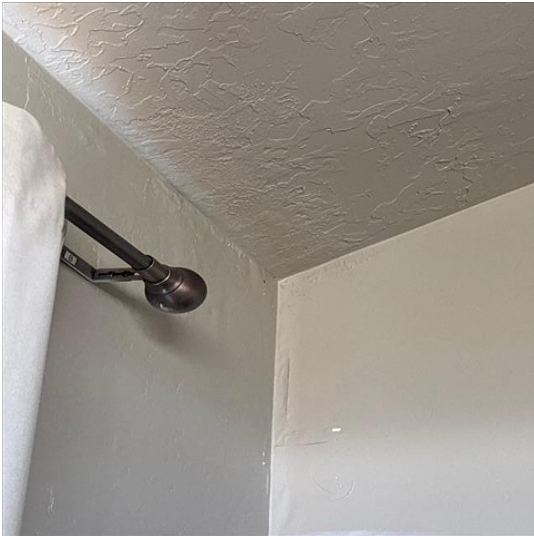
**Image Number:** 11  
**Observation:** Bubbling paint and moisture staining were observed, indicating active or prior moisture intrusion from above.

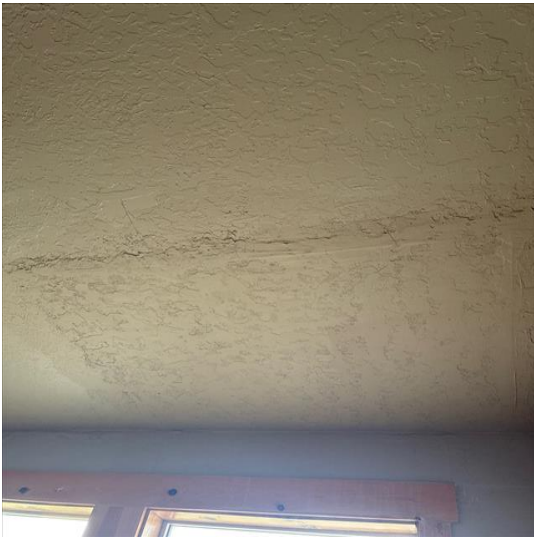
**Image Number:** 17  
**Observation:** This is a previous drywall repair due to an ice dam 2-3 years ago. A roof repair seems to have been done, alongside an installed heat cable.

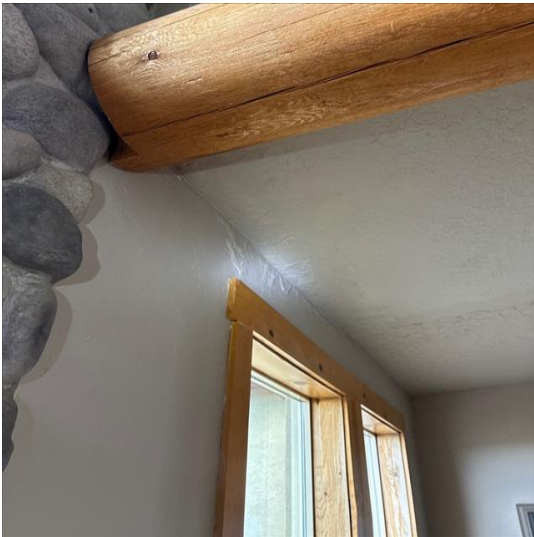
**Image Number:** 18  
**Observation:** The upper drywall was repaired from the ice dam, and the paint is showing signs of moisture intrusion.

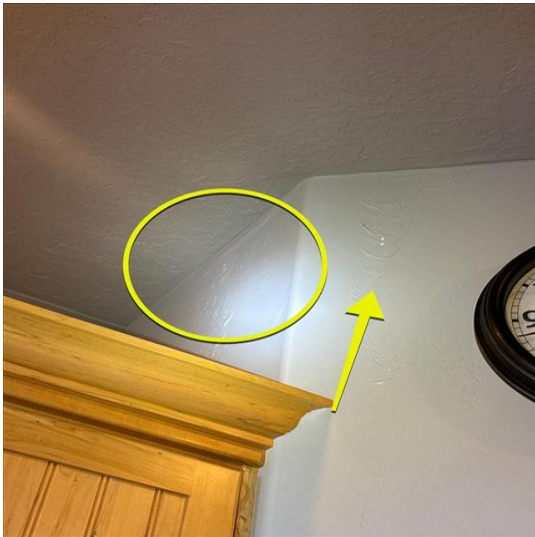
**Image Number:** 24  
**Observation:** **Observation:** Peeling tape and bubbled paint were observed in the kitchen indicating possible **moisture intrusion**.

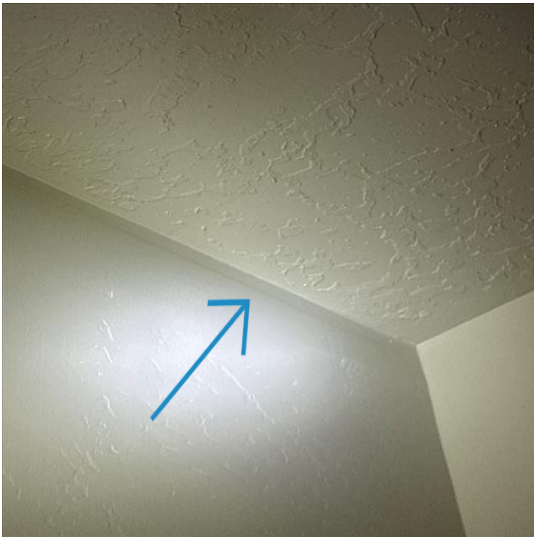
**Image Number:** 27  
**Observation:** Discoloration was observed at the drywall indicating possible moisture intrusion.

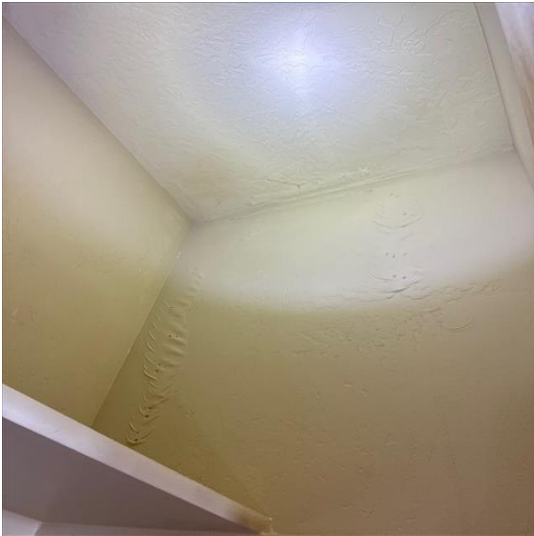
**Image Number:** 31  
**Observation:** Observation: Living room closet. There are some discoloration and bubbling of the paint indicating moisture intrusion.

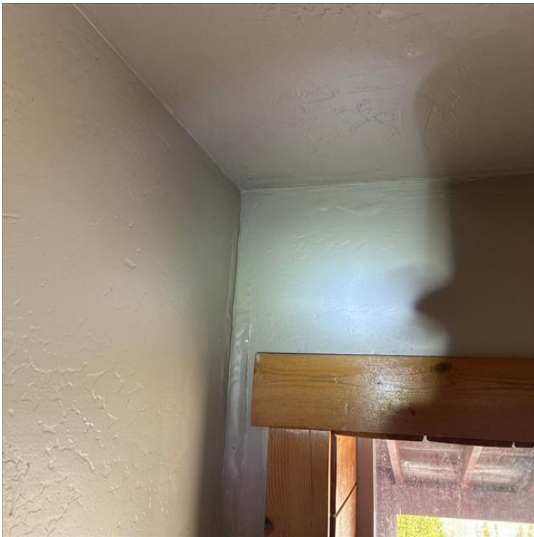
**Image Number:** 33  
**Observation:** Observation: Bubbling paint was observed at the ceiling near the roof pitch transition.

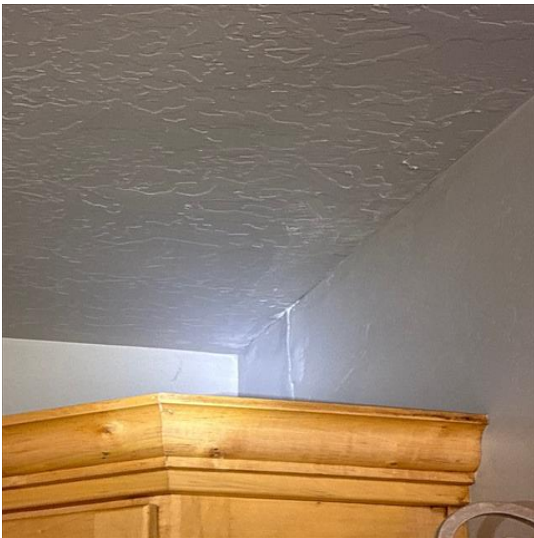
**Image Number:** 35  
**Observation:** Bubbling paint was observed at the ceiling near the roof pitch transition.

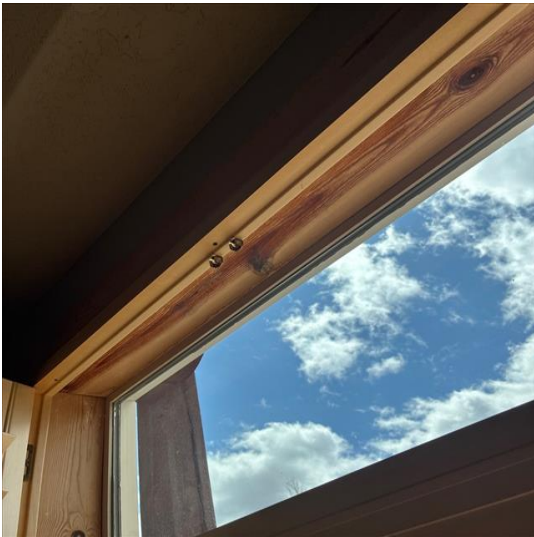
**Image Number:** 39  
**Observation:** Water staining was observed at the window jamb extensions in all the rooms. Possible sources include moisture intrusion from the roof system above, window flashing or sealant failure, or condensation. A definitive source could not be determined from visual inspection alone.

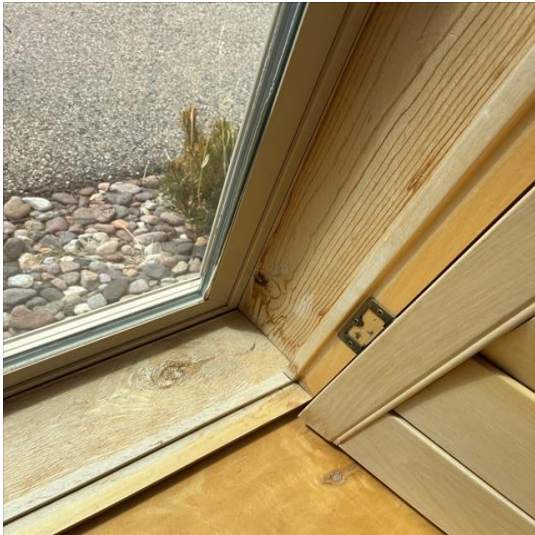
**Image Number: 40**  
**Observation: Observation:** Water staining was observed at the window jamb extensions in all the rooms. Possible sources include moisture intrusion from the roof system above, window flashing or sealant failure, or condensation. A definitive source could not be determined from visual inspection alone.

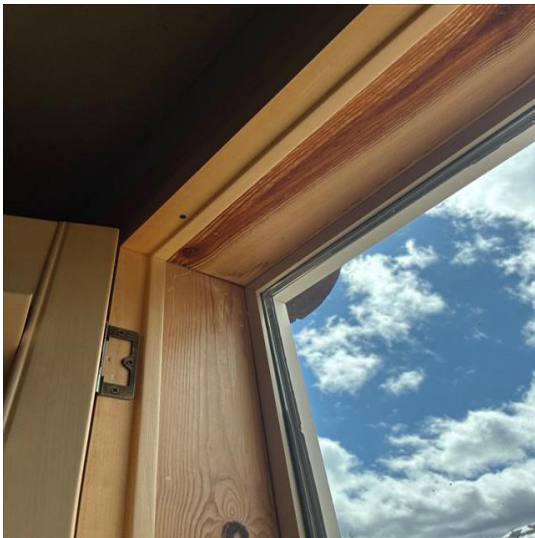
**Image Number: 41**  
**Observation: Observation:** Water staining was observed at the window jamb extensions in all the rooms. Possible sources include moisture intrusion from the roof system above, window flashing or sealant failure, or condensation. A definitive source could not be determined from visual inspection alone.

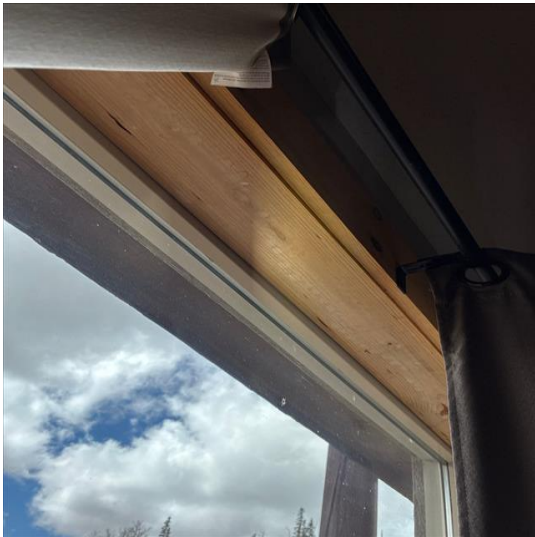
**Image Number: 42**  
**Observation: Observation:** Water staining was observed at the window jamb extensions in all the rooms. Possible sources include moisture intrusion from the roof system above, window flashing or sealant failure, or condensation. A definitive source could not be determined from visual inspection alone.

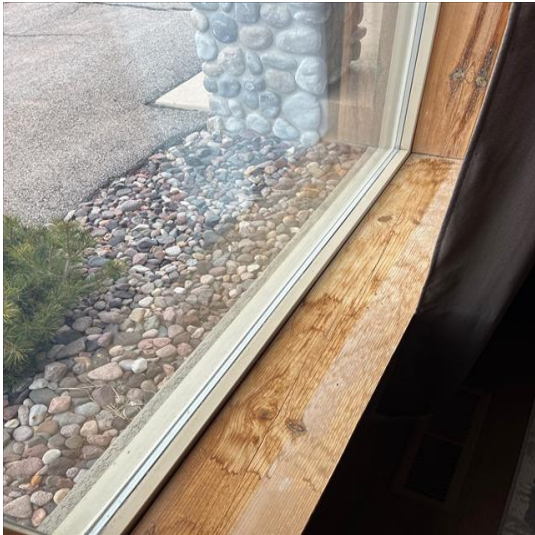
**Image Number: 43**  
**Observation: Observation:** Water staining was observed at the window jamb extensions in all the rooms. Possible sources include moisture intrusion from the roof system above, window flashing or sealant failure, or condensation. A definitive source could not be determined from visual inspection alone.

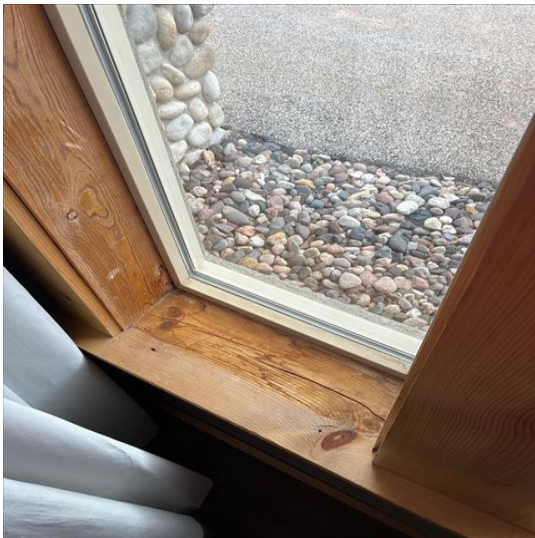
**Image Number: 44**  
**Observation: Observation:** Water staining was observed at the window jamb extensions in all the rooms. Possible sources include moisture intrusion from the roof system above, window flashing or sealant failure, or condensation. A definitive source could not be determined from visual inspection alone.

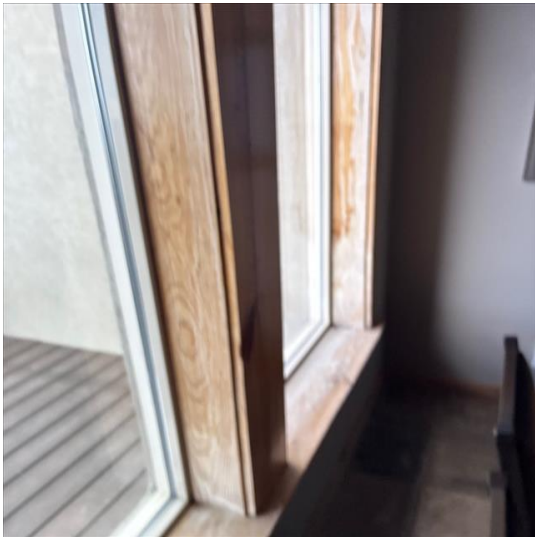
**Image Number: 45**  
**Observation: Observation:** Water staining was observed at the window jamb extensions in all the rooms. Possible sources include moisture intrusion from the roof system above, window flashing or sealant failure, or condensation. A definitive source could not be determined from visual inspection alone.

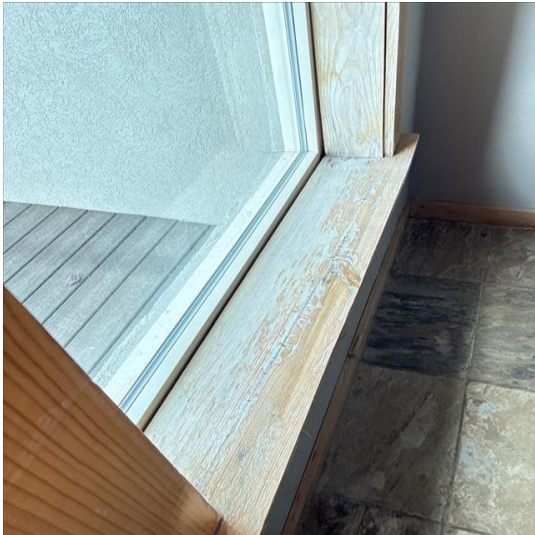
**Image Number: 46**  
**Observation: Observation:** Water staining was observed at the window jamb extensions in all the rooms. Possible sources include moisture intrusion from the roof system above, window flashing or sealant failure, or condensation. A definitive source could not be determined from visual inspection alone.

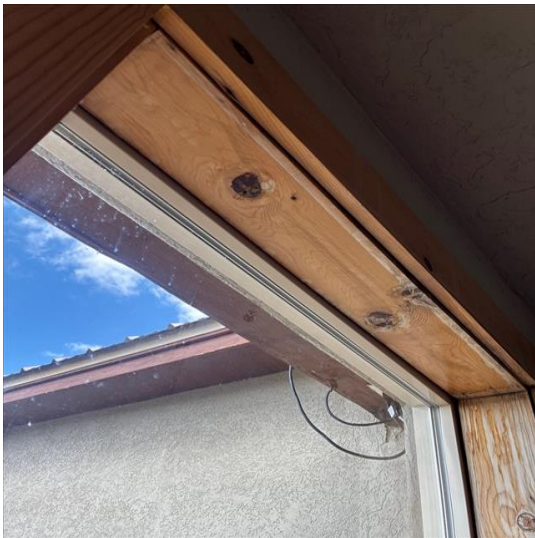
**Image Number: 47**  
**Observation: Observation:** Water staining was observed at the window jamb extensions in all the rooms. Possible sources include moisture intrusion from the roof system above, window flashing or sealant failure, or condensation. A definitive source could not be determined from visual inspection alone.

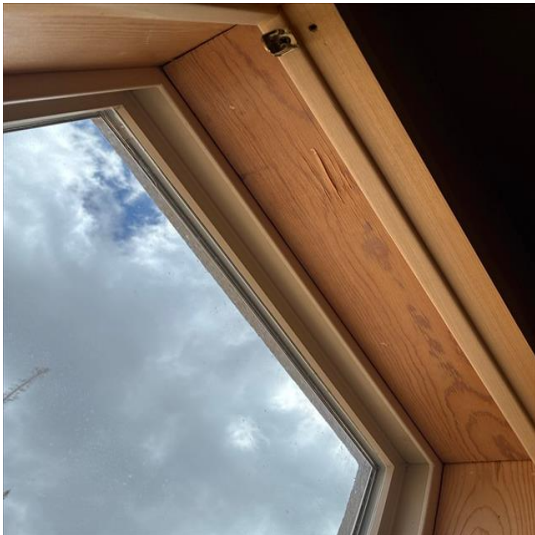
**Image Number: 48**  
**Observation: Observation:** Water staining was observed at the window jamb extensions in all the rooms. Possible sources include moisture intrusion from the roof system above, window flashing or sealant failure, or condensation. A definitive source could not be determined from visual inspection alone.

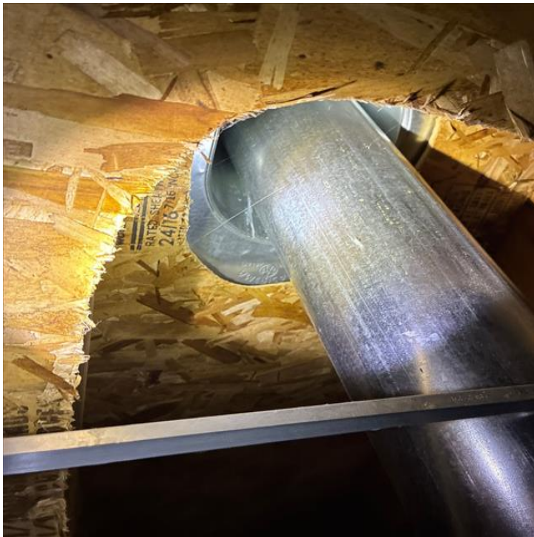
**Image Number:** 50

Observation: Moisture droplets were observed from internal equipment exhaust. This is a red flag because if it continues to happen it can cause damage.

The attic is not properly ventilated and is caused condensation to build as well as a most likely improperly sealed flashing on the roof.

**Remedy:** Seal the flashing and install proper ventilation.

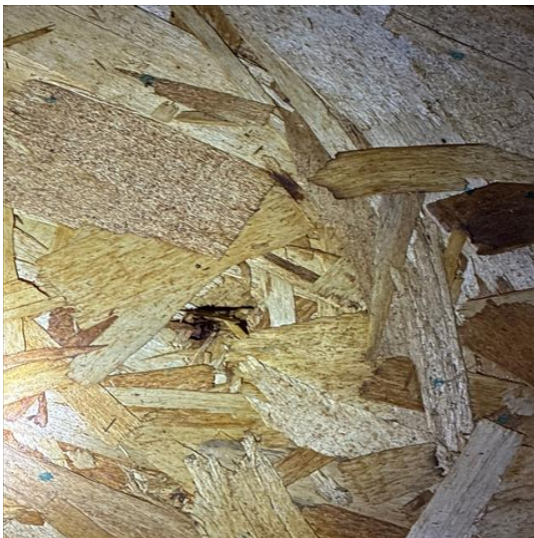
**Image Number: 59**

Observation: At the time of inspection, no actively wet surfaces were detected; however, multiple indicators of elevated attic humidity and prior or intermittent condensation were observed, including moisture staining on the underside of the roof sheathing, corrosion (rust) on roofing fasteners penetrating into the attic, and condensation droplets on the HVAC ductwork. Collectively, these conditions indicate that warm, humid air has been reaching the cold underside of the roof assembly and condensing on cooler surfaces, particularly during cold-weather conditions. Sustained attic condensation can deteriorate roof sheathing, accelerate fastener corrosion, reduce insulation performance, and contribute to ice dam formation.

Elevated attic humidity, likely resulting from a combination of moisture sources within the home (including the bathroom exhaust fan terminating in the attic &mdash; see prior observation) and inadequate ventilation to dissipate the moisture load.

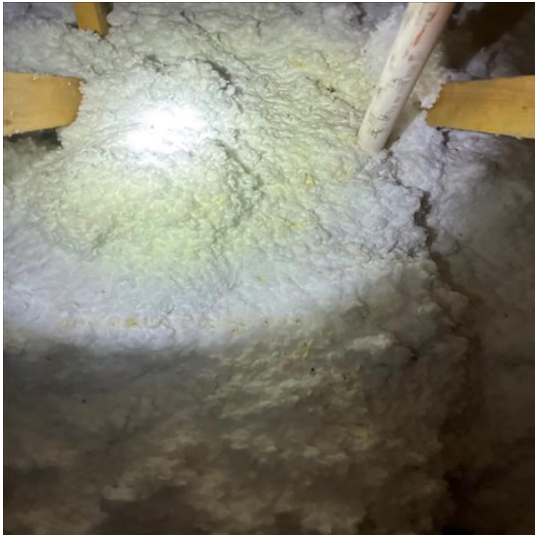
**Image Number:** 60

**Observation:** Rotting roof sheathing was observed along rafter lines in multiple locations, accompanied by moisture staining, dampened insulation with visible water droplets. At the time of inspection, no actively wet surfaces were detected. The localized pattern of sheathing rot along rafter lines is consistent with possible point-source moisture intrusion at **improperly installed roofing fasteners, in addition to attic condensation from elevated humidity**. Direct rooftop access was not available at the time of inspection to confirm fastener installation conditions from the exterior.

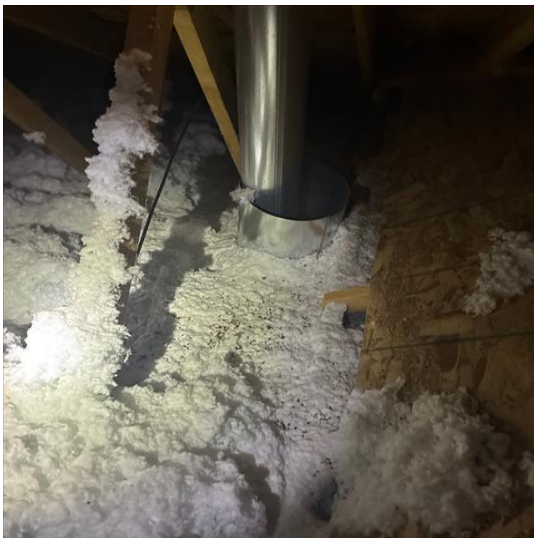
**Image Number: 71**

Evidence of Rodent Activity: Mouse droppings were observed in multiple locations throughout the attic. Rodent activity in the attic indicates a point of entry into the building envelope, which is often associated with gaps at roof penetrations, eaves, soffit-to-wall transitions, or damaged screening at vents. Rodent activity can also damage insulation, wiring, and ventilation components over time. A pest control professional should be engaged to assess the extent of activity and identify entry points; any identified entry points at the roof system or roof-to-wall transitions can then be addressed as part of corrective roof work.

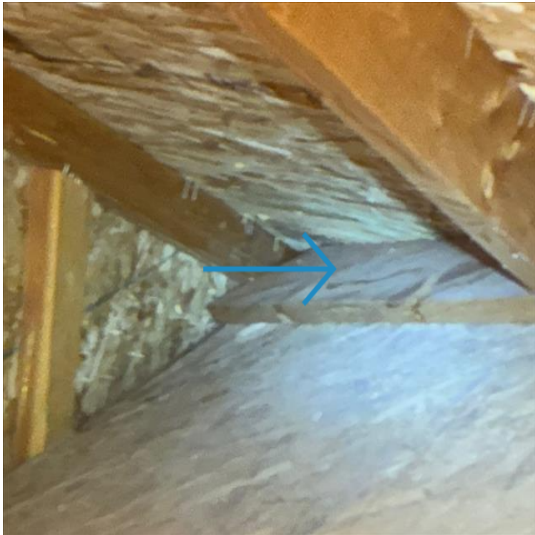
**Image Number: 79**  
**Observation: Observation:** Garage: Moisture stains were noticed along the eaves and valley rafters. Moisture stains were noticed on the garage drywall as well indicating roof leak. Roof access was limited and was unable to pinpoint where all the locations are.

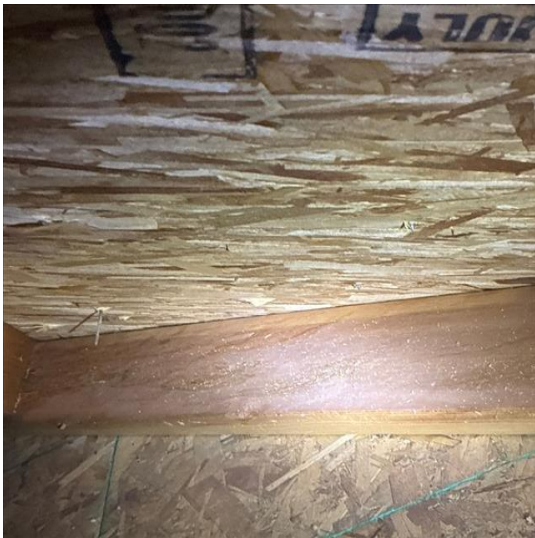
**Image Number: 80**  
**Observation: Observation:** Garage: Moisture stains were noticed along the eaves and valley rafters. Moisture stains were noticed on the garage drywall as well indicating roof leak. Roof access was limited and was unable to pinpoint where all the locations are.

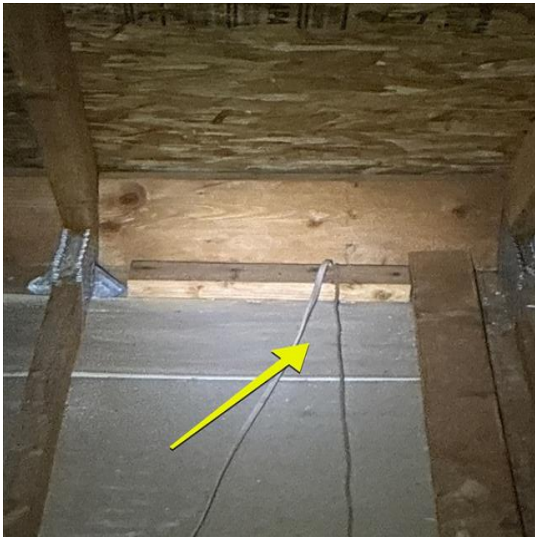
**Image Number: 81**  
**Observation: Observation:** Garage: Moisture stains were noticed along the eaves and valley rafters. Moisture stains were noticed on the garage drywall as well indicating roof leak. Roof access was limited and was unable to pinpoint where all the locations are.

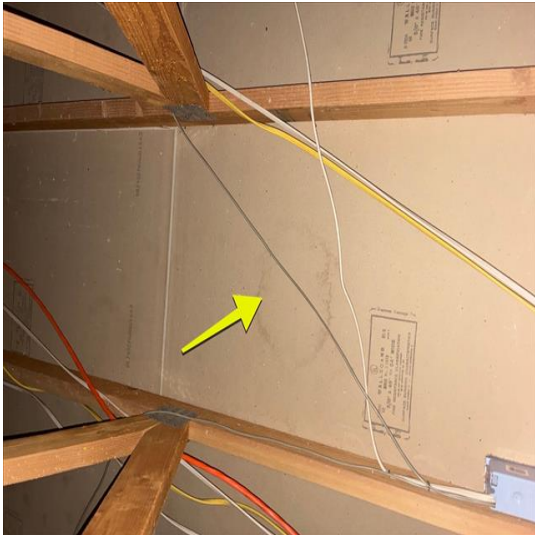
**Image Number:** 85  
**Observation:** **Observation:** Garage: Moisture stains were noticed along the eaves and valley rafters. Moisture stains were noticed on the garage drywall as well indicating roof leak. Roof access was limited and was unable to pinpoint where all the locations are.

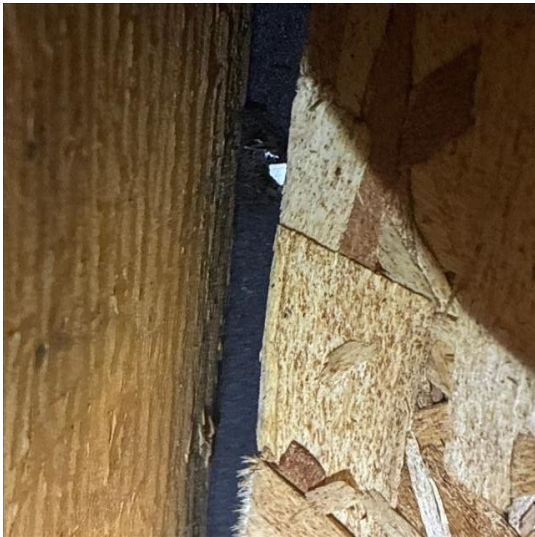
**Image Number:** 87  
**Observation:** **Observation:** Lack of ventilation was observed. This is a red flag because it can cause premature failure of a roofing system.  
**Cause:** It looks like at the time of installation the roofers forgot to cut the tar paper.

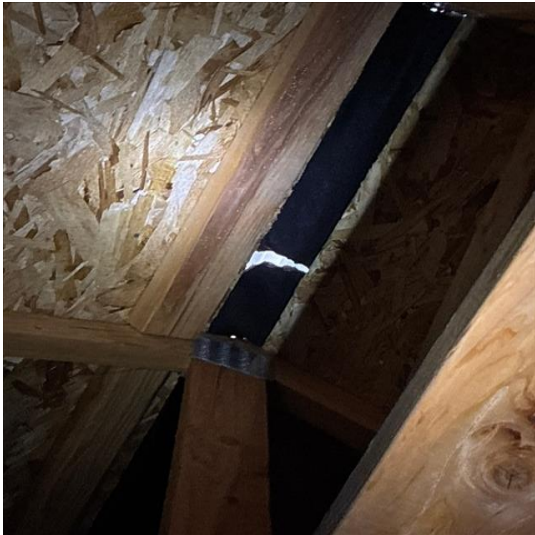
**Image Number:** 88  
**Observation:** **Observation:** Lack of ventilation was observed.  
This is a red flag because it can cause premature failure of a roofing system.  
**Cause:** It looks like at the time of installation the roofers forgot to cut the tar paper.

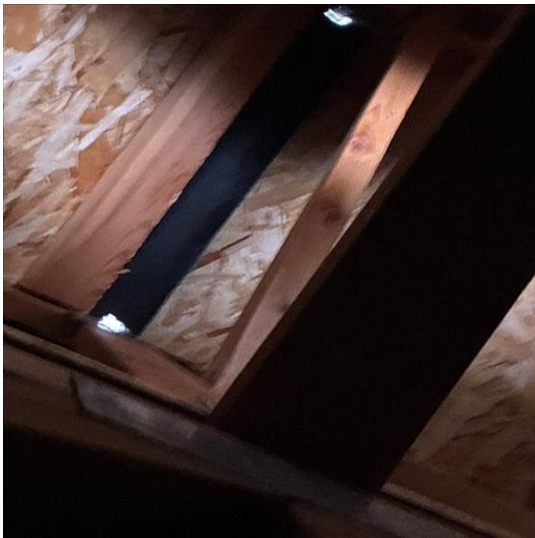
**Image Number:** 89  
**Observation:** **Observation:** Lack of ventilation was observed.  
This is a red flag because it can cause premature failure of a roofing system.  
**Cause:** It looks like at the time of installation the roofers forgot to cut the tar paper.

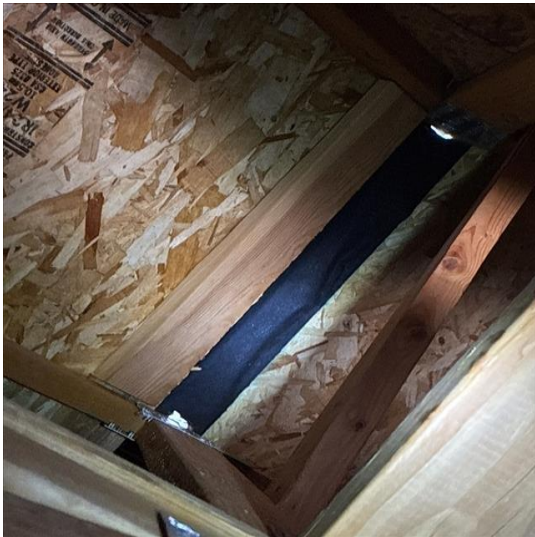
**Image Number:** 90  
**Observation:** **Observation:** Lack of ventilation was observed.  
This is a red flag because it can cause premature failure of a roofing system.  
**Cause:** It looks like at the time of installation the roofers forgot to cut the tar paper.

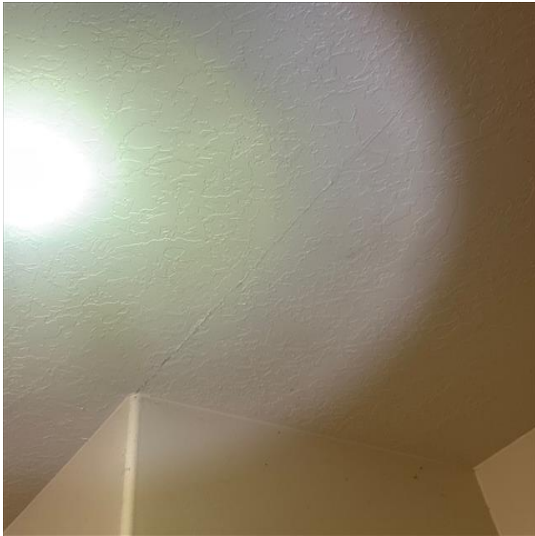
**Image Number:** 91  
**Observation:** Cracking was observed at the ceiling drywall seams in multiple locations. This condition is a **red flag**, indicating the potential for active or past moisture intrusion as a likelihood. The attic system directly above this area was inspected to identify the source and extent of the issue. Refer to attic photos.

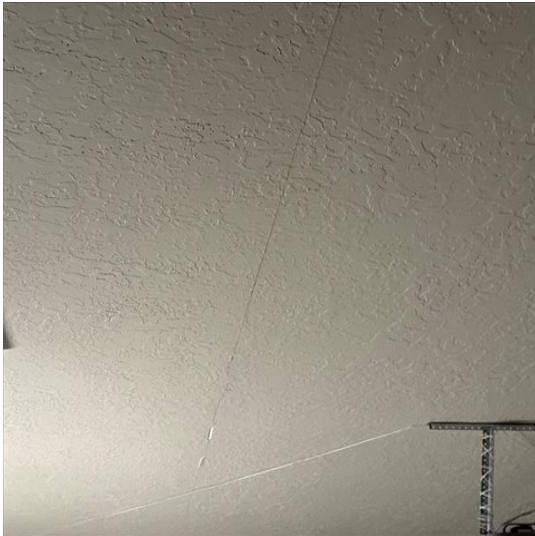
**Image Number:** 92  
**Observation:** Cracking was observed at the ceiling drywall seams in multiple locations. This condition is a **red flag**, indicating the potential for active or past moisture intrusion as a likelihood. The attic system directly above this area was inspected to identify the source and extent of the issue. Refer to attic photos.

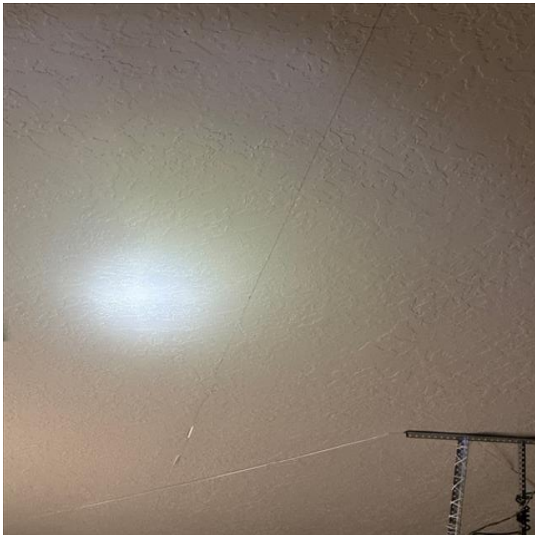
**Image Number:** 93  
**Observation:** Cracking was observed at the ceiling drywall seams in multiple locations. This condition is a **red flag**, indicating the potential for active or past moisture intrusion as a likelihood. The attic system directly above this area was inspected to identify the source and extent of the issue. Refer to attic photos.

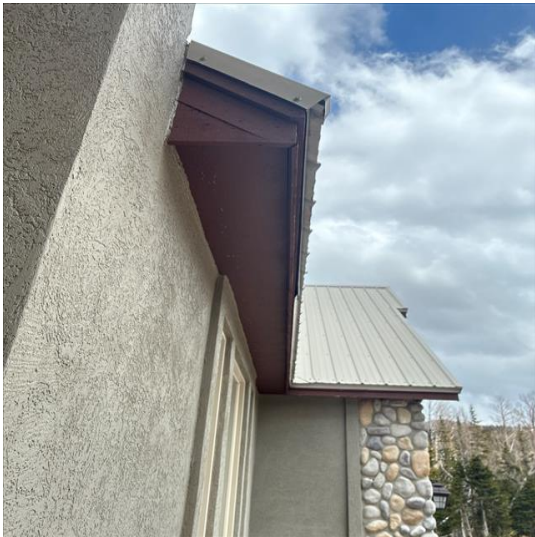
Image Number: 99  
Observation: Soffit overview.  
**\*\* No intake ventilation was observed during this inspection. This is important to have a proper ventilated home.**  
Remedy: Install soffit ventilation according to proper NFA guidelines.

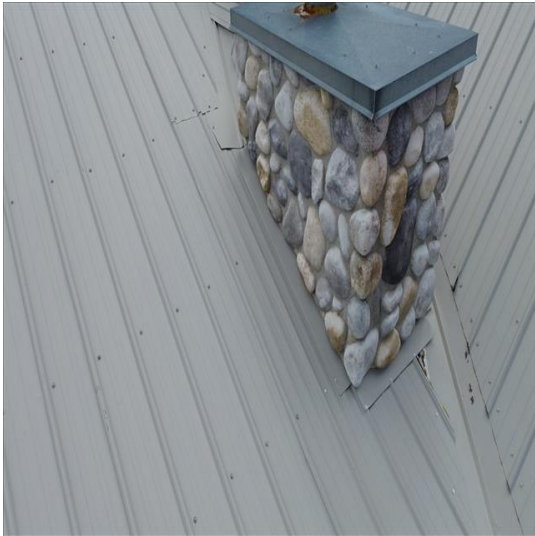
**Image Number:** 100  
**Observation:** **Observation:** Chimney flashing is installed correctly.  
**The chimney cap is starting to rust.**

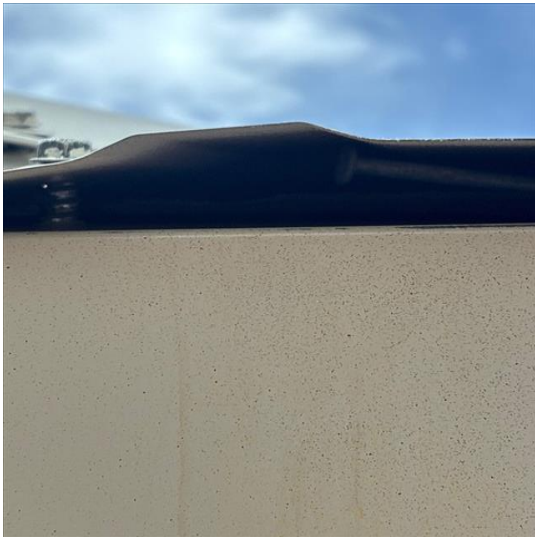
**Image Number:** 101  
**Observation:** Due to visual inspection, proper installation of ice and water shield could not be confirmed.  
**Determination:** Replacement required

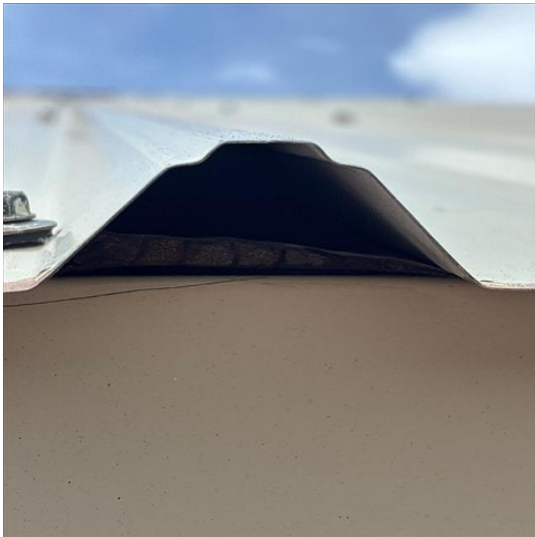
**Image Number:** 102  
**Observation:** Due to visual inspection, proper installation of ice and water shield could not be confirmed.  
**Determination:** Replacement required

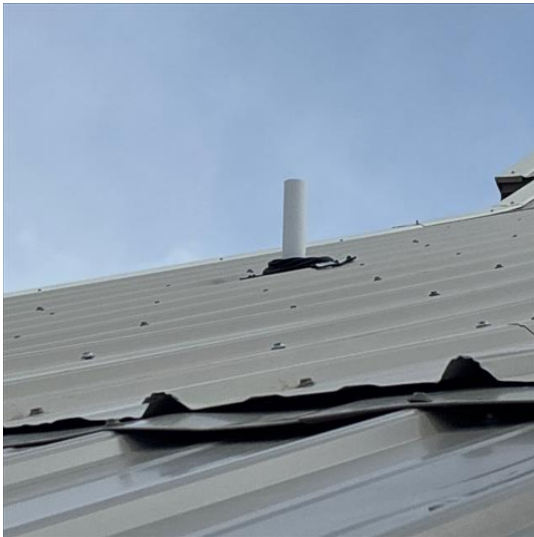
**Image Number:** 107

Observation: Roof pipe flashings are incorrectly installed and also need maintenance. They are relying on sealant which has a low life expectancy. One flashing was observed to be sunken which will allow moisture to pool and enter the home. Due to the wind for the drone and lack of access to the roof, not all penetrations were able to get thoroughly inspected.

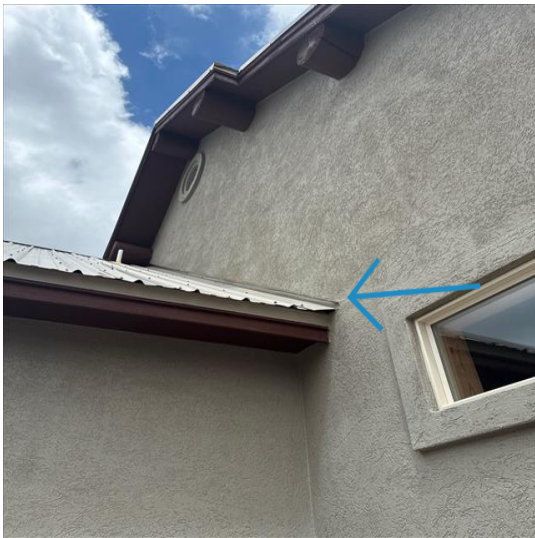
**Image Number:** 109  
**Observation:** **Observation:** No kickout/diverter flashing was installed as part of the roof system. This is a necessary component to prevent water from traveling behind walls and siding.  
**Cause:** Improper workmanship.  
**Remedy:** Have a qualified roofing professional integrate a kickout flashing as part of the roofing system. A siding contractor may be required as well.  
**Determination:** Replacement required

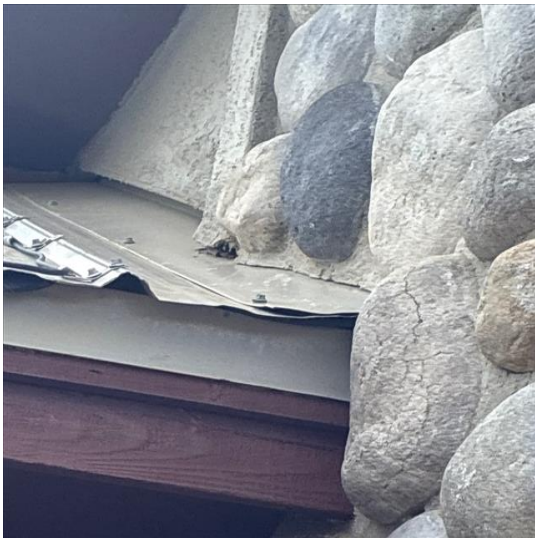
**Image Number:** 110  
**Observation:** **Observation:** No kickout/diverter flashing was installed as part of the roof system. This is a necessary component to prevent water from traveling behind walls and siding.  
**Cause:** Improper workmanship.  
**Remedy:** Have a qualified roofing professional integrate a kickout flashing as part of the roofing system. A siding contractor may be required as well.  
**Determination:** Replacement required

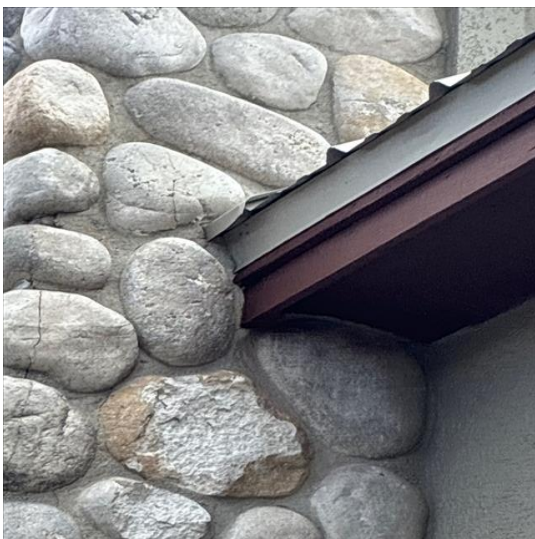
**Image Number:** 111  
**Observation:** **Observation:** No kickout/diverter flashing was installed as part of the roof system. This is a necessary component to prevent water from traveling behind walls and siding.  
**Cause:** Improper workmanship.  
**Remedy:** Have a qualified roofing professional integrate a kickout flashing as part of the roofing system. A siding contractor may be required as well.  
**Determination:** Replacement required

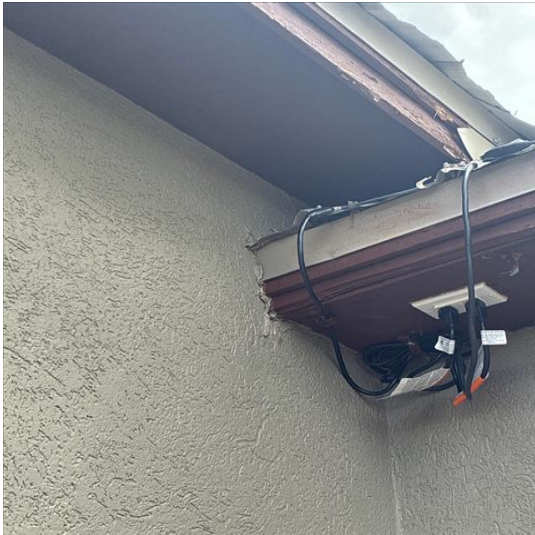
**Image Number:** 112  
**Observation:** **Observation:** No kickout/diverter flashing was installed as part of the roof system. This is a necessary component to prevent water from traveling behind walls and siding.  
**Cause:** Improper workmanship.  
**Remedy:** Have a qualified roofing professional integrate a kickout flashing as part of the roofing system. A siding contractor may be required as well.  
**Determination:** Replacement required

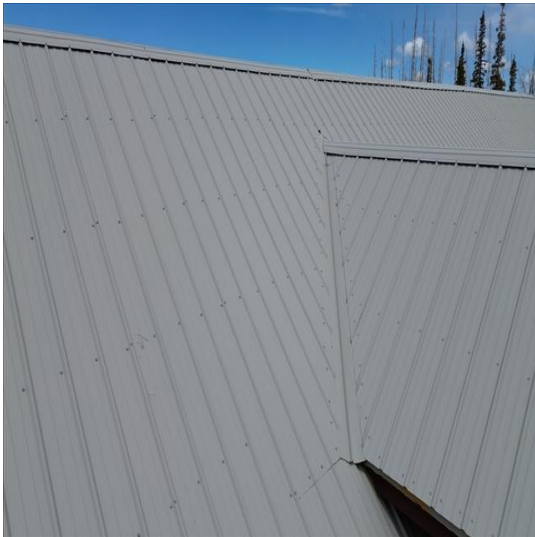
**Image Number:** 116  
**Observation:** Valley overview:  
Due to it being a visual inspection, I was unable to determine the proper installation of ice and water shield.  
**Determination:** Replacement required

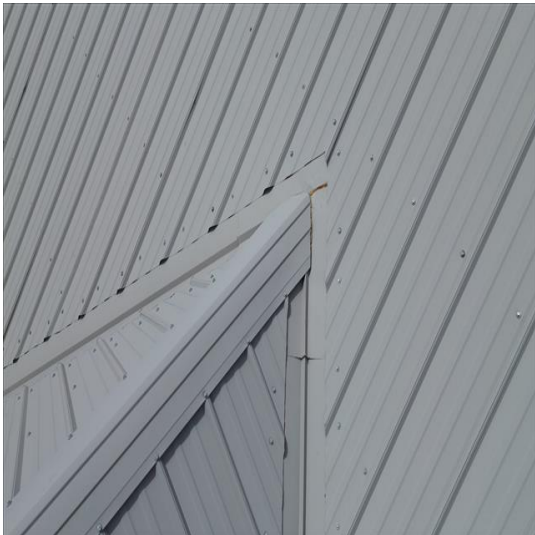
**Image Number:** 117  
**Observation:** Valley overview:  
Due to it being a visual inspection, I was unable to determine the proper installation of ice and water shield.  
**Determination:** Replacement required

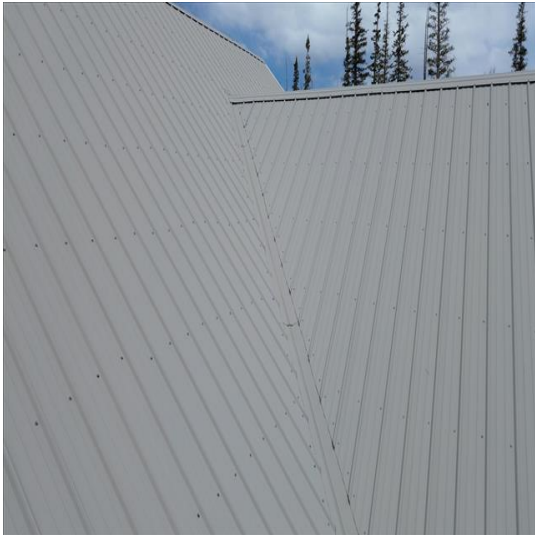
**Image Number:** 118  
**Observation:** Valley overview:  
Due to it being a visual inspection, I was unable to determine the proper installation of ice and water shield.  
**Determination:** Replacement required

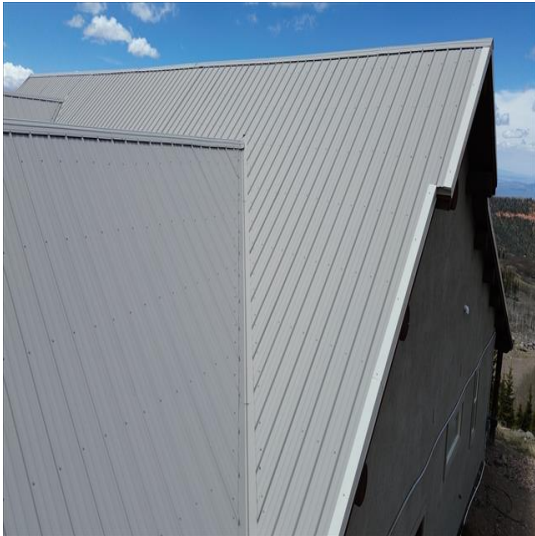
**Image Number:** 119  
**Observation:** Valley overview:  
Due to it being a visual inspection, I was unable to determine the proper installation of ice and water shield.  
**Determination:** Replacement required
