LeakFREE® Roof Inspection

Report No :
43287

Property Inspected :
10 Summer Street
Los Angeles, CA 90001

Inspected By :
John Smith
NRCIA Certified
Roof Inspector

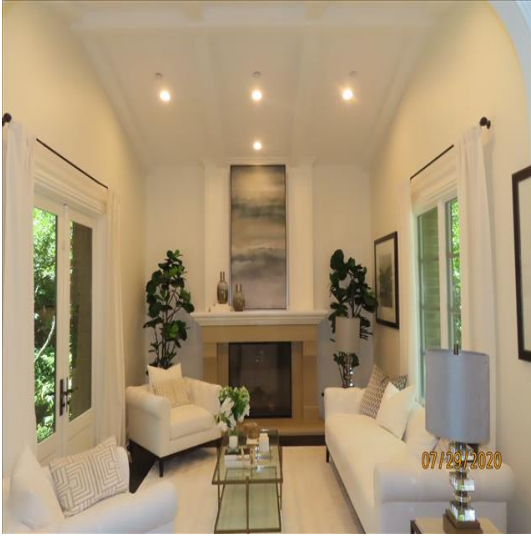
Image Number: 1

Observation: Interior Overview: Moisture stains/damage was not visually observed at the time of the inspection.

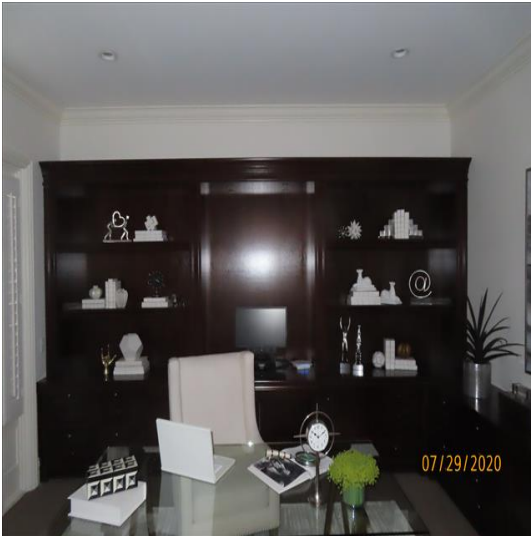
Image Number: 2

Observation: Interior Overview: Moisture stains/damage was not visually observed at the time of the inspection.

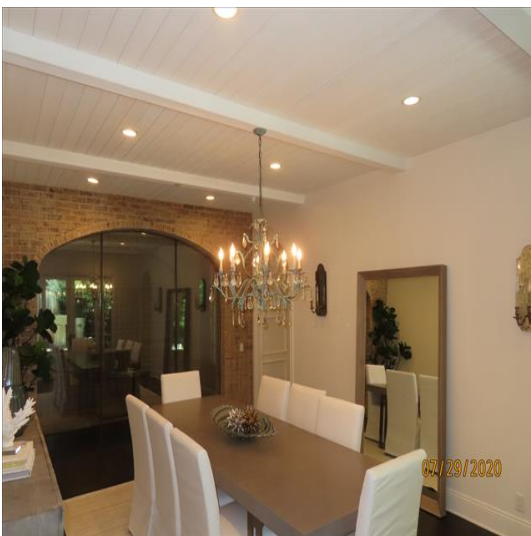
Image Number: 3

Observation: Interior Overview: Moisture stains/damage was not visually observed at the time of the inspection.

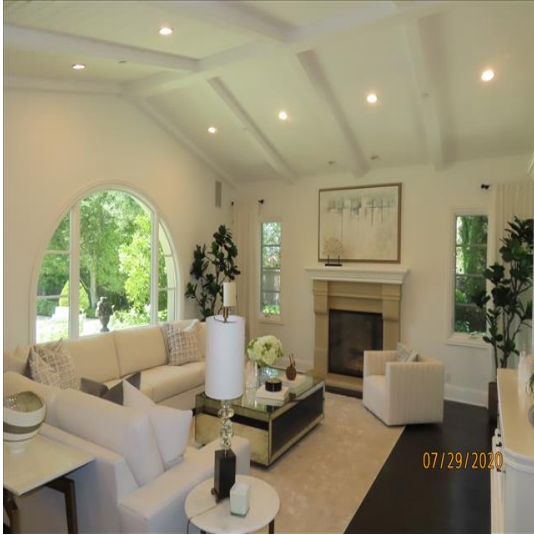
Image Number: 4

Observation: Interior Overview: Moisture stains/damage was not visually observed at the time of the inspection.

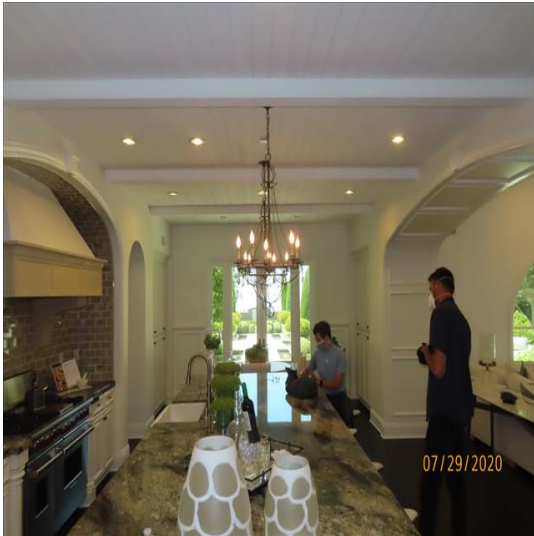
Image Number: 5

Observation: Interior Overview: Moisture stains/damage was not visually observed at the time of the inspection.

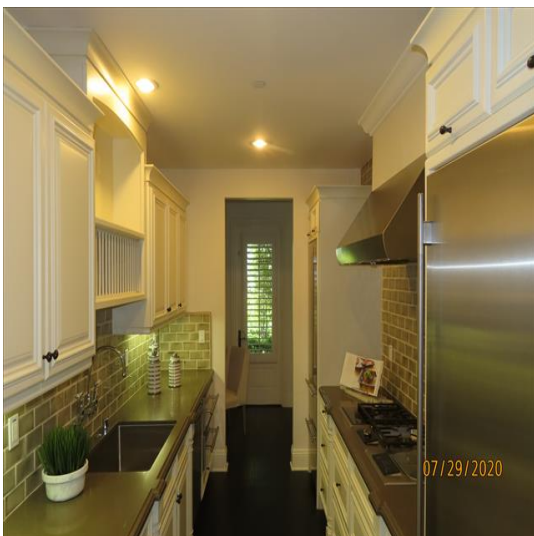
Image Number: 6

Observation: Interior Overview: Moisture stains/damage was not visually observed at the time of the inspection.

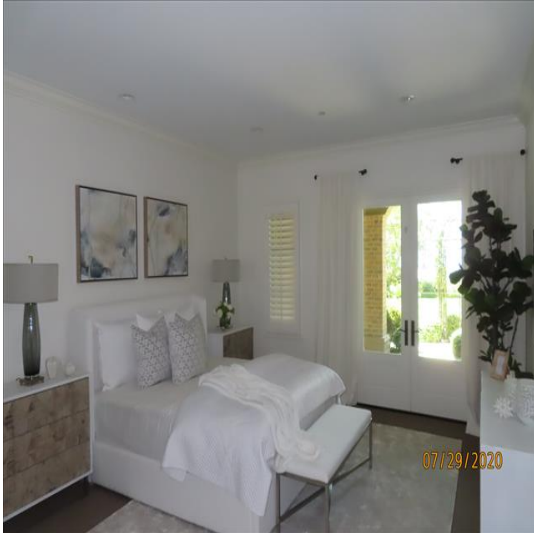
Image Number: 7

Observation: Interior Overview: Moisture stains/damage was not visually observed at the time of the inspection.

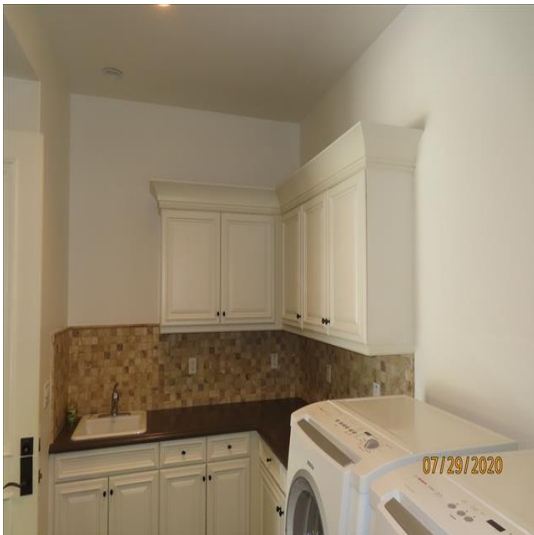
Image Number: 8

Observation: Interior Overview: Moisture stains/damage was not visually observed at the time of the inspection.

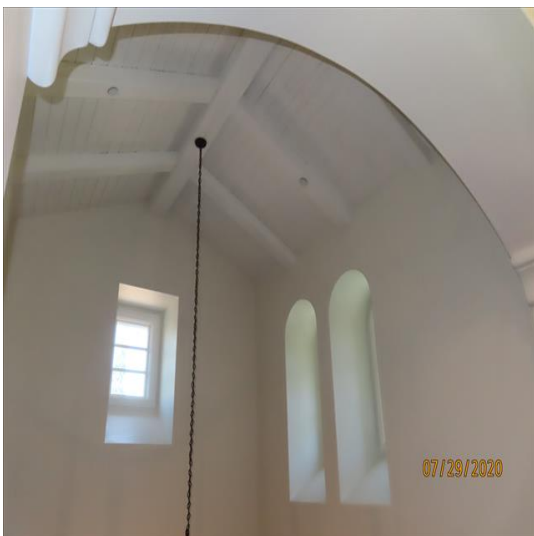
Image Number: 9

Observation: Interior Overview: Moisture stains/damage was not visually observed at the time of the inspection.

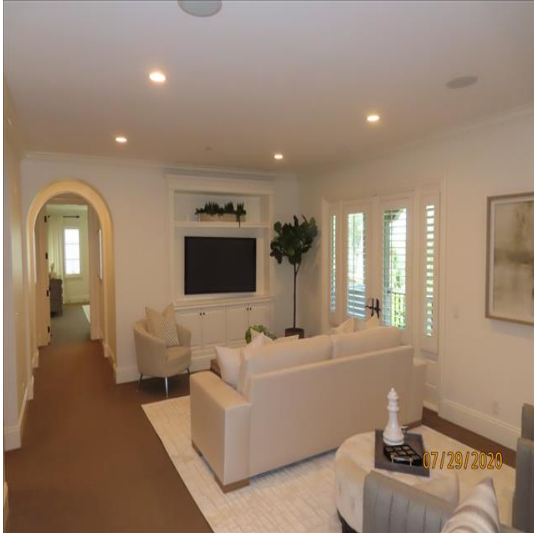
Image Number: 10

Observation: Interior Overview: Moisture stains/damage was not visually observed at the time of the inspection.

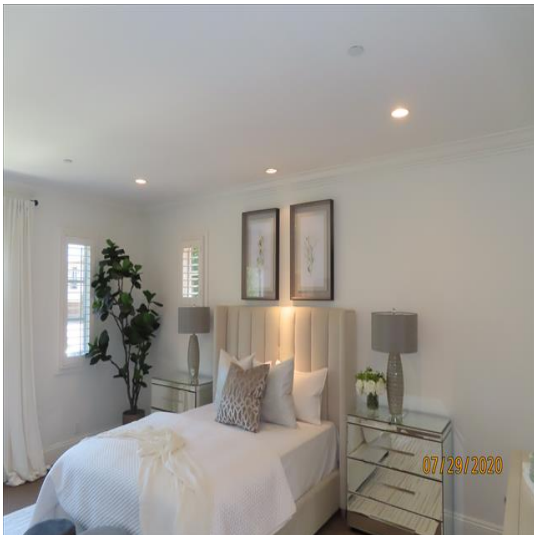
Image Number: 11

Observation: Interior Overview: Moisture stains/damage was not visually observed at the time of the inspection.

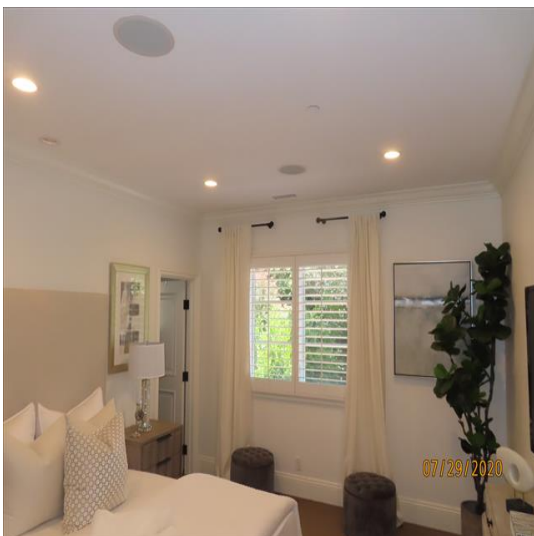
Image Number: 12

Observation: Interior Overview: Moisture stains/damage was not visually observed at the time of the inspection.

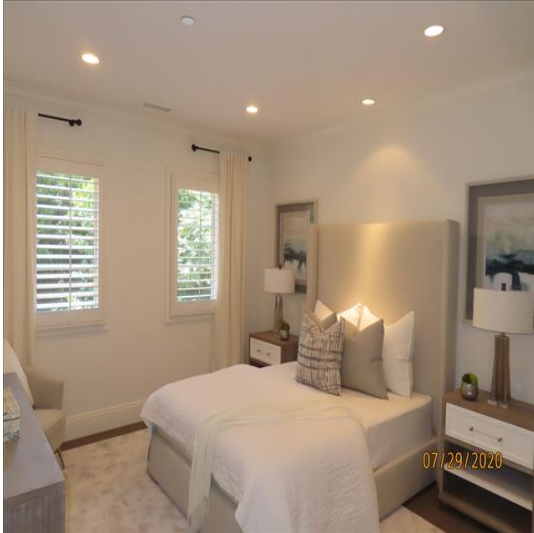
Image Number: 13

Observation: Interior Overview: Moisture stains/damage was not visually observed at the time of the inspection.

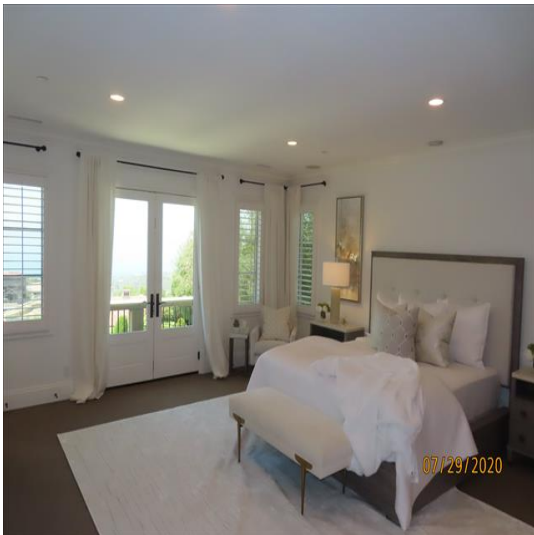
Image Number: 14

Observation: Interior Overview: Moisture stains/damage was not visually observed at the time of the inspection.

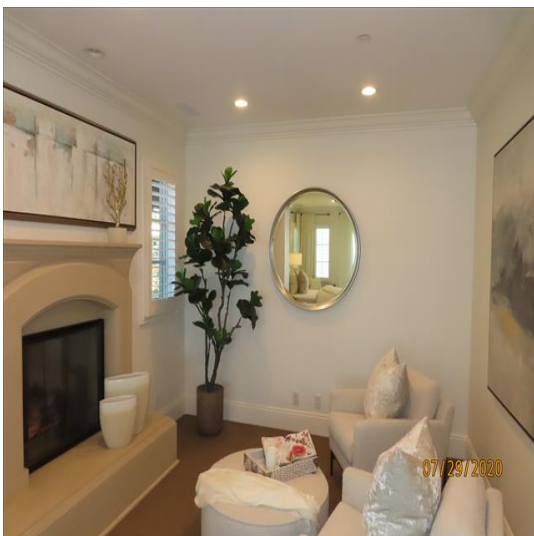
Image Number: 15

Observation: Interior Overview: Moisture stains/damage was not visually observed at the time of the inspection.

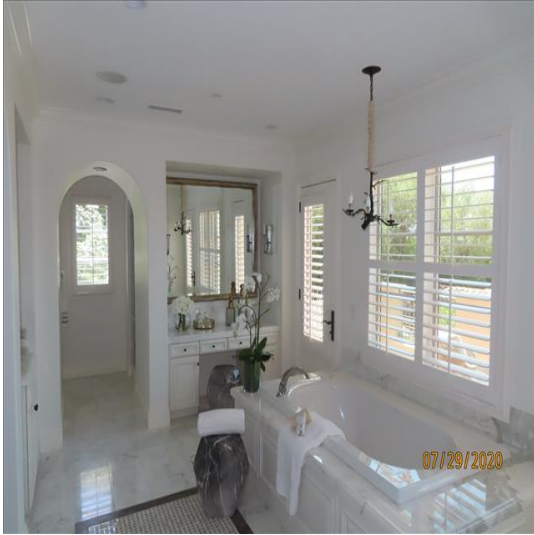
Image Number: 16

Observation: Interior Overview: Moisture stains/damage was not visually observed at the time of the inspection.

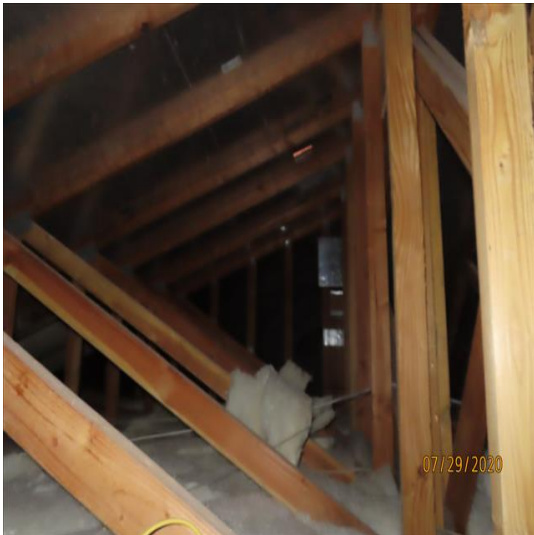
Image Number: 17

Observation: Overview of the attic: Access was limited in certain locations due to framing and HVAC equipment.

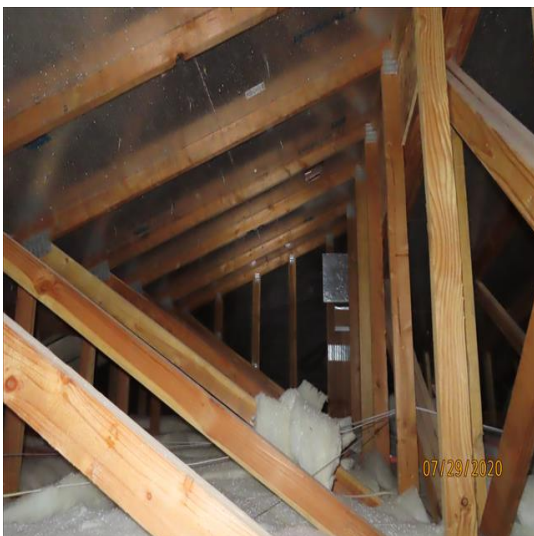
Image Number: 18

Observation: Overview of the attic: Access was limited in certain locations due to framing and HVAC equipment.

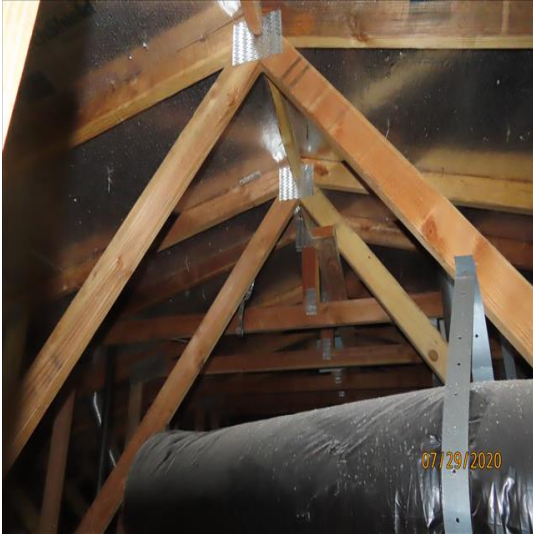
Image Number: 19

Observation: Overview of the attic: Access was limited in certain locations due to framing and HVAC equipment.

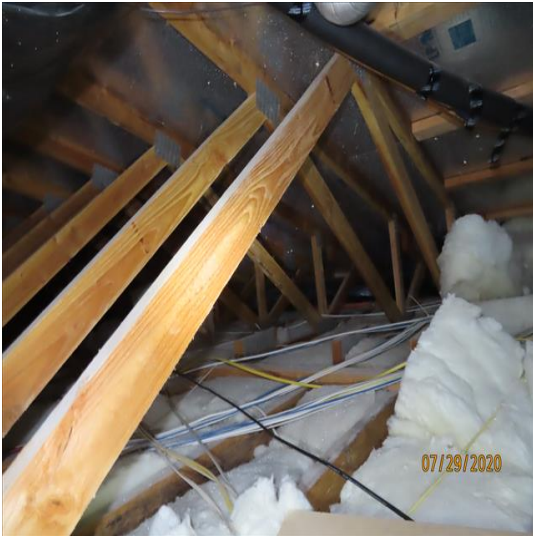
Image Number: 20

Observation: Overview of the attic: Access was limited in certain locations due to framing and HVAC equipment.

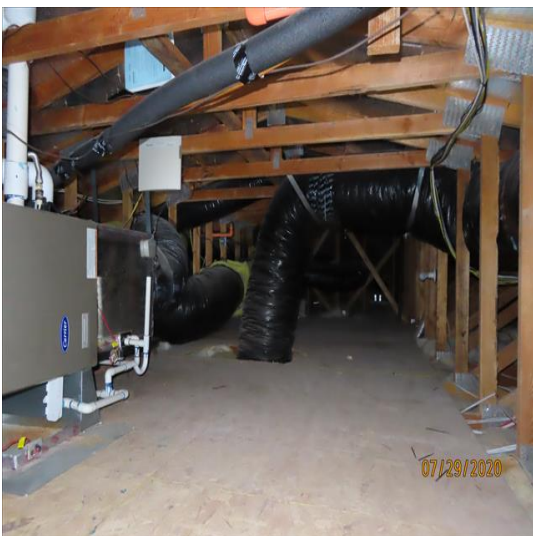
Image Number: 21

Observation: Overview of the attic: Access was limited in certain locations due to framing and HVAC equipment.

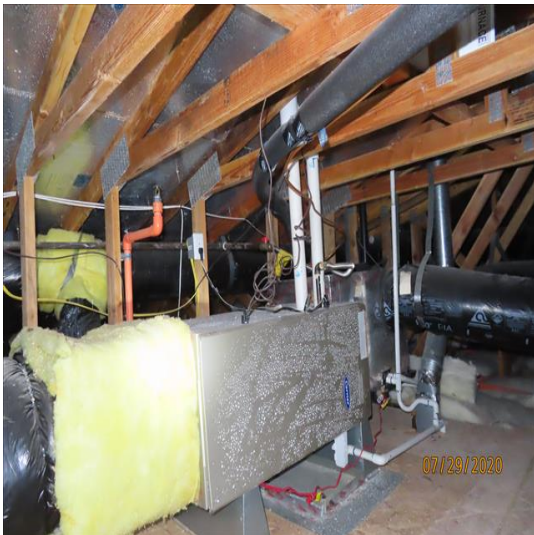
Image Number: 23

Observation: Overview of the attic: Access was limited in certain locations due to framing and HVAC equipment.

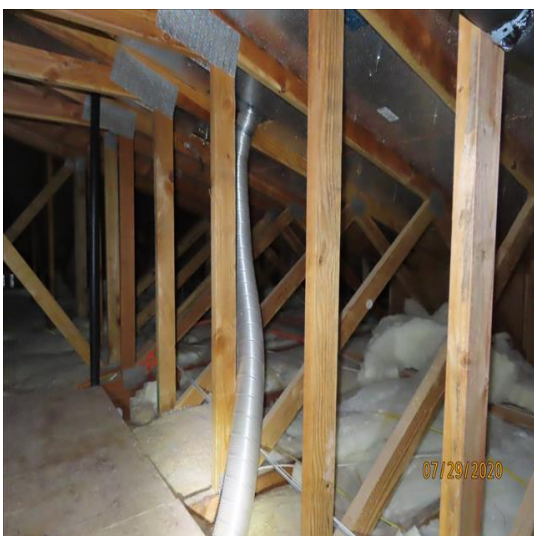
Image Number: 24

Observation: Overview of the attic: Access was limited in certain locations due to framing and HVAC equipment.

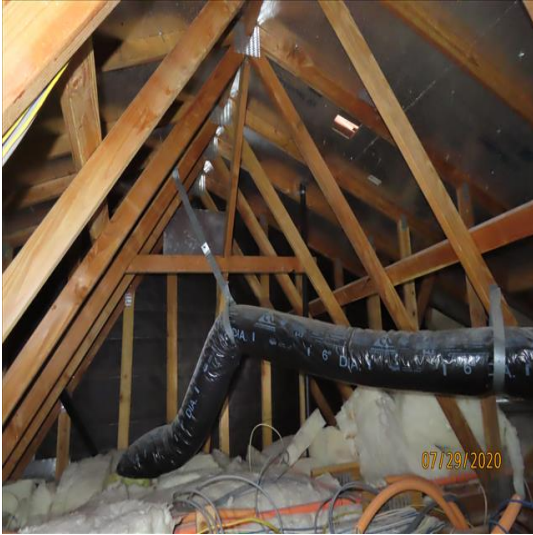
Image Number: 25

Observation: Overview of the attic: Access was limited in certain locations due to framing and HVAC equipment.

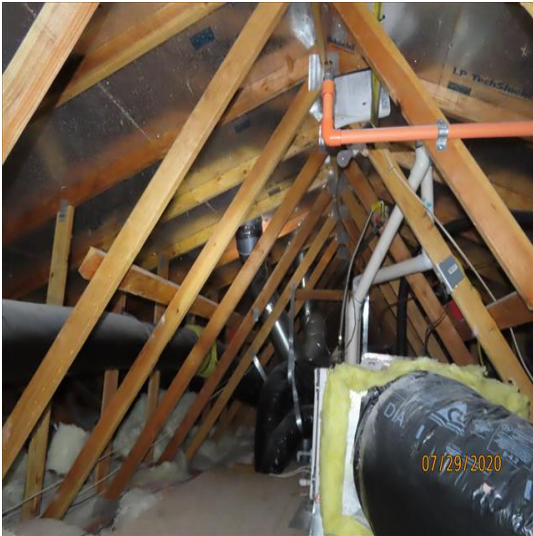
Image Number: 26

Observation: Overview of the attic: Access was limited in certain locations due to framing and HVAC equipment.

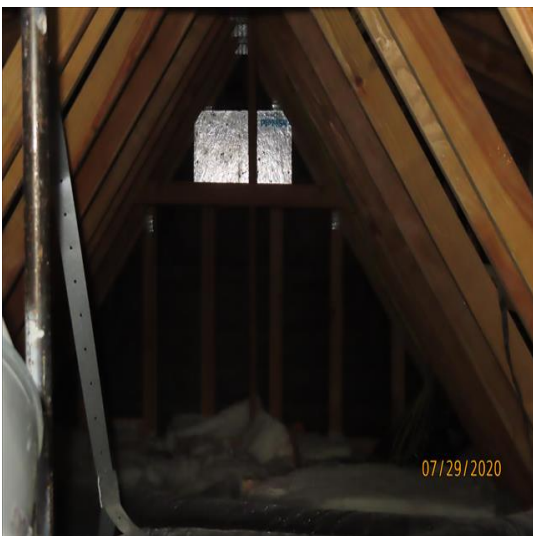
Image Number: 27

Observation: Overview of the attic: Access was limited in certain locations due to framing and HVAC equipment.

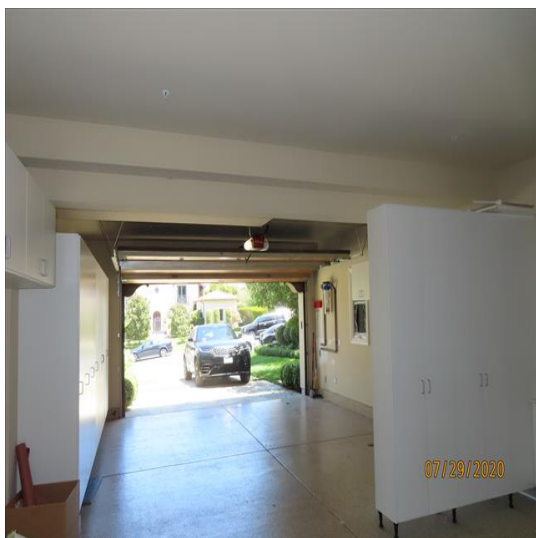
Image Number: 29

Observation: Overview of the garage:

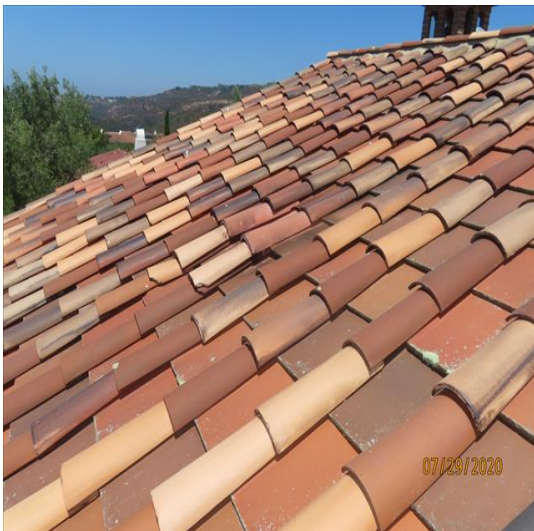
Image Number: 33

Observation: Overview of the clay tile roof system: The typical life expectancy of the waterproof felt underlayment is 25-30 years from date of installation.

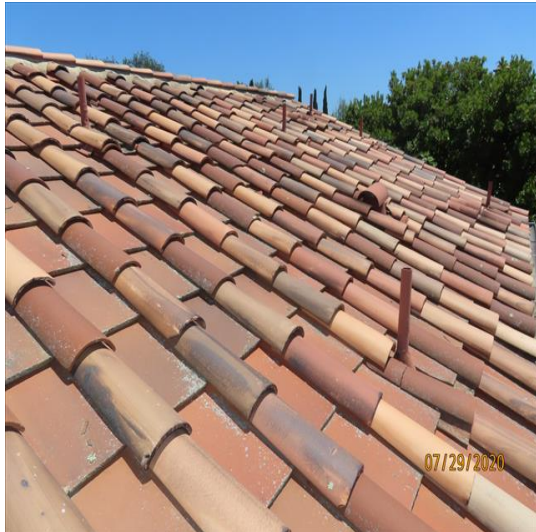
Image Number: 34

Observation: Overview of the clay tile roof system: The typical life expectancy of the waterproof felt underlayment is 25-30 years from date of installation.

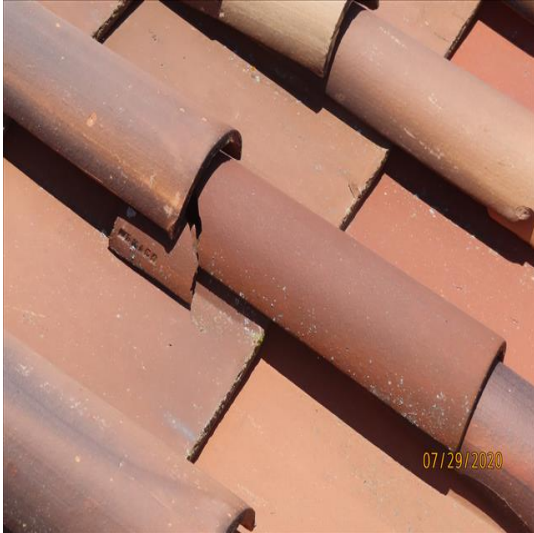
Image Number: 43

Observation: Broken/damaged tiles were observed in various locations throughout the roof system.

Determination: Roof Repair required for LeakFREE Roof Certification

Remedy: Remove and replace all necessary damaged tiles.

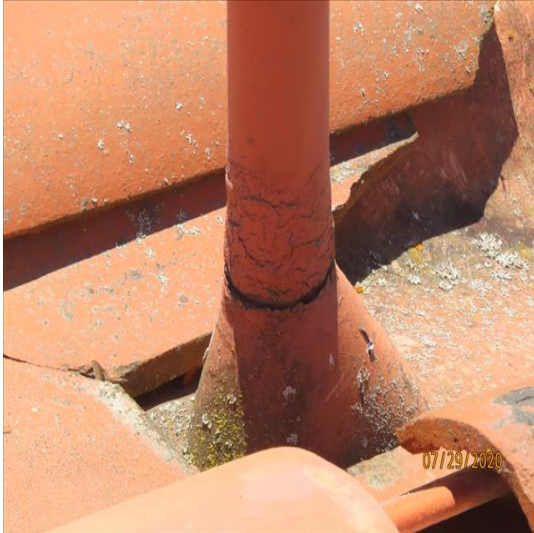
Image Number: 46

Observation: The sealant is cracked and deteriorated at various penetrations throughout the roof system. The roof penetrations need to be cleaned and re-sealed approximately every 5 years.

Determination: Roof Repair required for LeakFREE Roof Certification

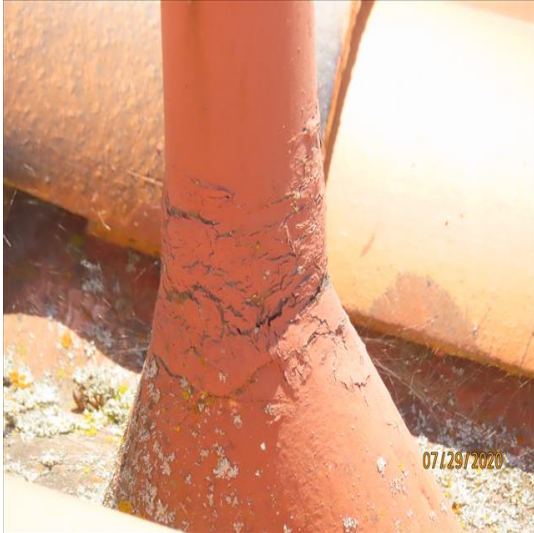
Image Number: 49

Observation: The sealant is cracked and deteriorated at various penetrations throughout the roof system. The roof penetrations need to be cleaned and re-sealed approximately every 5 years.

Determination: Roof Repair required for LeakFREE Roof Certification

Remedy: Clean, re-seal and paint all roof penetrations.

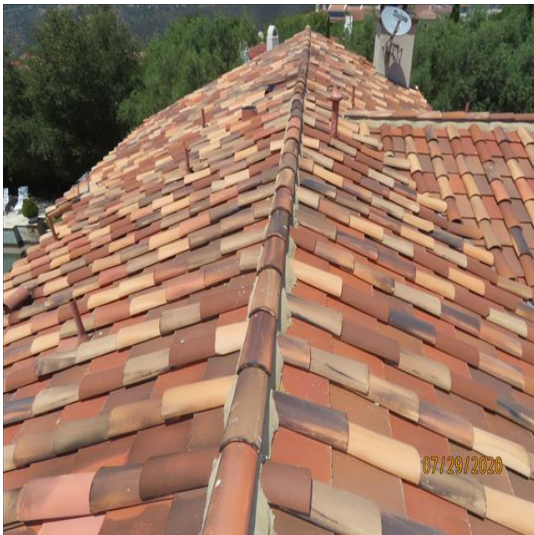
Image Number: 50

Observation: Overview of the clay tile roof system: The typical life expectancy of the waterproof felt underlayment is 25-30 years from date of installation.

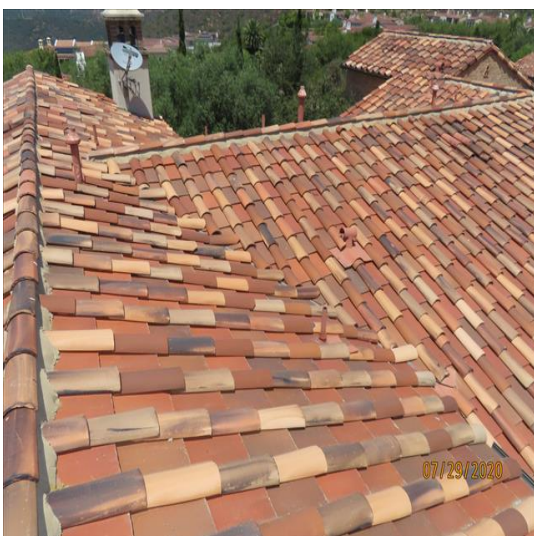
Image Number: 51

Observation: Overview of the clay tile roof system: The typical life expectancy of the waterproof felt underlayment is 25-30 years from date of installation.

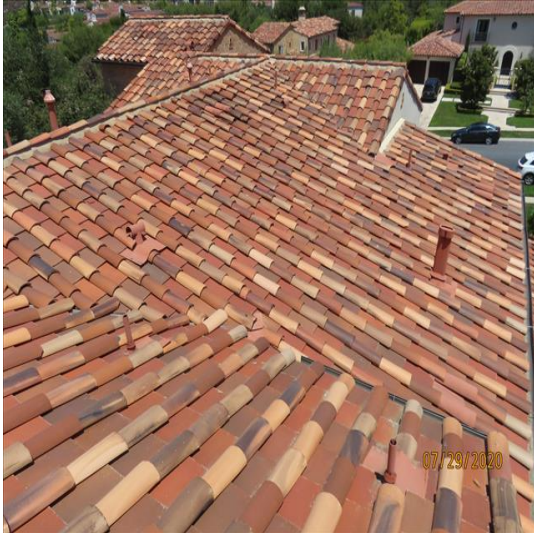
Image Number: 52

Observation: Overview of the clay tile roof system: The typical life expectancy of the waterproof felt underlayment is 25-30 years from date of installation.

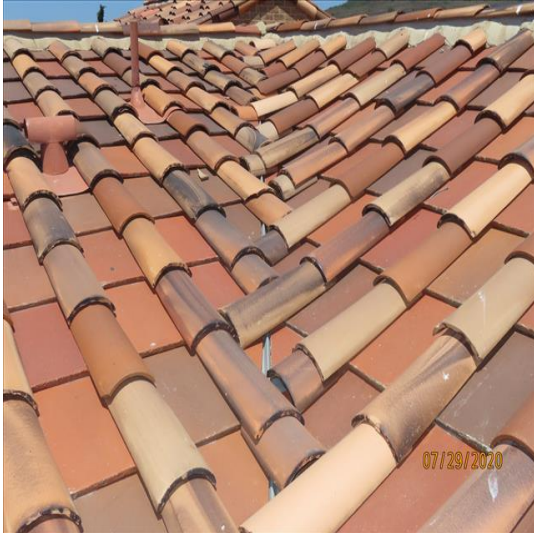
Image Number: 58

Observation: The tiles in the valley were woven together rather than properly cut back. The close cut tiles will impede proper drainage of water and debris. When water can't flow down the valley, it will be pushed laterally under the tiles causing interior moisture intrusion. This is the predominant cause of leaks on a tile roof system.

Determination: Roof Repair required for LeakFREE Roof Certification

Remedy: Valley repair: Cut the tiles at the valley locations to expose approximately 3" of the valley metal.

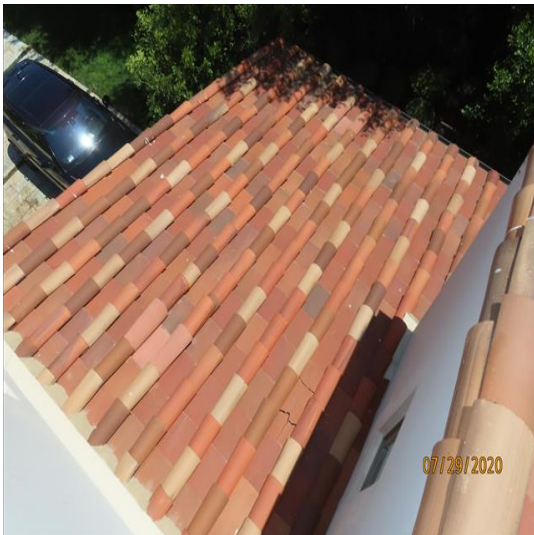
Image Number: 59

Observation: Overview of the clay tile roof system: The typical life expectancy of the waterproof felt underlayment is 25-30 years from date of installation.

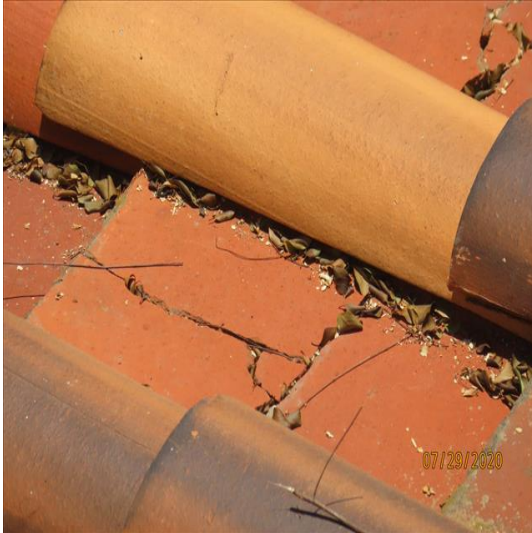
Image Number: 64

Observation: Broken/damaged tiles were observed in various locations throughout the roof system.

Determination: Roof Repair required for LeakFREE Roof Certification

Remedy: Remove and replace all necessary damaged tiles.

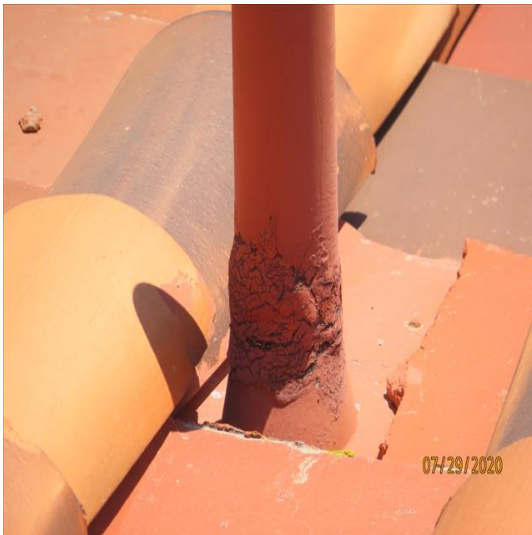
Image Number: 65

Observation: The sealant is cracked and deteriorated at various penetrations throughout the roof system. The roof penetrations need to be cleaned and re-sealed approximately every 5 years.

Determination: Roof Repair required for LeakFREE Roof Certification

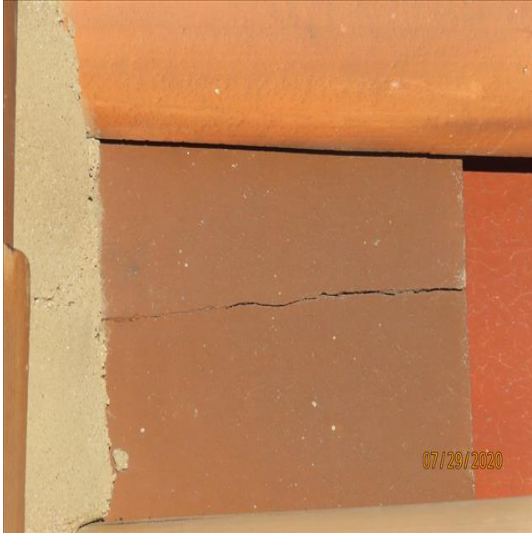
Image Number: 67

Observation: Broken/damaged tiles were observed in various locations throughout the roof system.

Determination: Roof Repair required for LeakFREE Roof Certification

Remedy: Remove and replace all necessary damaged tiles.

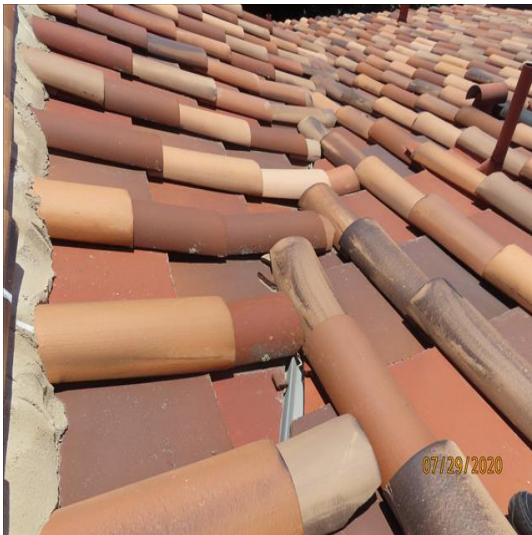
Image Number: 68

Observation: The tiles in the valley were woven together rather than properly cut back. The close cut tiles will impede proper drainage of water and debris. When water can't flow down the valley, it will be pushed laterally under the tiles causing interior moisture intrusion. This is the predominant cause of leaks on a tile roof system.

Determination: Roof Repair required for LeakFREE Roof Certification

Remedy: Valley repair: Cut the tiles at the valley locations to expose approximately 3" of the valley metal.

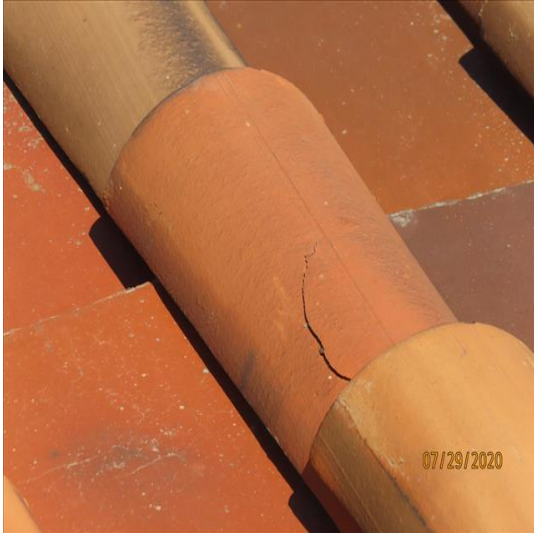
Image Number: 70

Observation: Broken/damaged tiles were observed in various locations throughout the roof system.

Determination: Roof Repair required for LeakFREE Roof Certification

Remedy: Remove and replace all necessary damaged tiles.

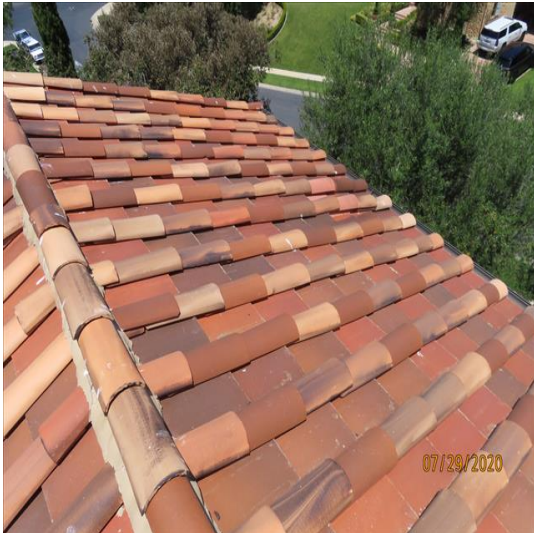
Image Number: 71

Observation: Overview of the clay tile roof system: The typical life expectancy of the waterproof felt underlayment is 25-30 years from date of installation.

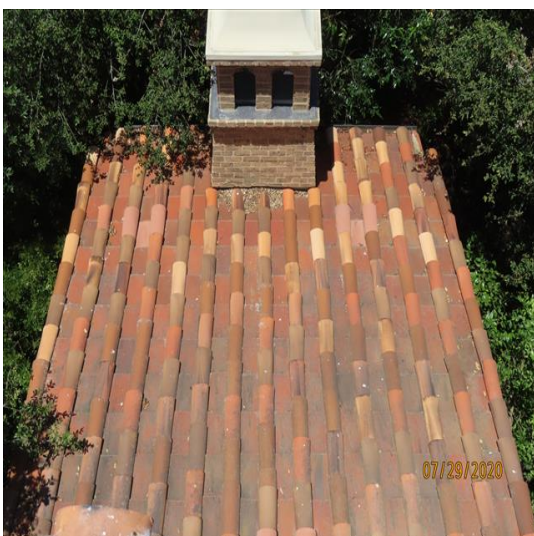
Image Number: 72

Observation: Overview of the clay tile roof system: The typical life expectancy of the waterproof felt underlayment is 25-30 years from date of installation.

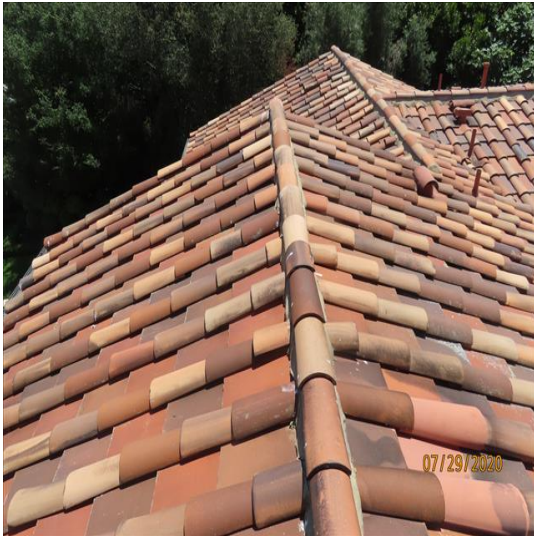
Image Number: 74

Observation: Overview of the clay tile roof system: The typical life expectancy of the waterproof felt underlayment is 25-30 years from date of installation.

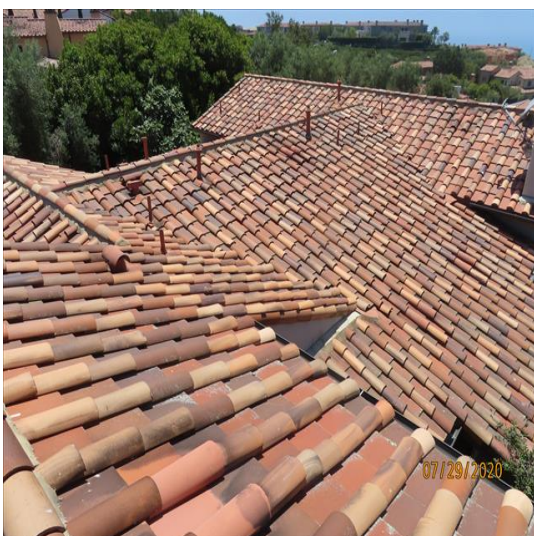
Image Number: 75

Observation: Overview of the clay tile roof system: The typical life expectancy of the waterproof felt underlayment is 25-30 years from date of installation.

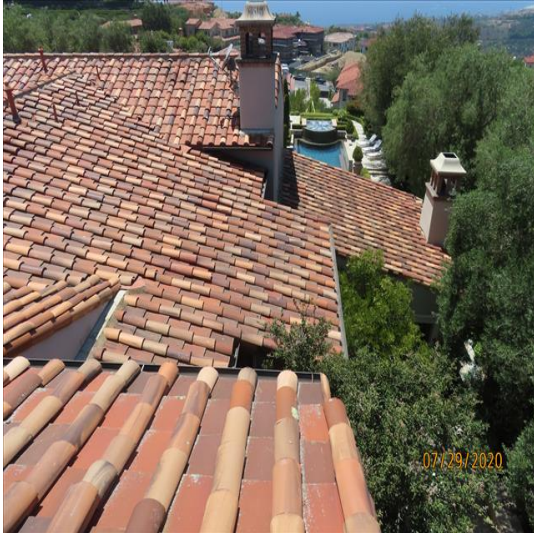
Image Number: 76

Observation: Overview of the clay tile roof system: The typical life expectancy of the waterproof felt underlayment is 25-30 years from date of installation.

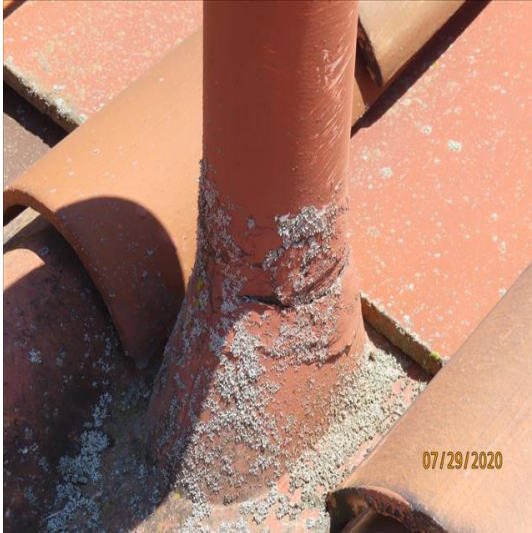
Image Number: 79

Observation: The sealant is cracked and deteriorated at various penetrations throughout the roof system. The roof penetrations need to be cleaned and re-sealed approximately every 5 years.

Determination: Roof Repair required for LeakFREE Roof Certification

Remedy: Clean, re-seal and paint all roof penetrations.

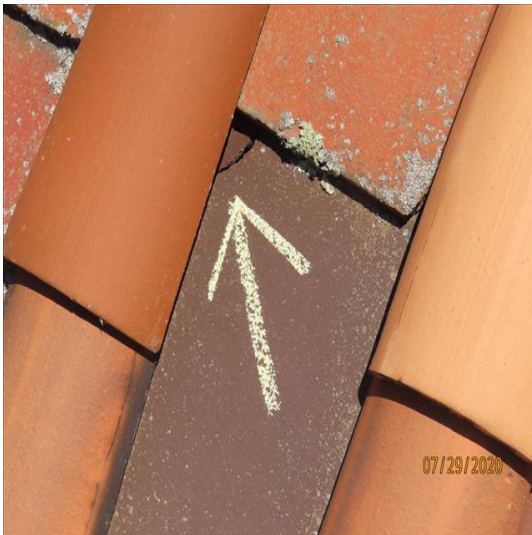
Image Number: 80

Observation: Broken/damaged tiles were observed in various locations throughout the roof system.

Determination: Roof Repair required for LeakFREE Roof Certification

Remedy: Remove and replace all necessary damaged tiles.

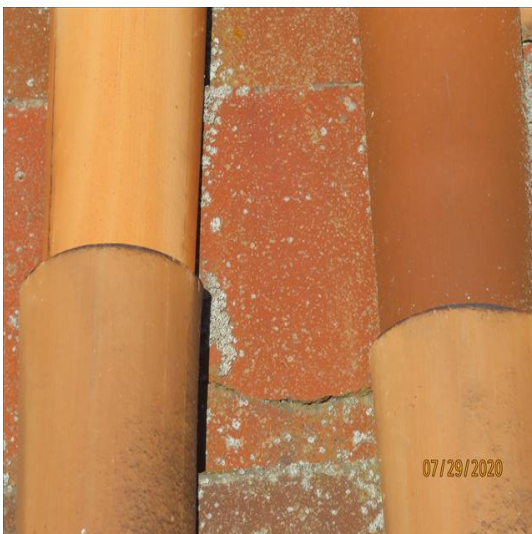
Image Number: 81

Observation: Broken/damaged tiles were observed in various locations throughout the roof system.

Determination: Roof Repair required for LeakFREE Roof Certification

Remedy: Remove and replace all necessary damaged tiles.

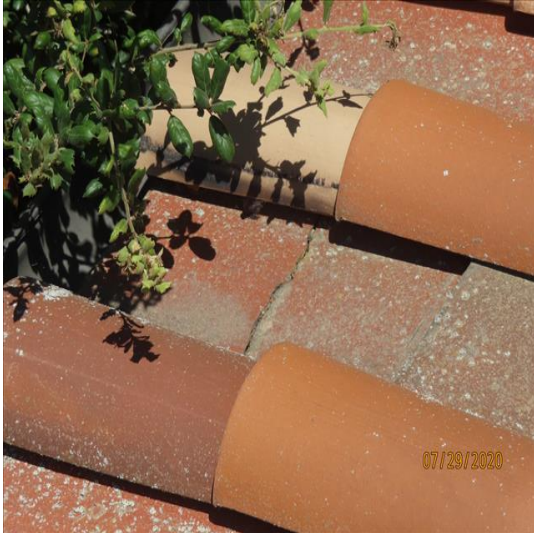
Image Number: 82

Observation: Broken/damaged tiles were observed in various locations throughout the roof system.

Determination: Roof Repair required for LeakFREE Roof Certification

Remedy: Remove and replace all necessary damaged tiles.

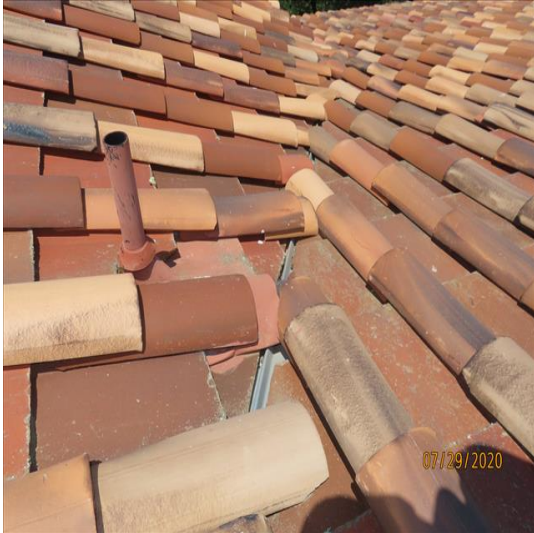
Image Number: 85

Observation: The tiles in the valley were woven together rather than properly cut back. The close cut tiles will impede proper drainage of water and debris. When water can't flow down the valley, it will be pushed laterally under the tiles causing interior moisture intrusion. This is the predominant cause of leaks on a tile roof system.

Determination: Roof Repair required for LeakFREE Roof Certification

Remedy: Valley repair: Cut the tiles at the valley locations to expose approximately 3" of the valley metal.

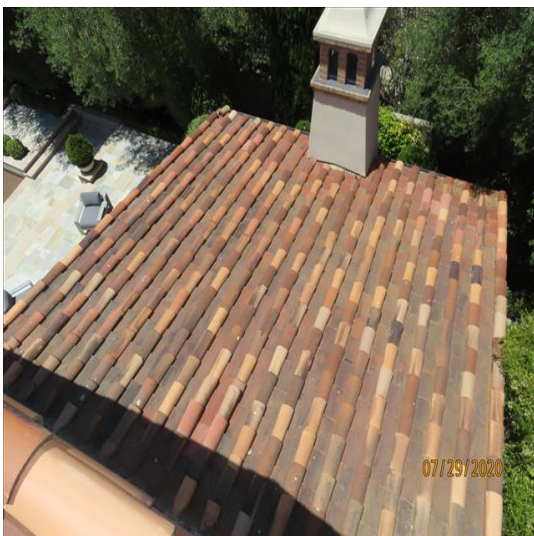
Image Number: 90

Observation: Overview of the clay tile roof system: The typical life expectancy of the waterproof felt underlayment is 25-30 years from date of installation.

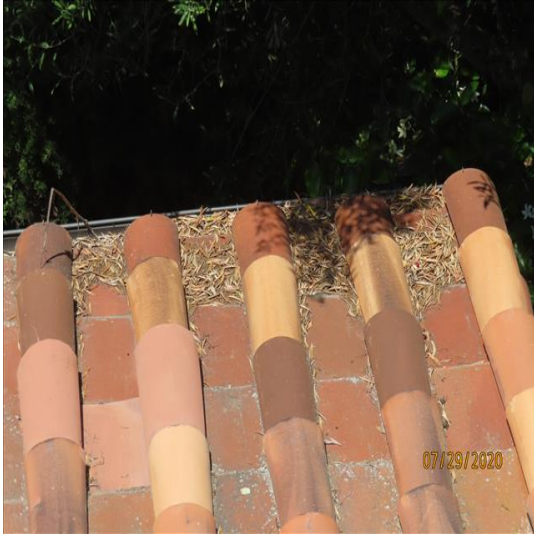
Image Number: 91

Observation: A build up of debris was observed in various locations throughout the roof system. This will impede proper drainage of rain water.

Determination: Roof Repair required for LeakFREE Roof Certification

Remedy: Upon completion of the roof repairs, clean all possible debris off the roof. This is recommended at least once a year prior to the rainy season.

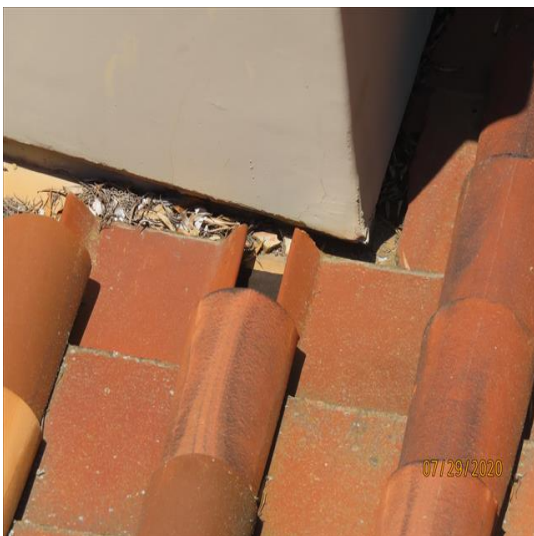
Image Number: 93

Observation: Broken/damaged tiles were observed in various locations throughout the roof system.

Determination: Roof Repair required for LeakFREE Roof Certification

Remedy: Remove and replace all necessary damaged tiles.

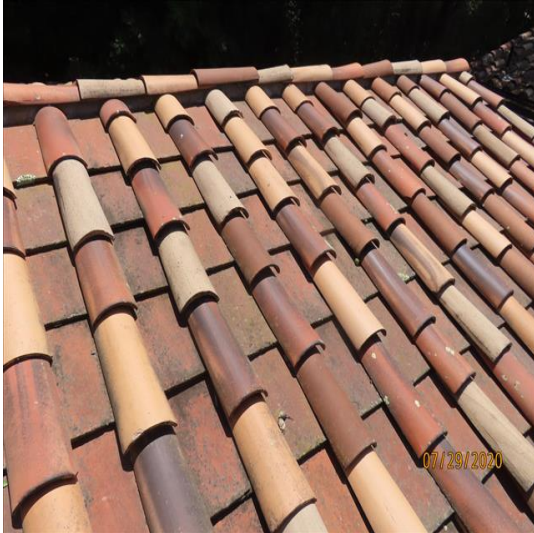
Image Number: 94

Observation: Overview of the clay tile roof system: The typical life expectancy of the waterproof felt underlayment is 25-30 years from date of installation.

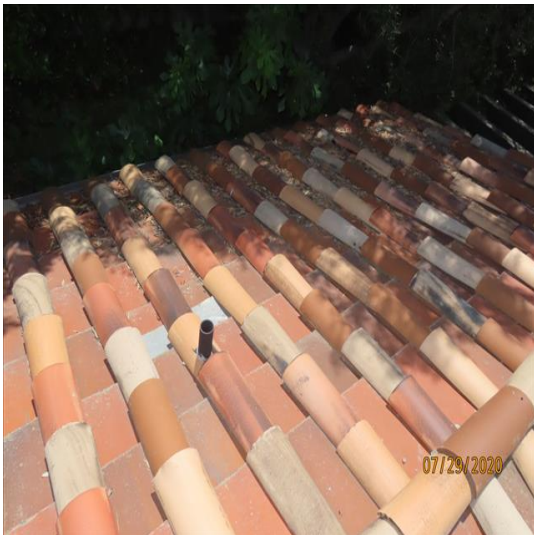
Image Number: 95

Observation: Overview of the clay tile roof system: The typical life expectancy of the waterproof felt underlayment is 25-30 years from date of installation.

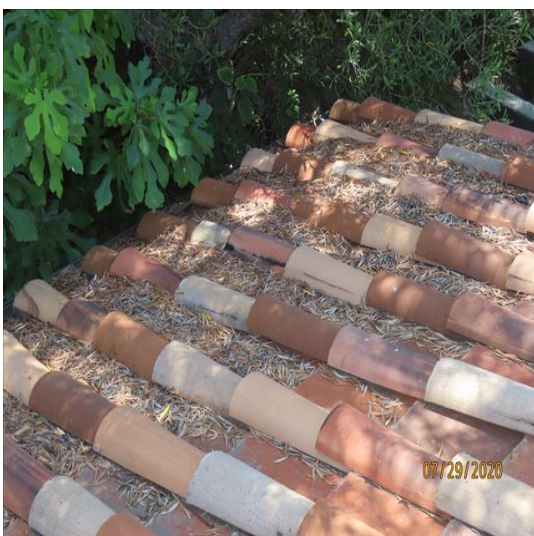
Image Number: 96

Observation: A build up of debris was observed in various locations throughout the roof system. This will impede proper drainage of rain water.

Determination: Roof Repair required for LeakFREE Roof Certification

Remedy: Upon completion of the roof repairs, clean all possible debris off the roof. This is recommended at least once a year prior to the rainy season.

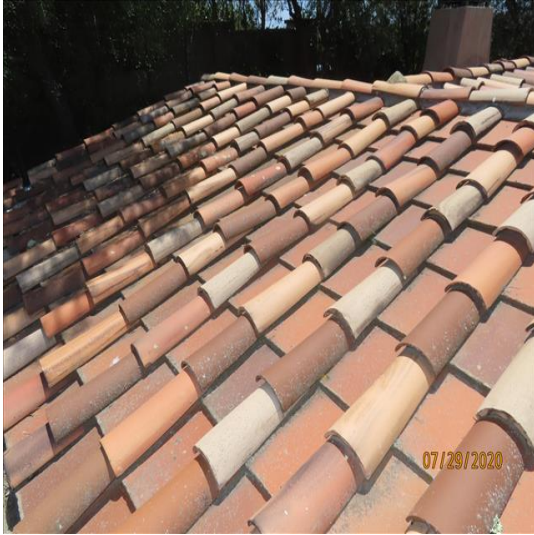
Image Number: 97

Observation: Overview of the clay tile roof system: The typical life expectancy of the waterproof felt underlayment is 25-30 years from date of installation.

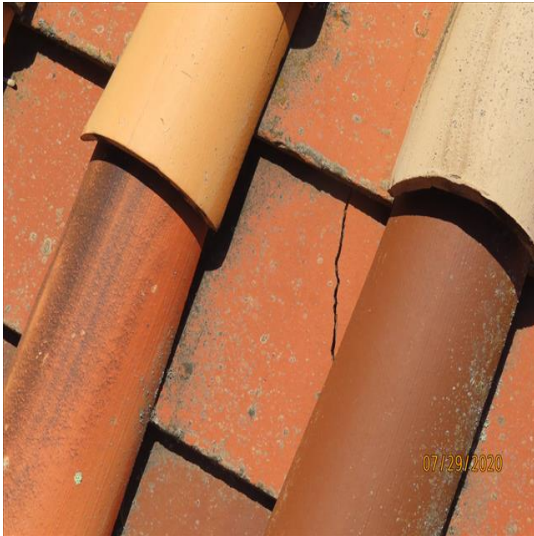
Image Number: 98

Observation: Broken/damaged tiles were observed in various locations throughout the roof system.

Determination: Roof Repair required for LeakFREE Roof Certification

Remedy: Remove and replace all necessary damaged tiles.

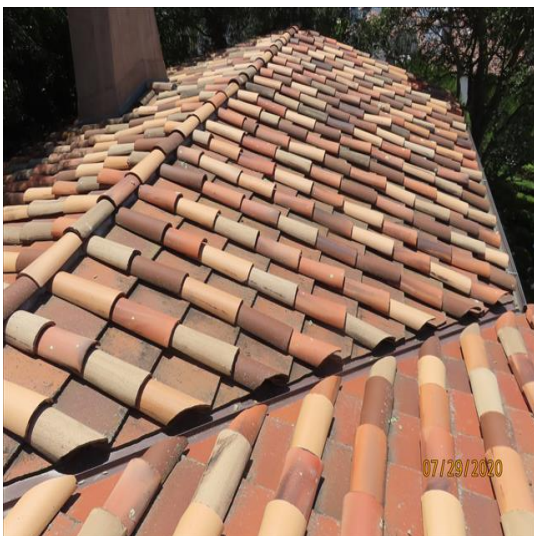
Image Number: 99

Observation: Overview of the clay tile roof system: The typical life expectancy of the waterproof felt underlayment is 25-30 years from date of installation.

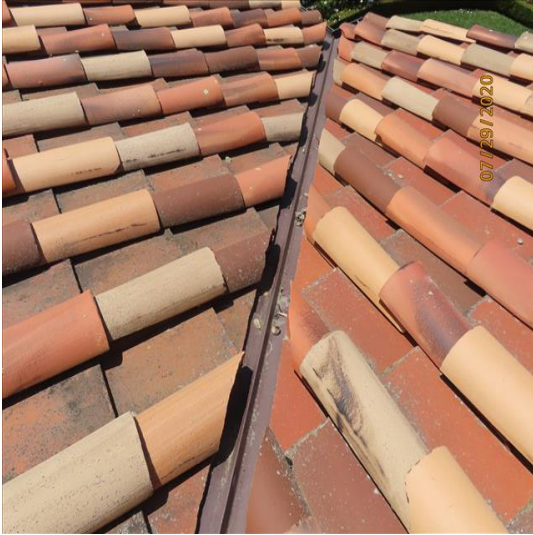
Image Number: 100

Observation: The tiles in this valley were properly cut back.

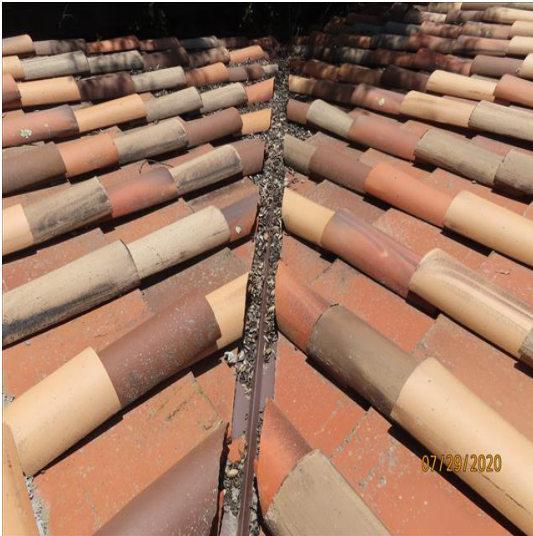
Image Number: 101

Observation: The tiles in this valley were properly cut back.

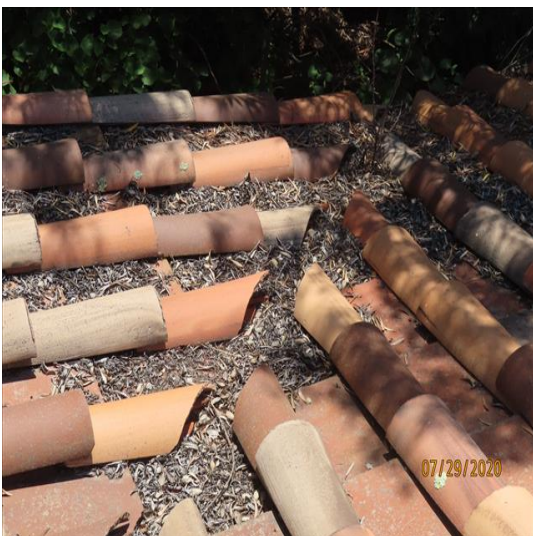
Image Number: 102

Observation: A build up of debris was observed in various locations throughout the roof system. This will impede proper drainage of rain water.

Determination: Roof Repair required for LeakFREE Roof Certification

Remedy: Upon completion of the roof repairs, clean all possible debris off the roof. This is recommended at least once a year prior to the rainy season.

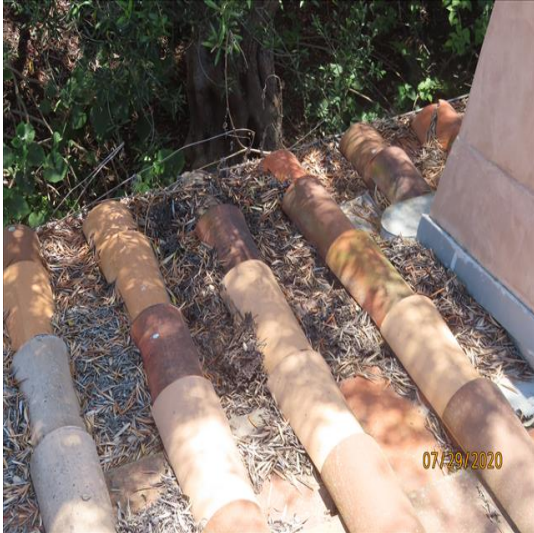
Image Number: 103

Observation: A build up of debris was observed in various locations throughout the roof system. This will impede proper drainage of rain water.

Determination: Roof Repair required for LeakFREE Roof Certification

Remedy: Upon completion of the roof repairs, clean all possible debris off the roof. This is recommended at least once a year prior to the rainy season.

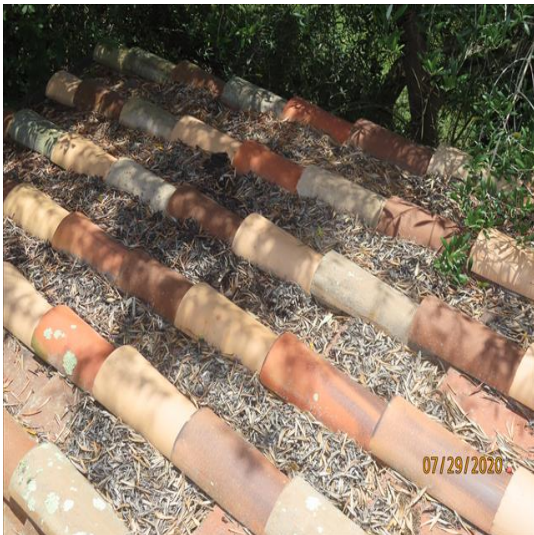
Image Number: 104

Observation: A build up of debris was observed in various locations throughout the roof system. This will impede proper drainage of rain water.

Determination: Roof Repair required for LeakFREE Roof Certification

Remedy: Upon completion of the roof repairs, clean all possible debris off the roof. This is recommended at least once a year prior to the rainy season.

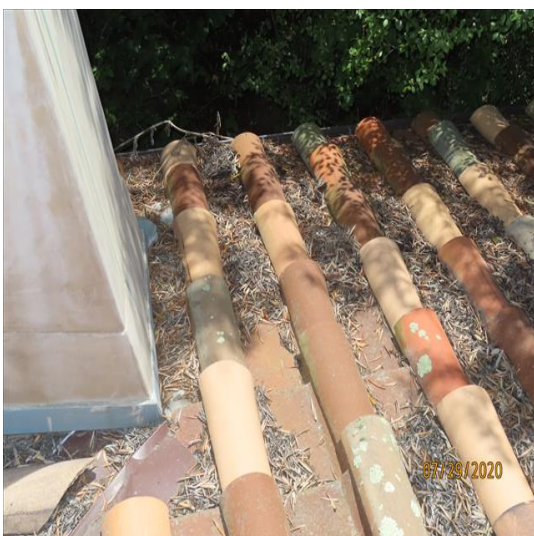
Image Number: 105

Observation: A build up of debris was observed in various locations throughout the roof system. This will impede proper drainage of rain water.

Determination: Roof Repair required for LeakFREE Roof Certification

Remedy: Upon completion of the roof repairs, clean all possible debris off the roof. This is recommended at least once a year prior to the rainy season.
