LeakFREE® Roof Inspection

Report No :
43287

Property Inspected :
10 Summer Street
Los Angeles, CA 90001

Inspected By :
John Smith
NRCIA Certified
Roof Inspector

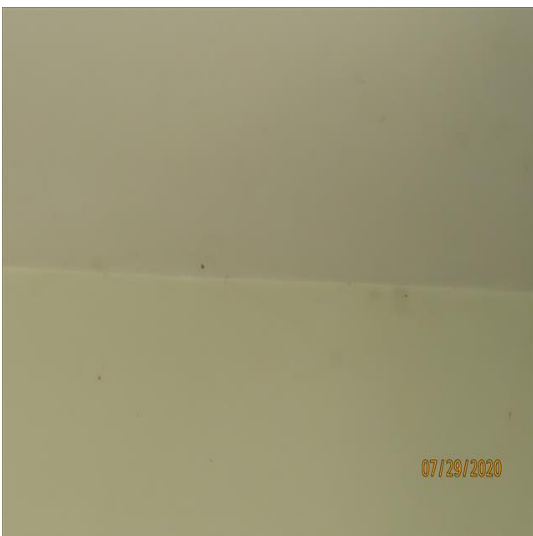
Image Number: 108

Observation: Moisture intrusion was observed beneath the deck systems.

Remedy: Recommend a further detailed evaluation by a licensed deck specialist.

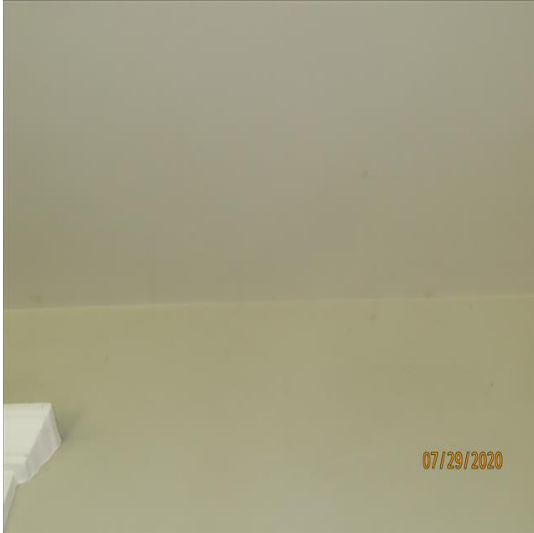
Image Number: 109

Observation: Moisture intrusion was observed beneath the deck systems.

Remedy: Recommend a further detailed evaluation by a licensed deck specialist.

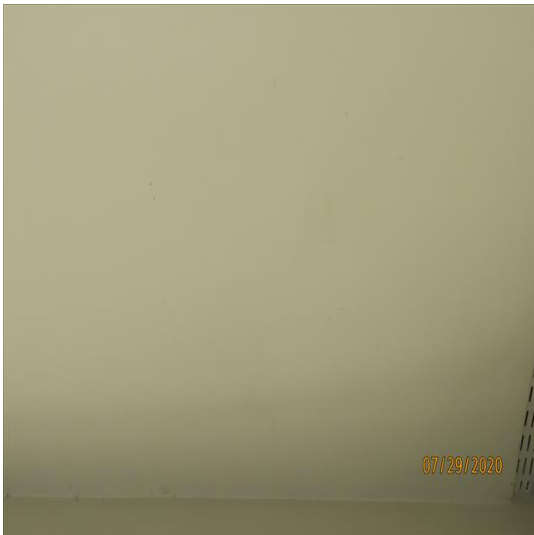
Image Number: 110

Observation: Moisture intrusion was observed beneath the deck systems.

Remedy: Recommend a further detailed evaluation by a licensed deck specialist.
