# LeakFREE® Roof Inspection

**Report No:**  
135207

**Inspection Date:**  
05/04/2026

**Property Inspected:**  
303 N Granite Ct  
Brian Head, UT, 84719

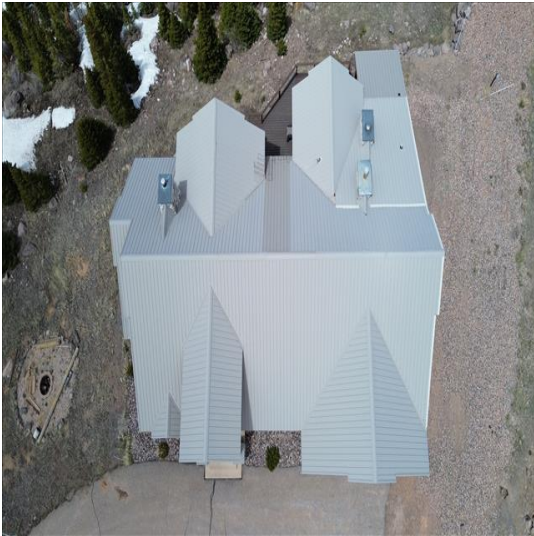
Image Number: 1  
Observation:  
Determination: Replacement required

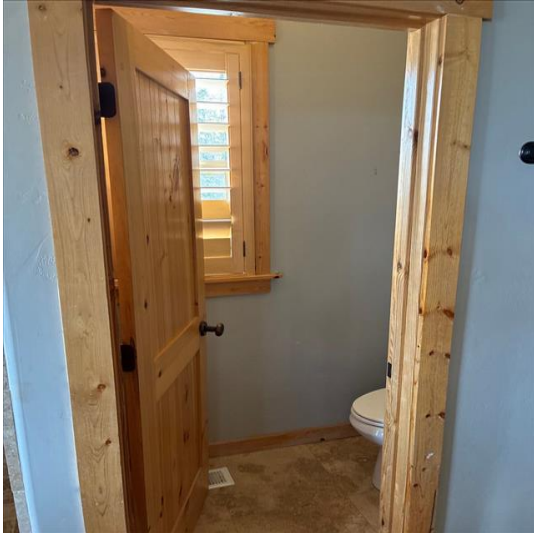
**Image Number: 4**

**Observation:** Master bathroom overview: Moisture intrusion resulting from a roof leak was **NOT** reported or observed in this room.

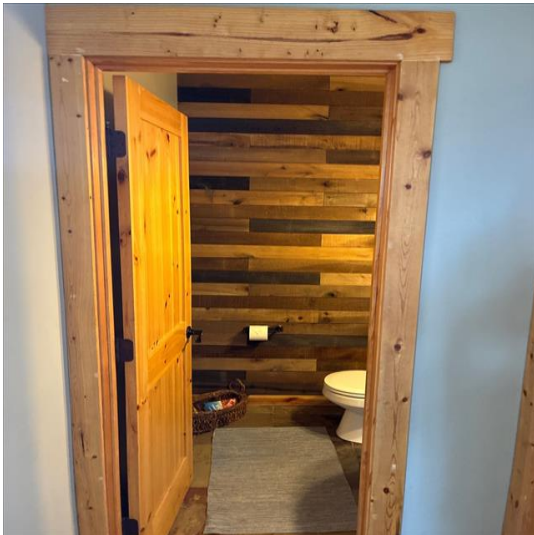
**Image Number: 5**

**Observation:** Overview: Bathroom Exhaust Termination: The master bathroom exhaust fan was observed to terminate into the open attic space which is a **red flag**. Bathroom exhaust fans are required to vent to the building exterior. Discharging warm, moist air into the attic introduces humidity that can condense on cold roof sheathing, saturate insulation, contribute to ice dam formation, and accelerate deterioration of roof structural components.

**Cause:** Improper bathroom exhaust installation — duct not extended to a code-compliant exterior termination.

**Remedy:** Recommend extending the bathroom exhaust duct to terminate at a code-compliant exterior location by a qualified mechanical or general contractor.

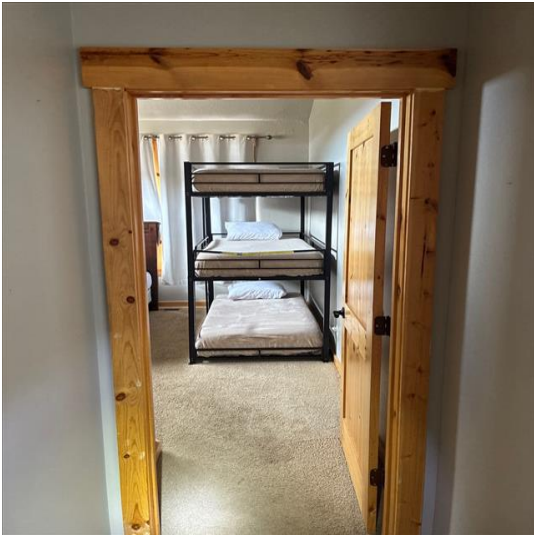
**Image Number:** 10  
**Observation:** Bedroom 2: Overview.

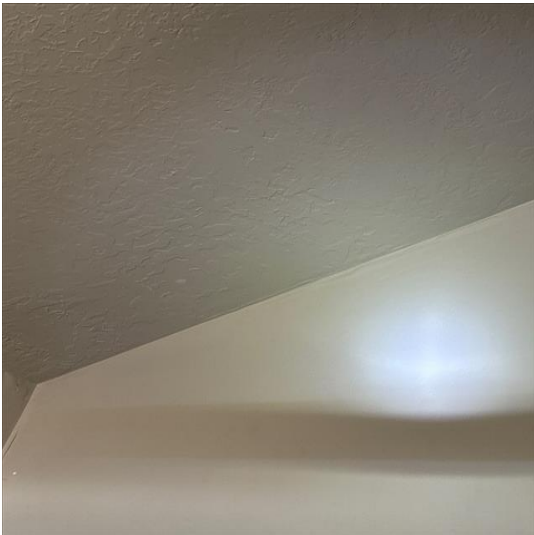
**Image Number:** 12  
**Observation:** Bubbling paint and moisture staining were observed, indicating active or prior moisture intrusion from above.

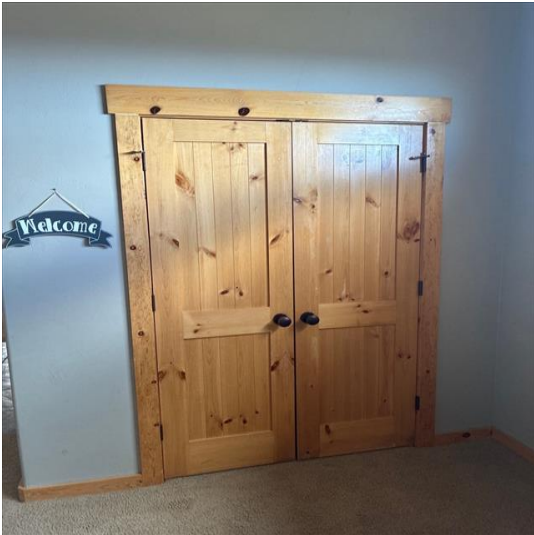
**Image Number:** 13  
**Observation:** Observation: Bedroom closet overview. Moisture intrusion was NOT reported or observed.

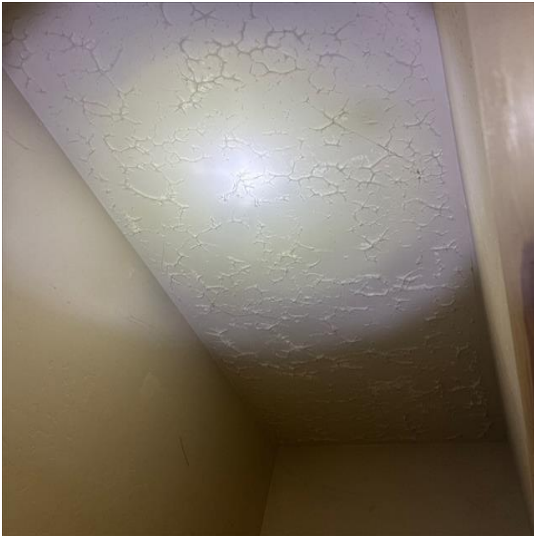
**Image Number:** 14  
**Observation:** Observation: Bedroom closet overview. Moisture intrusion was NOT reported or observed.

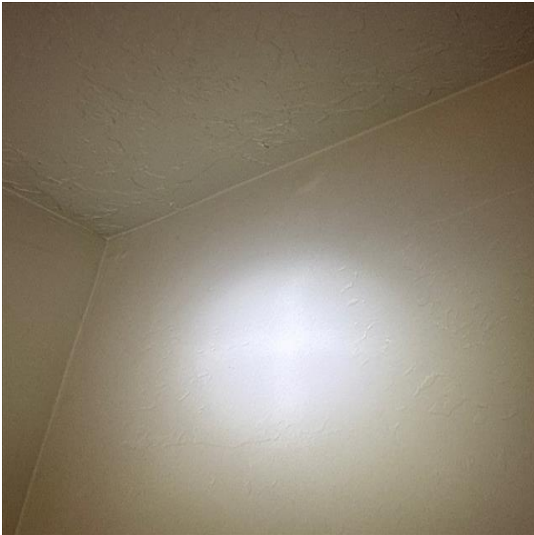
**Image Number:** 16  
**Observation:** Bubbling paint and moisture staining were observed, indicating active or prior moisture intrusion from above.

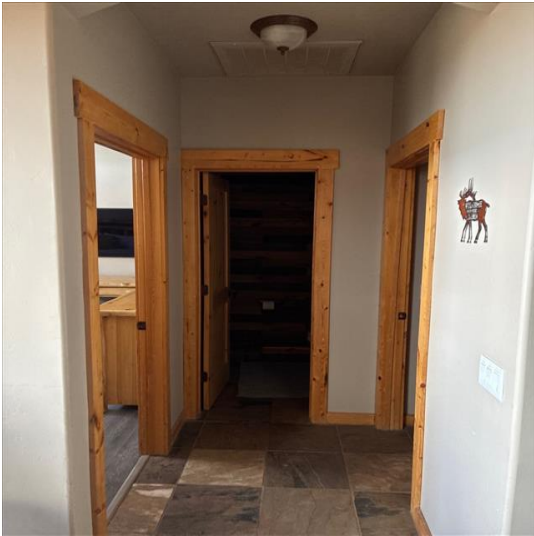
Image Number: 19  
Observation: Signs of moisture were NOT observed.

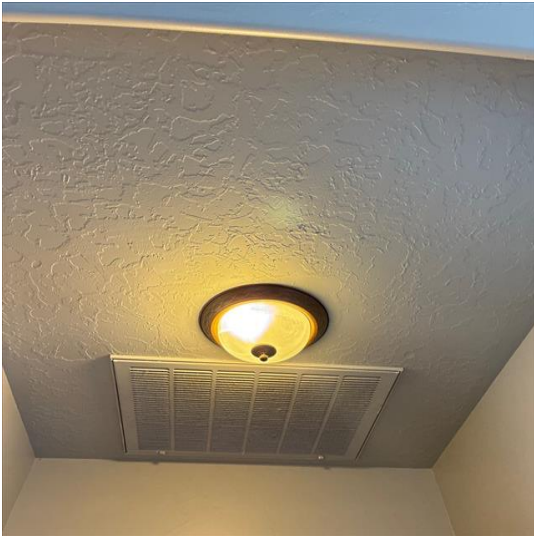
Image Number: 20  
Observation: Signs of moisture were NOT observed.

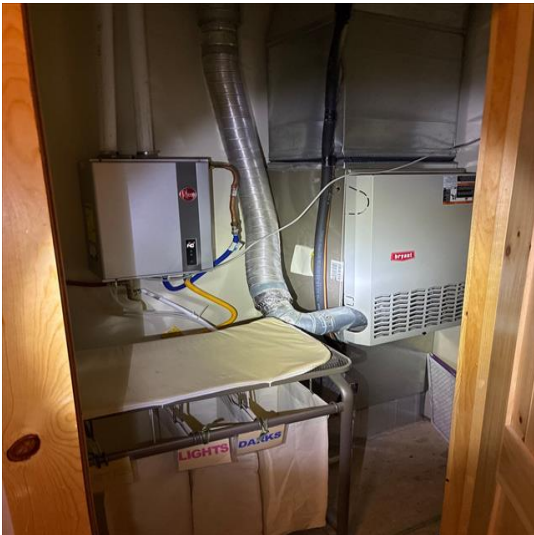
Image Number: 21  
Observation: Overview: Moisture intrusion resulting from a roof leak was NOT reported or observed in this room.

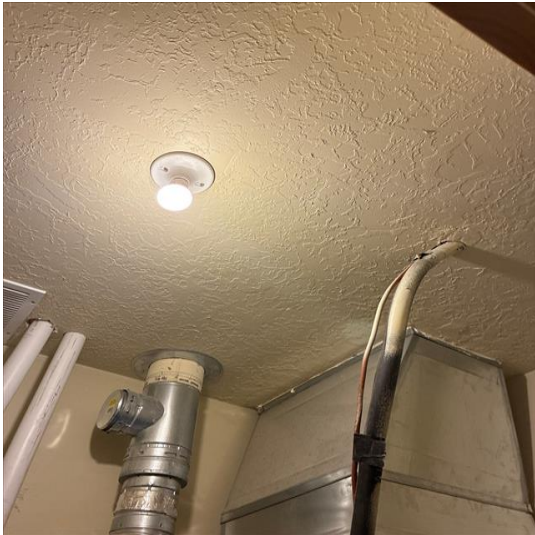
**Image Number:** 22  
**Observation:** Overview: Moisture intrusion resulting from a roof leak was **NOT** reported or observed in this room.

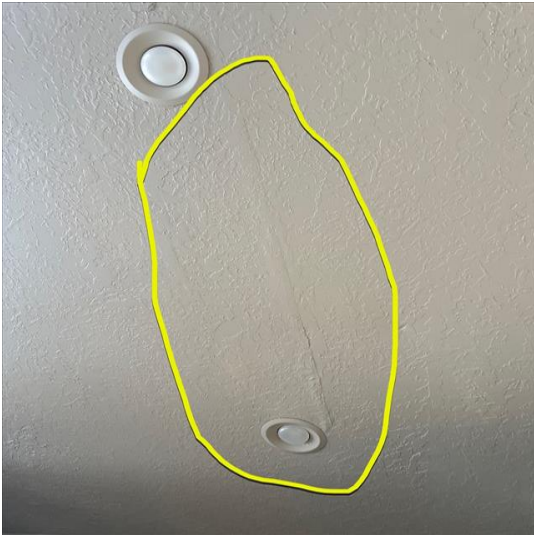
**Image Number:** 25  
**Observation:** Peeling tape and bubbled paint were observed in the kitchen indicating possible moisture intrusion.

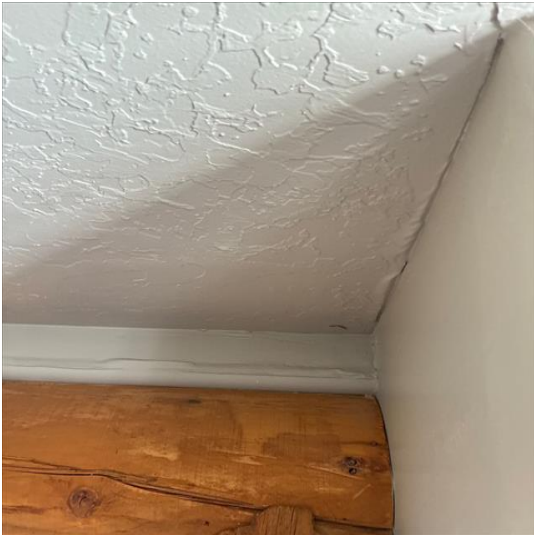
**Image Number:** 34  
**Observation:** Bubbling paint was observed at the ceiling near the roof pitch transition.

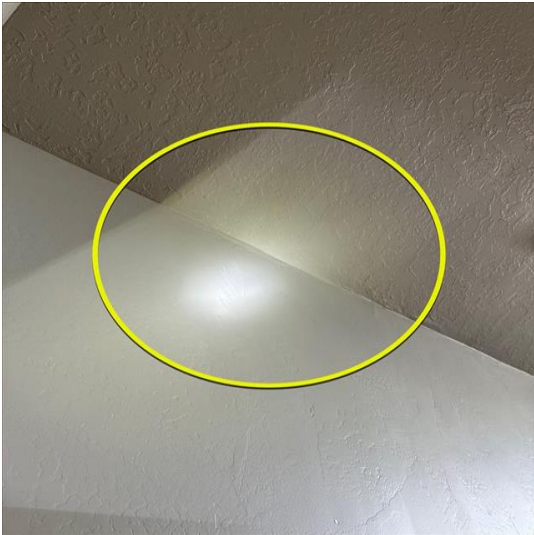
**Image Number:** 37  
**Observation:** Bubbling paint was observed in the corner where the wall meets the ceiling. This condition is a red flag, indicating the potential for active or past moisture intrusion.

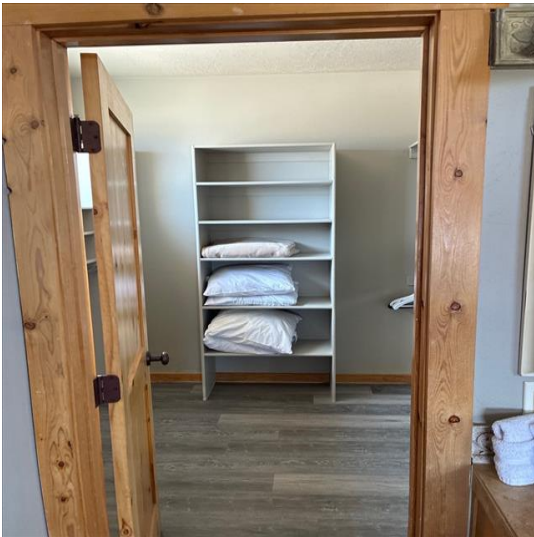
**Image Number:** 38  
**Observation:** Master bedroom overview: Moisture intrusion resulting from a roof leak was **NOT** reported or observed in this room.

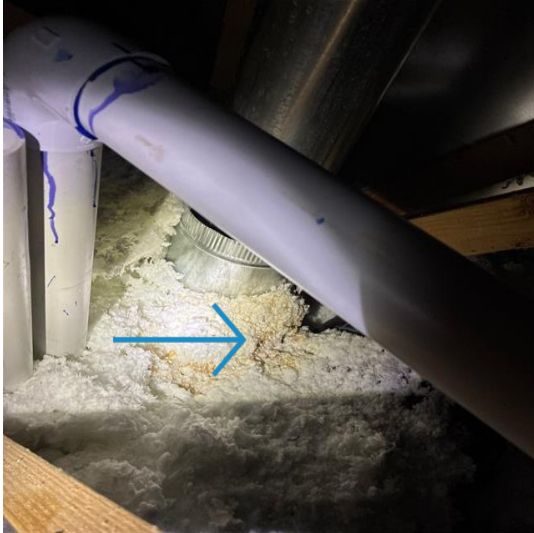
**Image Number: 52**

**Determination: Workmanship Defect** (Image Number: [50](#), [51](#), [52](#) )

Observation: Moisture droplets were observed from internal equipment exhaust. This is a red flag because if it continues to happen it can cause damage.

The attic is not properly ventilated and is caused condensation to build as well as a most likely improperly sealed flashing on the roof.

**Observation: Observation:** Moisture droplets were observed from internal equipment exhaust. This is a **red flag** because if it continues to happen it can cause damage.

**Cause:** The attic is not properly ventilated and is caused condensation to build as well as a most likely improperly sealed flashing on the roof.

**Remedy:** Seal the flashing and install proper ventilation.

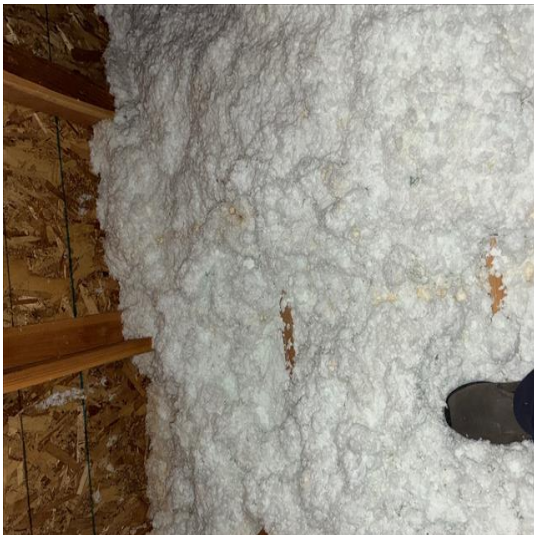
**Image Number: 53**

**Observation: Observation:** A line a moisture on the insulation directly below the butting of OSB sheathing. This is likely caused by wicking of water due to condensation.

**Cause:** Improper workmanship.

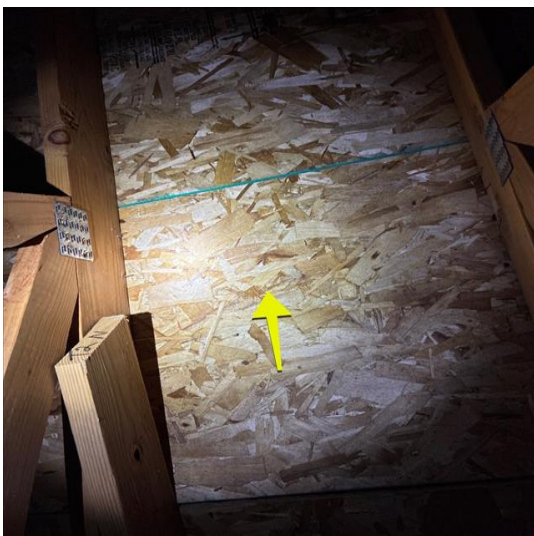
**Image Number: 54**

**Determination: Workmanship Defect** (Image Number: [54](#), [58](#), [59](#), [61](#), [65](#), [66](#), [70](#), [73](#) )

Observation: At the time of inspection, no actively wet surfaces were detected; however, multiple indicators of elevated attic humidity and prior or intermittent condensation were observed, including moisture staining on the underside of the roof sheathing, corrosion (rust) on roofing fasteners penetrating into the attic, and condensation droplets on the HVAC ductwork. Collectively, these conditions indicate that warm, humid air has been reaching the cold underside of the roof assembly and condensing on cooler surfaces, particularly during cold-weather conditions. Sustained attic condensation can deteriorate roof sheathing, accelerate fastener corrosion, reduce insulation performance, and contribute to ice dam formation.

Elevated attic humidity, likely resulting from a combination of moisture sources within the home (including the bathroom exhaust fan terminating in the attic &mdash; see prior observation) and inadequate ventilation to dissipate the moisture load.

**Observation: Observation:** At the time of inspection, no actively wet surfaces were detected; however, multiple indicators of elevated attic humidity and prior or intermittent condensation were observed, including **moisture staining** on the underside of the roof sheathing, corrosion (rust) on roofing fasteners penetrating into the attic, and condensation droplets on the HVAC ductwork. Collectively, these conditions indicate that warm, humid air has been reaching the cold underside of the roof assembly and condensing on cooler surfaces, particularly during cold-weather conditions. Sustained attic condensation can deteriorate roof sheathing, accelerate fastener corrosion, reduce insulation performance, and contribute to ice dam formation.

**Remedy:** Recommend evaluation of the attic ventilation system by a qualified roofing contractor to determine whether intake ventilation (soffit vents) and exhaust ventilation (ridge, gable, or roof vents) meet current code and industry standards for the home's attic volume. Corrective work may include adding or clearing soffit venting, installing or upgrading exhaust venting, and ensuring a balanced ventilation system. In coordination with ventilation improvements, recommend addressing identified moisture sources within the home to reduce humidity loading into the attic.

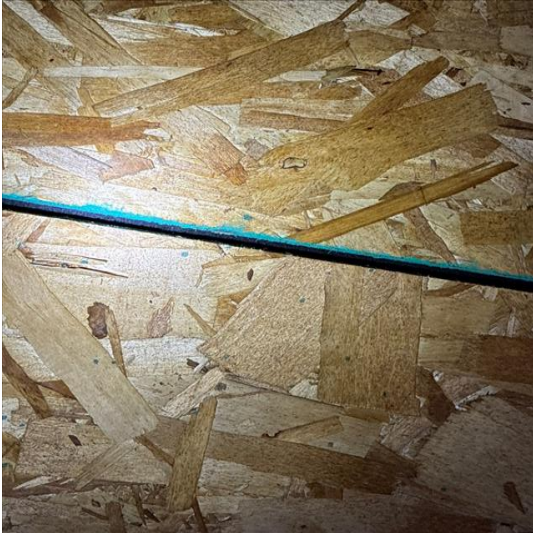
**Image Number: 55**

**Observation: Observation:** A line a moisture on the insulation directly below the butting of OSB sheathing. This is likely caused by wicking of water due to condensation.

**Cause:** Improper workmanship.

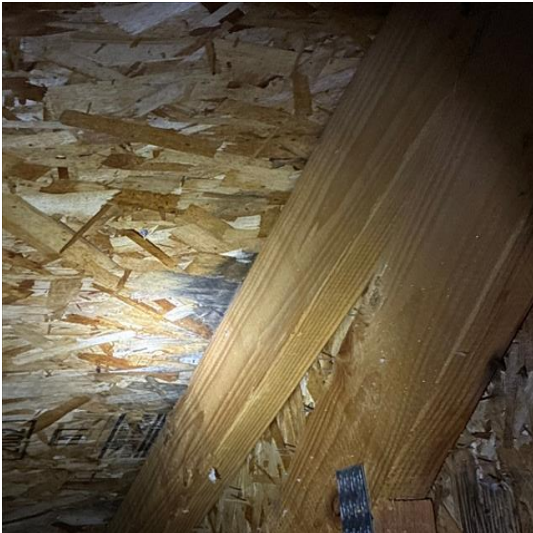
**Image Number: 56**

**Observation: Observation:** Rotting roof sheathing was observed along rafter lines in multiple locations, accompanied by moisture staining, dampened insulation with visible water droplets. At the time of inspection, no actively wet surfaces were detected. The localized pattern of sheathing rot along rafter lines is consistent with possible point-source moisture intrusion at **improperly installed roofing fasteners, in addition to attic condensation from elevated humidity**. Direct rooftop access was not available at the time of inspection to confirm fastener installation conditions from the exterior.

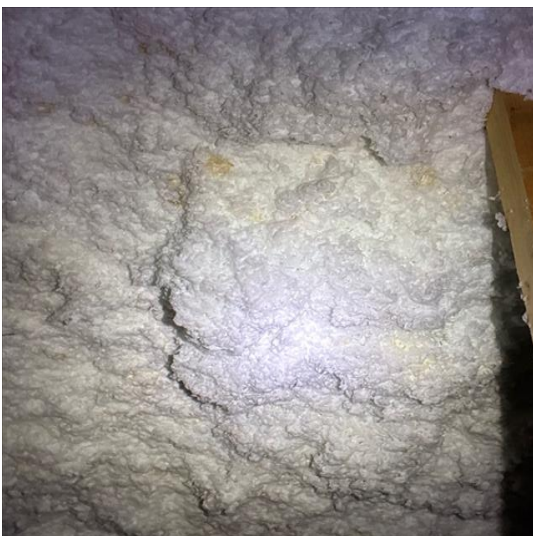
**Image Number: 57**

**Observation: Observation:** Rotting roof sheathing was observed along rafter lines in multiple locations, accompanied by moisture staining, dampened insulation with visible water droplets. At the time of inspection, no actively wet surfaces were detected. The localized pattern of sheathing rot along rafter lines is consistent with possible point-source moisture intrusion at **improperly installed roofing fasteners, in addition to attic condensation from elevated humidity**. Direct rooftop access was not available at the time of inspection to confirm fastener installation conditions from the exterior.

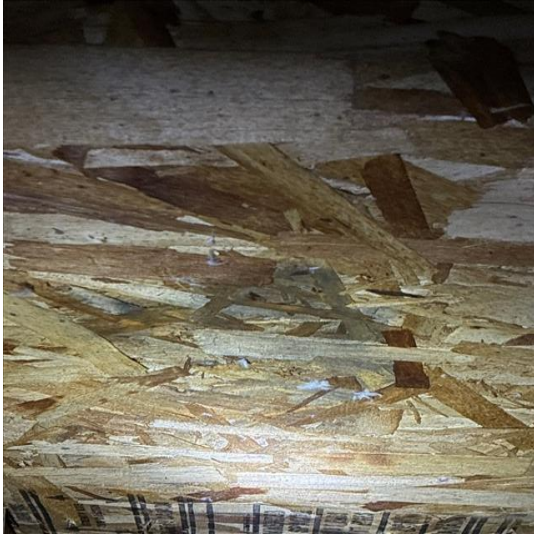
**Image Number: 58**

**Observation:** At the time of inspection, no actively wet surfaces were detected; however, multiple indicators of elevated attic humidity and prior or intermittent condensation were observed, including **moisture staining** on the underside of the roof sheathing, corrosion (rust) on roofing fasteners penetrating into the attic, and condensation droplets on the HVAC ductwork. Collectively, these conditions indicate that warm, humid air has been reaching the cold underside of the roof assembly and condensing on cooler surfaces, particularly during cold-weather conditions. Sustained attic condensation can deteriorate roof sheathing, accelerate fastener corrosion, reduce insulation performance, and contribute to ice dam formation.

**Remedy:** Recommend evaluation of the attic ventilation system by a qualified roofing contractor to determine whether intake ventilation (soffit vents) and exhaust ventilation (ridge, gable, or roof vents) meet current code and industry standards for the home's attic volume. Corrective work may include adding or clearing soffit venting, installing or upgrading exhaust venting, and ensuring a balanced ventilation system. In coordination with ventilation improvements, recommend addressing identified moisture sources within the home to reduce humidity loading into the attic.

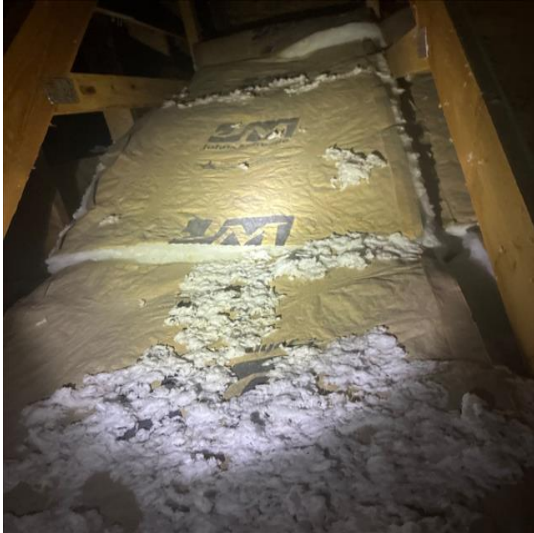
**Image Number: 62**

**Observation: Observation:** Rotting roof sheathing was observed along rafter lines in multiple locations, accompanied by moisture staining, dampened insulation with visible water droplets. At the time of inspection, no actively wet surfaces were detected. The localized pattern of sheathing rot along rafter lines is consistent with possible point-source moisture intrusion at **improperly installed roofing fasteners, in addition to attic condensation from elevated humidity**. Direct rooftop access was not available at the time of inspection to confirm fastener installation conditions from the exterior.

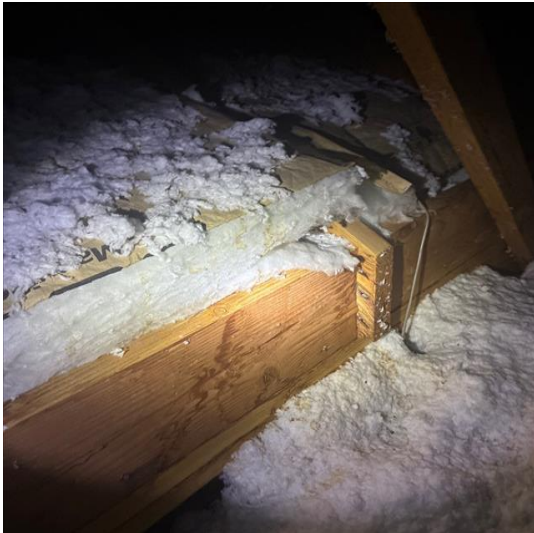
**Image Number: 63**

**Observation: Observation:** Rotting roof sheathing was observed along rafter lines in multiple locations, accompanied by moisture staining, dampened insulation with visible water droplets. At the time of inspection, no actively wet surfaces were detected. The localized pattern of sheathing rot along rafter lines is consistent with possible point-source moisture intrusion at **improperly installed roofing fasteners, in addition to attic condensation from elevated humidity**. Direct rooftop access was not available at the time of inspection to confirm fastener installation conditions from the exterior.

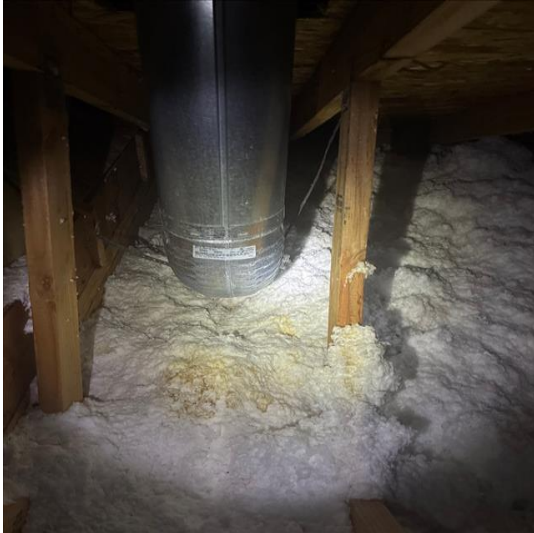
**Image Number:** 64

**Observation:** Vent pipe going through the roof has moisture stains along with moisture on the insulation below. This can happen because the flashing above is not sealed properly.

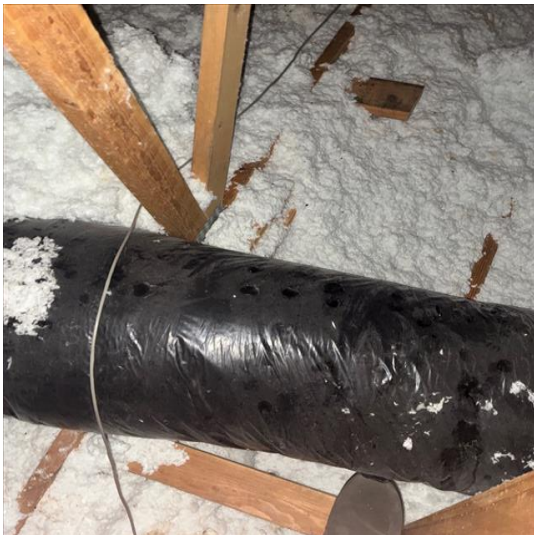
**Image Number:** 65

**Observation:** At the time of inspection, no actively wet surfaces were detected; however, multiple indicators of elevated attic humidity and prior or intermittent condensation were observed, including moisture staining on the underside of the roof sheathing, corrosion (rust) on roofing fasteners penetrating into the attic, and condensation droplets on the HVAC ductwork. Collectively, these conditions indicate that warm, humid air has been reaching the cold underside of the roof assembly and condensing on cooler surfaces, particularly during cold-weather conditions. Sustained attic condensation can deteriorate roof sheathing, accelerate fastener corrosion, reduce insulation performance, and contribute to ice dam formation.

**Cause:** Elevated attic humidity, likely resulting from a combination of moisture sources within the home (including the bathroom exhaust fan terminating in the attic — see prior observation) and inadequate ventilation to dissipate the moisture load.

**Remedy:** Recommend evaluation of the attic ventilation system by a qualified roofing contractor to determine whether intake ventilation (soffit vents) and exhaust ventilation (ridge, gable, or roof vents) meet current code and industry standards for the home's attic volume. Corrective work may include adding or clearing soffit venting, installing or upgrading exhaust venting, and ensuring a balanced ventilation system. In coordination with ventilation improvements, recommend addressing identified moisture sources within the home to reduce humidity loading into the attic.

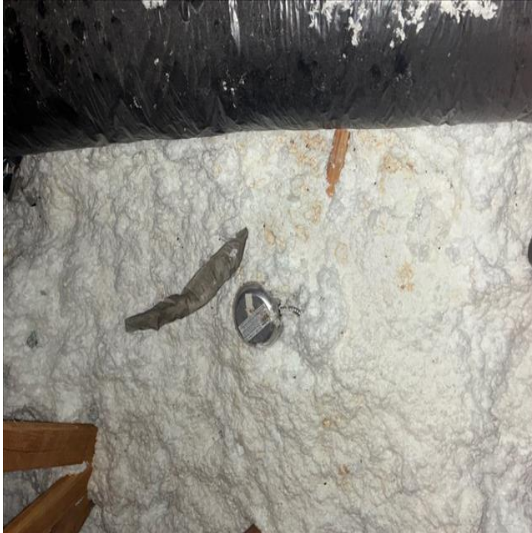
**Image Number: 66**

**Observation:** At the time of inspection, no actively wet surfaces were detected; however, multiple indicators of elevated attic humidity and prior or intermittent condensation were observed, including **moisture staining** on the underside of the roof sheathing, corrosion (rust) on roofing fasteners penetrating into the attic, and condensation droplets on the HVAC ductwork. Collectively, these conditions indicate that warm, humid air has been reaching the cold underside of the roof assembly and condensing on cooler surfaces, particularly during cold-weather conditions. Sustained attic condensation can deteriorate roof sheathing, accelerate fastener corrosion, reduce insulation performance, and contribute to ice dam formation.

**Cause:** Elevated attic humidity, likely resulting from a combination of moisture sources within the home (including the bathroom exhaust fan terminating in the attic — see prior observation) and inadequate ventilation to dissipate the moisture load.

**Remedy:** Recommend evaluation of the attic ventilation system by a qualified roofing contractor to determine whether intake ventilation (soffit vents) and exhaust ventilation (ridge, gable, or roof vents) meet current code and industry standards for the home's attic volume. Corrective work may include adding or clearing soffit venting, installing or upgrading exhaust venting, and ensuring a balanced ventilation system. In coordination with ventilation improvements, recommend addressing identified moisture sources within the home to reduce humidity loading into the attic.

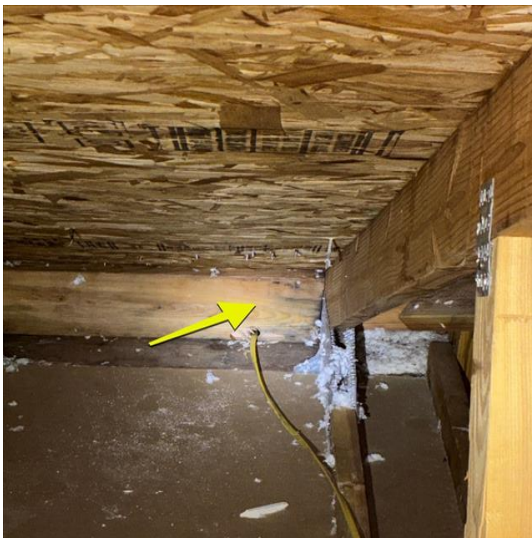
**Image Number: 67**

**Observation:** Moisture damage along the eaves of the home. This most likely happened during the ice dams that occur and improper installation of screws.

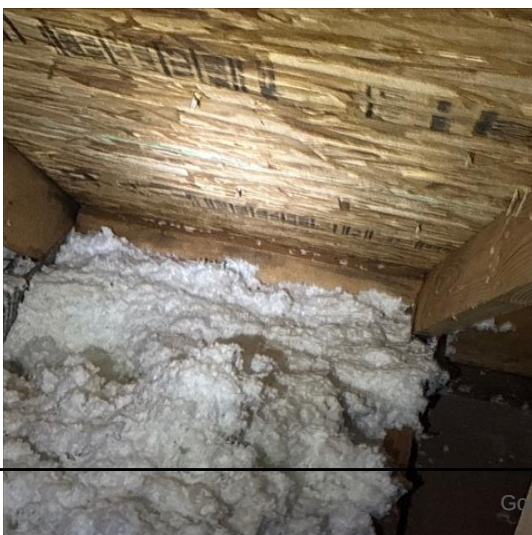
**Image Number: 68**

**Observation:** Moisture damage along the eaves of the home. This most likely happened during the ice dams that occur and improper installation of screws.

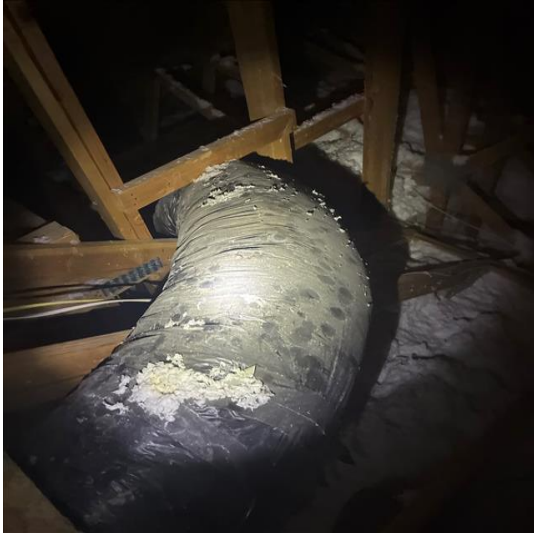
**Image Number: 70**

**Observation:** At the time of inspection, no actively wet surfaces were detected; however, multiple indicators of elevated attic humidity and prior or intermittent condensation were observed, including **moisture staining** on the underside of the roof sheathing, corrosion (rust) on roofing fasteners penetrating into the attic, and condensation droplets on the HVAC ductwork. Collectively, these conditions indicate that warm, humid air has been reaching the cold underside of the roof assembly and condensing on cooler surfaces, particularly during cold-weather conditions. Sustained attic condensation can deteriorate roof sheathing, accelerate fastener corrosion, reduce insulation performance, and contribute to ice dam formation.

**Cause:** Elevated attic humidity, likely resulting from a combination of moisture sources within the home (including the bathroom exhaust fan terminating in the attic — see prior observation) and inadequate ventilation to dissipate the moisture load.

**Remedy:** Recommend evaluation of the attic ventilation system by a qualified roofing contractor to determine whether intake ventilation (soffit vents) and exhaust ventilation (ridge, gable, or roof vents) meet current code and industry standards for the home's attic volume. Corrective work may include adding or clearing soffit venting, installing or upgrading exhaust venting, and ensuring a balanced ventilation system. In coordination with ventilation improvements, recommend addressing identified moisture sources within the home to reduce humidity loading into the attic.

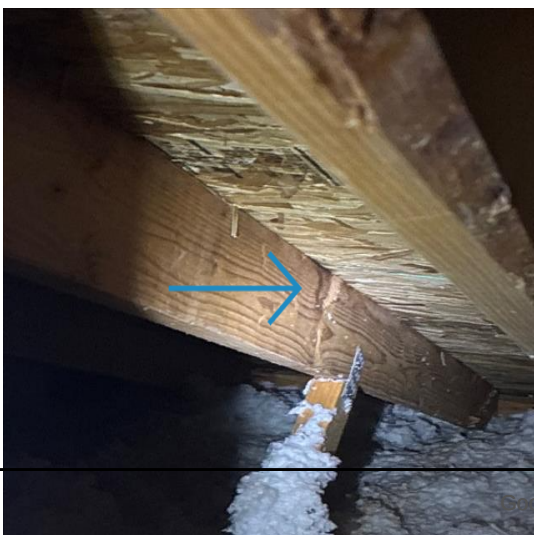
**Image Number: 72**

**Observation:** Rotting roof sheathing was observed along rafter lines in multiple locations, accompanied by moisture staining, dampened insulation with visible water droplets. At the time of inspection, no actively wet surfaces were detected. The localized pattern of sheathing rot along rafter lines is consistent with possible point-source moisture intrusion at **improperly installed roofing fasteners, in addition to attic condensation from elevated humidity**. Direct rooftop access was not available at the time of inspection to confirm fastener installation conditions from the exterior.

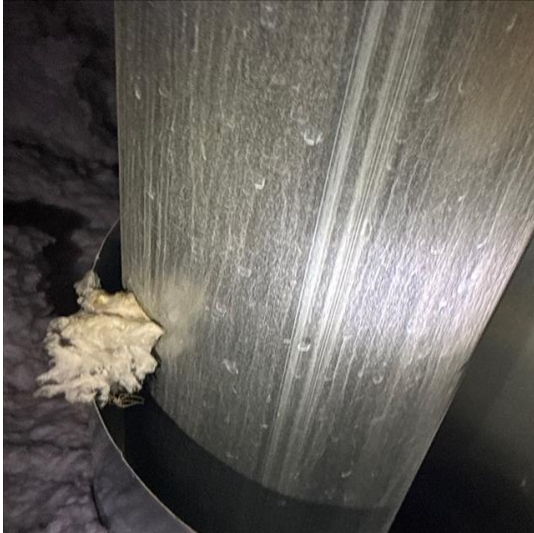
**Image Number:** 73

**Observation:** At the time of inspection, no actively wet surfaces were detected; however, multiple indicators of elevated attic humidity and prior or intermittent condensation were observed, including **moisture staining** on the underside of the roof sheathing, corrosion (rust) on roofing fasteners penetrating into the attic, and condensation droplets on the HVAC ductwork. Collectively, these conditions indicate that warm, humid air has been reaching the cold underside of the roof assembly and condensing on cooler surfaces, particularly during cold-weather conditions. Sustained attic condensation can deteriorate roof sheathing, accelerate fastener corrosion, reduce insulation performance, and contribute to ice dam formation.

**Cause:** Elevated attic humidity, likely resulting from a combination of moisture sources within the home (including the bathroom exhaust fan terminating in the attic — see prior observation) and inadequate ventilation to dissipate the moisture load.

**Remedy:** Recommend evaluation of the attic ventilation system by a qualified roofing contractor to determine whether intake ventilation (soffit vents) and exhaust ventilation (ridge, gable, or roof vents) meet current code and industry standards for the home's attic volume. Corrective work may include adding or clearing soffit venting, installing or upgrading exhaust venting, and ensuring a balanced ventilation system. In coordination with ventilation improvements, recommend addressing identified moisture sources within the home to reduce humidity loading into the attic.

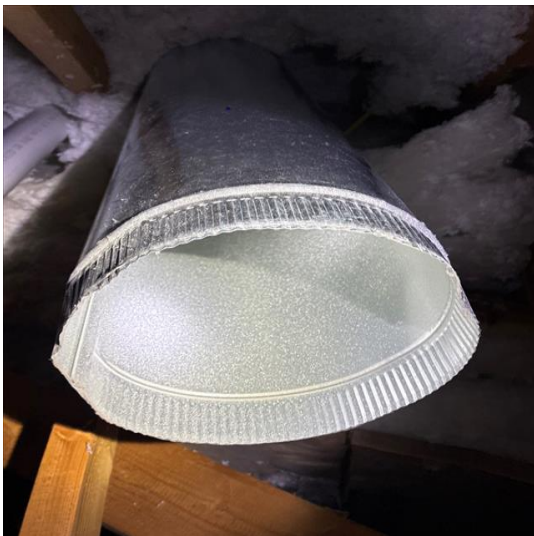
**Image Number:** 74

**Observation:** The bathroom exhaust fan was observed to **terminate into the open attic space rather than extending to the building exterior**. Recommend correction by a qualified mechanical or general contractor.

**Cause:** Improper workmanship.

**Remedy:** Recommend extending the vent pipe through the roof to a code-compliant exterior termination, with proper roof flashing and sealing at the penetration, by a qualified plumbing contractor in coordination with a qualified roofing contractor for the new roof penetration.

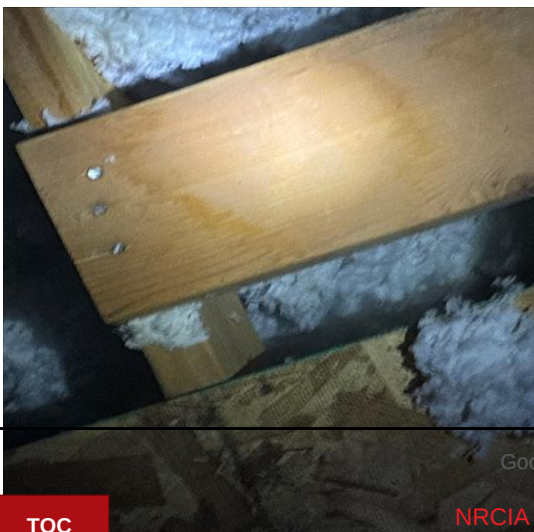
**Image Number:** 75

**Observation:** Above the living room. Larger moisture stain indicating **moisture intrusion**. Due to limited roof access during inspection, direct location could not be found.

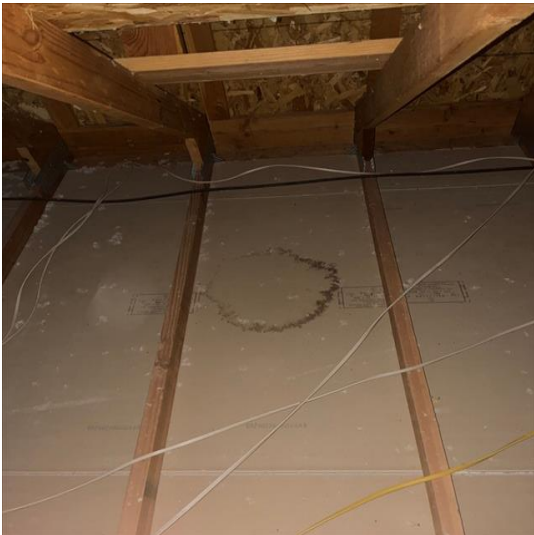
Image Number: 78  
**Observation:** Observation: Garage: Moisture stains were noticed along the eaves and valley rafters. Moisture stains were noticed on the garage drywall as well indicating roof leak. Roof access was limited and was unable to pinpoint where all the locations are.

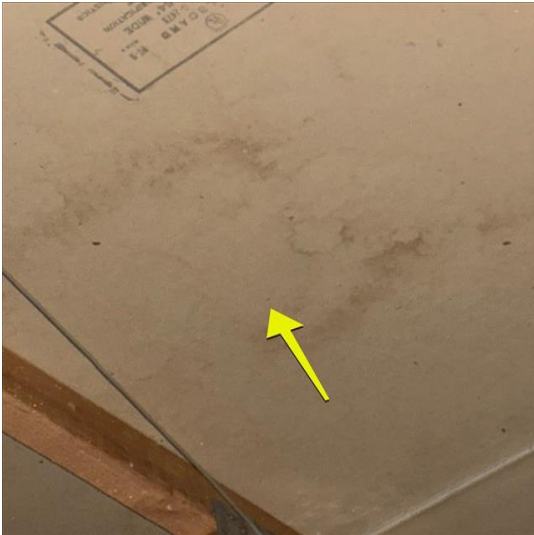
**Image Number: 82**  
**Observation: Observation:** Garage: Moisture stains were noticed along the eaves and valley rafters. Moisture stains were noticed on the garage drywall as well indicating roof leak. Roof access was limited and was unable to pinpoint where all the locations are.

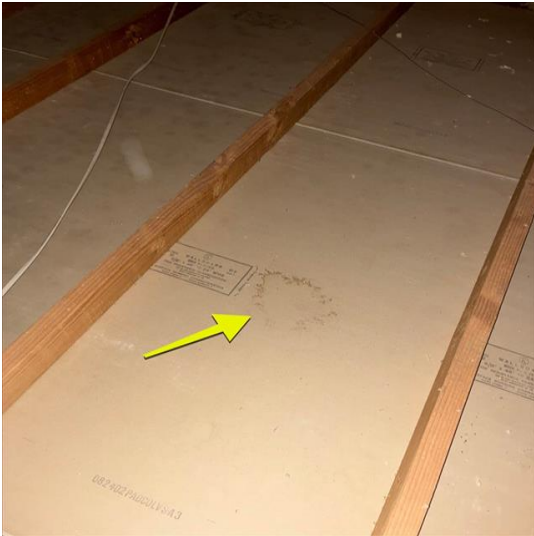
**Image Number: 83**  
**Observation: Observation:** Garage: Moisture stains were noticed along the eaves and valley rafters. Moisture stains were noticed on the garage drywall as well indicating roof leak. Roof access was limited and was unable to pinpoint where all the locations are.

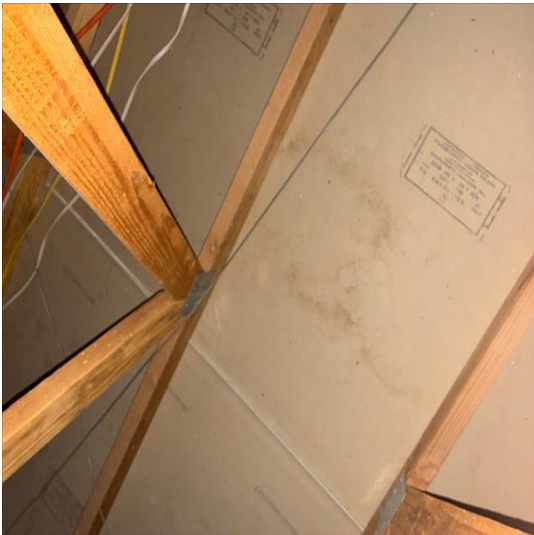
**Image Number: 84**  
**Observation: Observation:** Garage: Moisture stains were noticed along the eaves and valley rafters. Moisture stains were noticed on the garage drywall as well indicating roof leak. Roof access was limited and was unable to pinpoint where all the locations are.

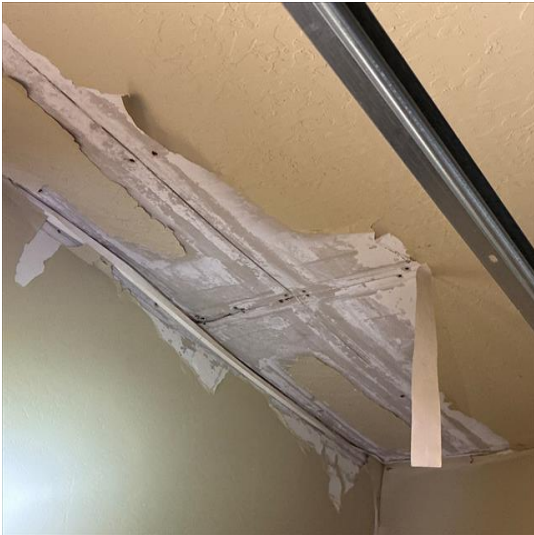
**Image Number:** 94  
**Observation:** **Observation:** Cracking and moisture staining were observed at the ceiling drywall seams in multiple locations. This condition is a **red flag**, indicating the potential for active or past moisture intrusion.

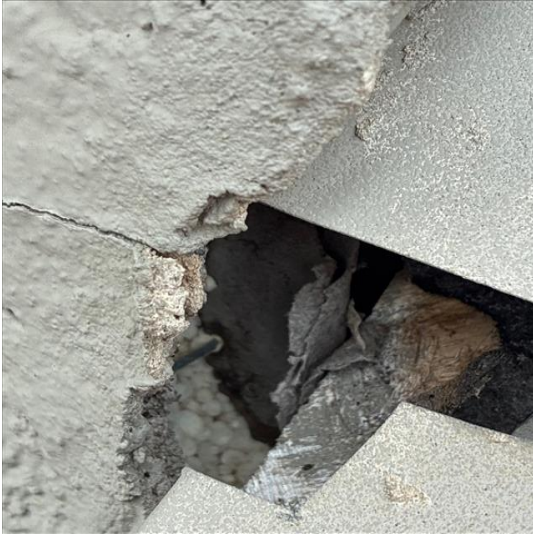
**Image Number:** 103

**Observation:** **Observation:** Wood is exposed the elements. This is important to address because it will continue to rot and also continue the siding to crack.

**Cause:** Improper workmanship.

**Determination:** Replacement required

**Remedy:** Properly install diverter flashing.

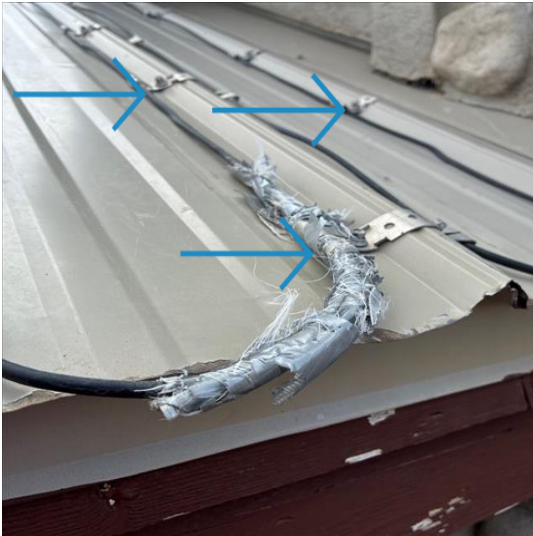
**Image Number:** 104

**Observation:** **Observation:** The heat cable gaskets are on top of the strap. They are supposed to be the lowest point of contact to ensure water intrusion.

**Cause:** Improper workmanship.

**Determination:** Replacement required

**Remedy:** If heat cables are kept, they should be installed with the gaskets at the lowest point of contact.

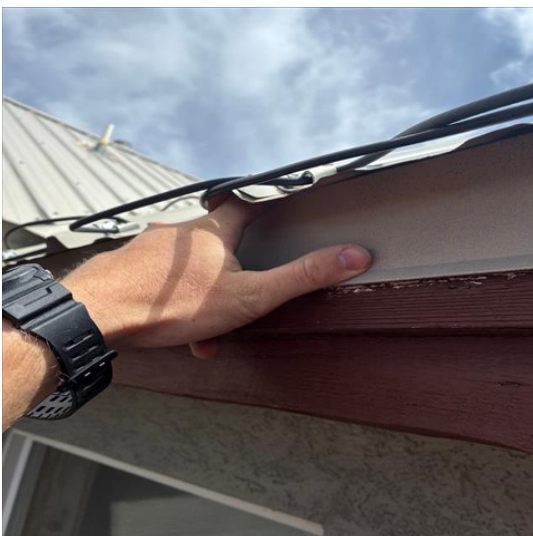
**Image Number:** 105

**Observation:** Due to visual inspection, proper installation of ice and water shield could not be confirmed.

**Determination:** Replacement required

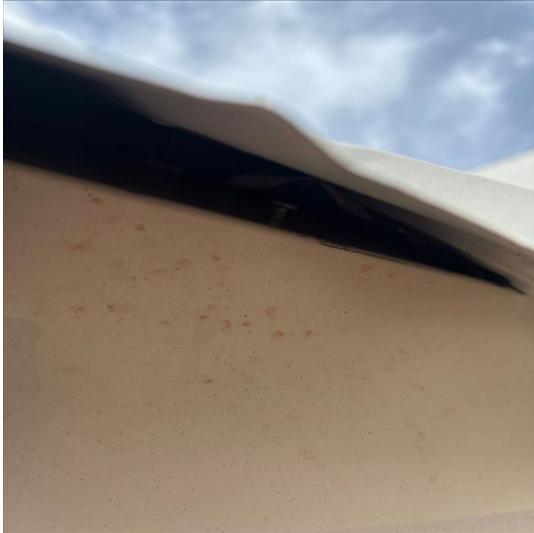
**Image Number:** 106

**Observation:** Due to visual inspection, proper installation of ice and water shield could not be confirmed.

**Determination:** Replacement required

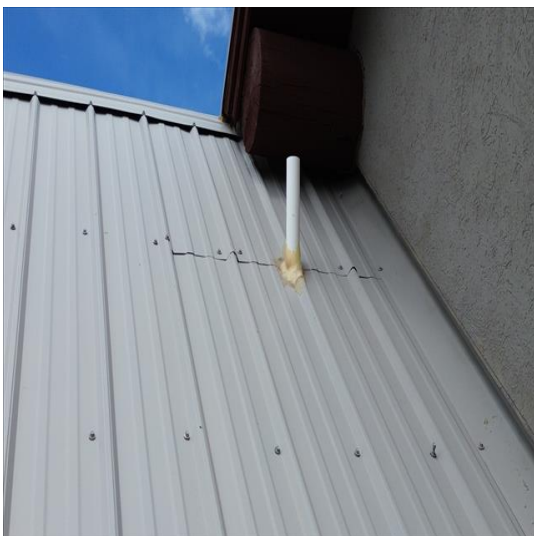
**Image Number:** 108

**Observation:** **Observation:** Roof pipe flashings are incorrectly installed and also need maintenance. They are relying on sealant which has a low life expectancy. One flashing was observed to be sunken which will allow moisture to pool and enter the home. Due to the wind for the drone and lack of access to the roof, not all penetrations were able to get thoroughly inspected.

**Determination:** Replacement required

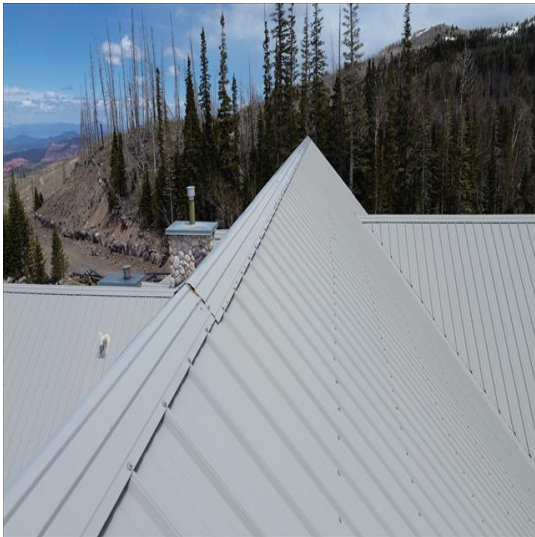
**Image Number:** 113  
**Observation:** Ridge Overview.  
**Determination:** Replacement required

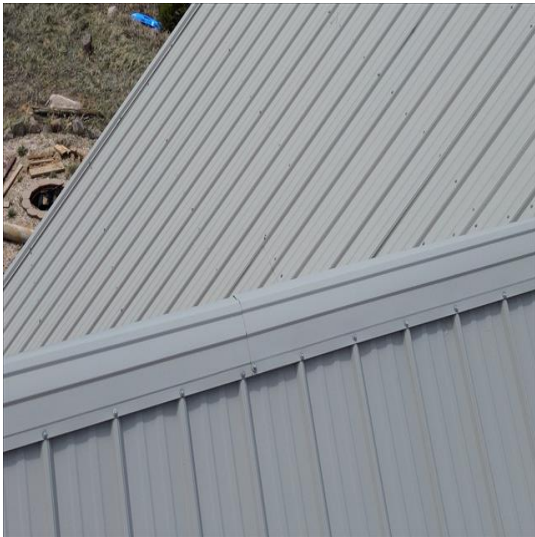
**Image Number:** 114  
**Observation:** Ridge Overview.  
**Determination:** Replacement required

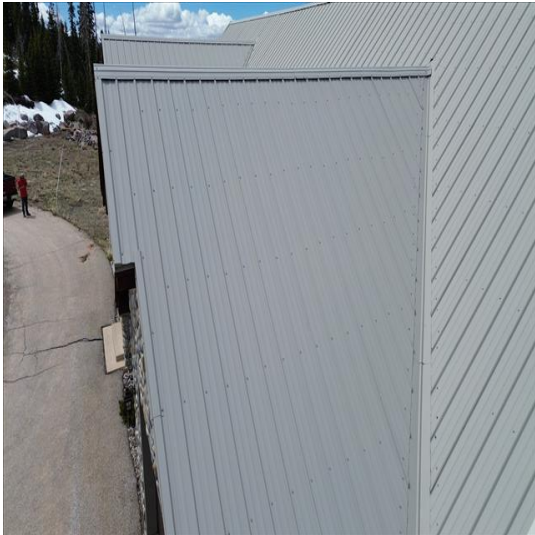
**Image Number:** 115  
**Observation:** Ridge Overview.  
**Determination:** Replacement required
